Facilities Assessment Report

November 3, 2015

County of Champaign, Illinois

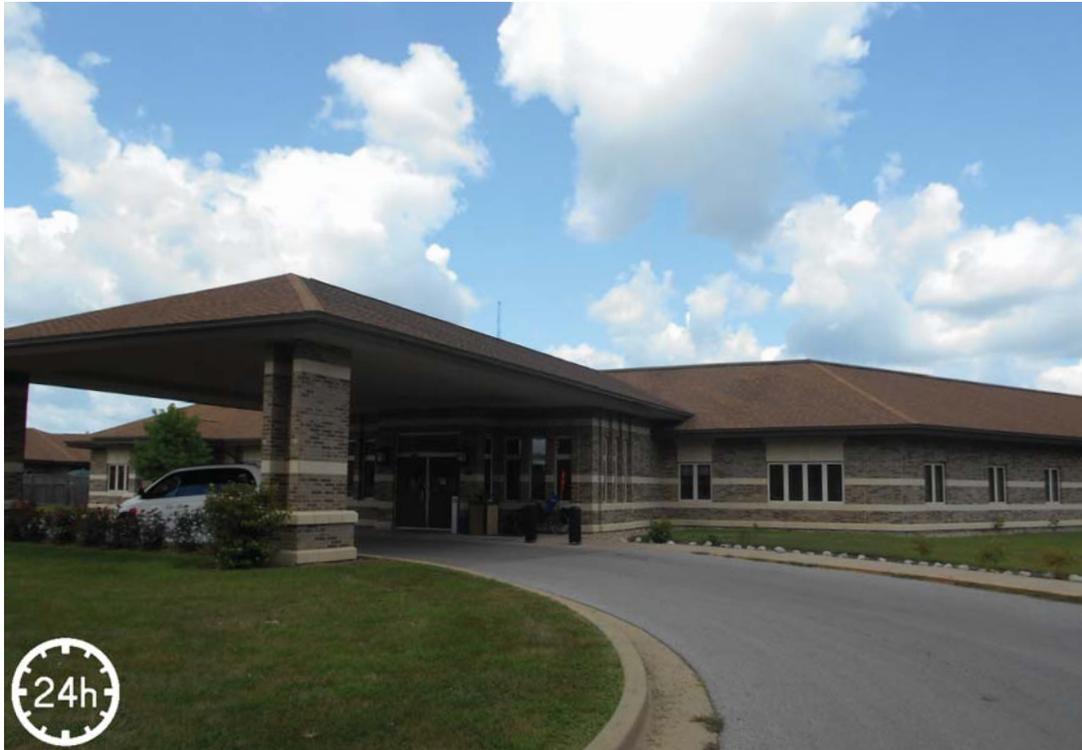
Nursing Home

- This building has a back-up generator.
- Brick masonry requires cleaning, minor re-pointing.
- Metal materials on and around exterior deteriorating and staining concrete.
- Exterior soffit panels missing, exposing non-weather resistant materials.
- Cosmetic scratches and damage to interior doors and frames.
- Interior flooring in good condition, minor staining and wear from normal use.
- Wall finishes in generally good condition, some impact damage and scratches.
- Tile floor and base in kitchen damaged and cracked. Some missing grout.
- Ceiling tiles in generally good condition, some water stains and damaged tiles.
- Existing nurse's call system has reliability issues and should be replaced.
- The return air system has several operational and control issues.

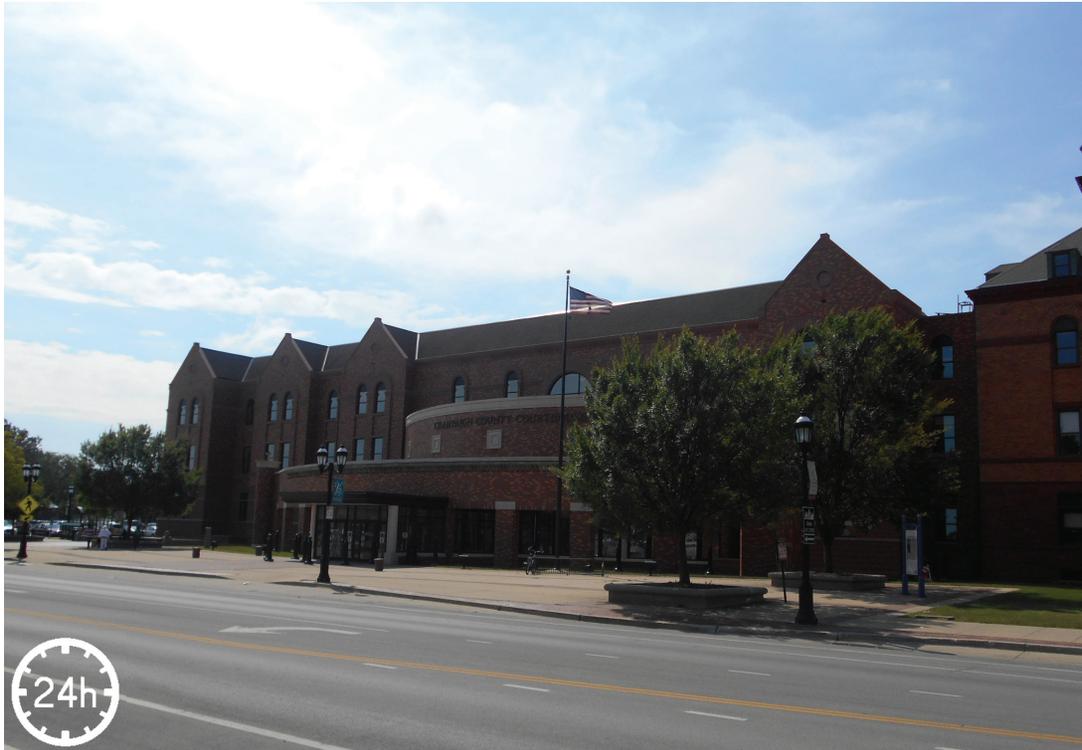
Courthouse Addition

- This building has a back-up generator.
- Interior walls and surfaces in good condition, minor drywall damage.
- Wall covering in courtrooms damaged and torn in various locations.
- Courtroom carpet tiles worn.
- Epoxy coating heavily worn and masonry crack in holding cells.
- Gutters and flashing dented in places.
- Standing water, moss and plants growing in roof ballast.
- Some masonry efflorescence and joint deterioration on facade.
- Scratches and some damage to interior wood doors.
- Steel mansard supporting structure needs to be painted.
- HVAC provided by air handling units, boilers, and chillers. Shared with original building.

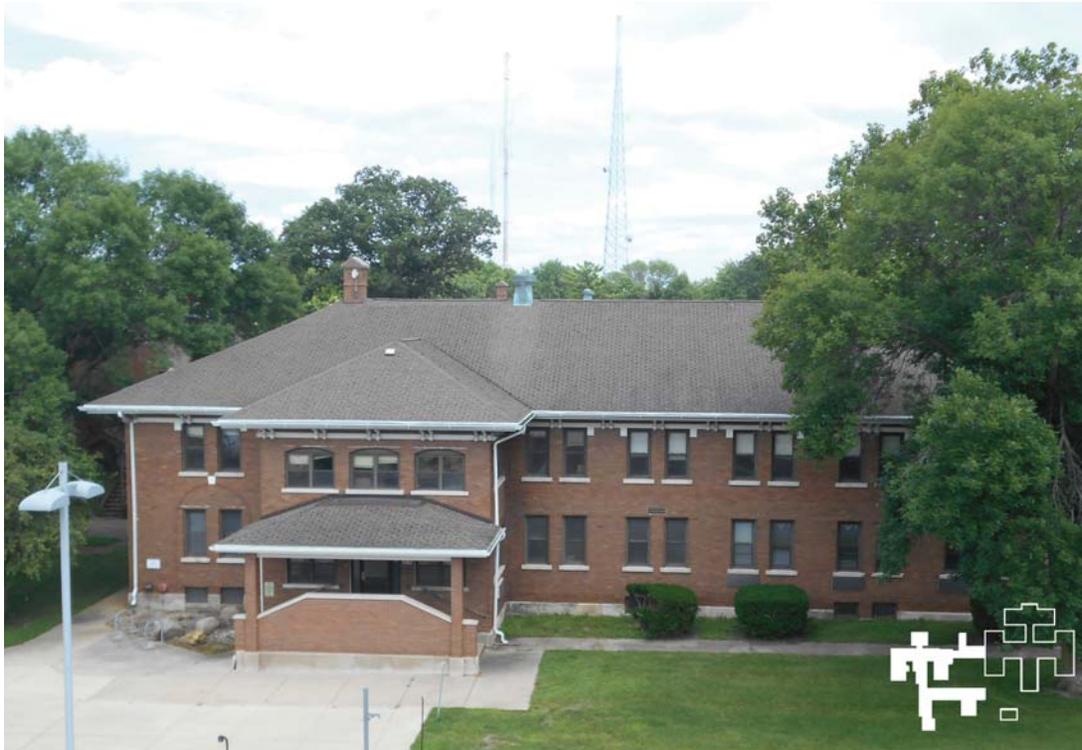
ILEAS Original Building

- The building is in various states of disrepair as a result of limited use/abandonment.
- Most of the flooring is damaged or missing; Interior wall finishes are worn and peeling.
- Ceilings tiles and gypsum board ceilings are heavily damaged and deteriorated.
- Fire doors in basement do not meet code requirements.
- There is mold present at areas of failing roof.
- Landscaping is overgrown and encroaching on the building; organic material in gutters.
- Water infiltration and efflorescence on exterior brick.
- Asphalt roofing requires total replacement.
- Roof structure needs to be replaced in several areas.
- All MEP infrastructure requires replacement.
- Spaces served by 4 pipe fan coil units that are nearing end of useful life.

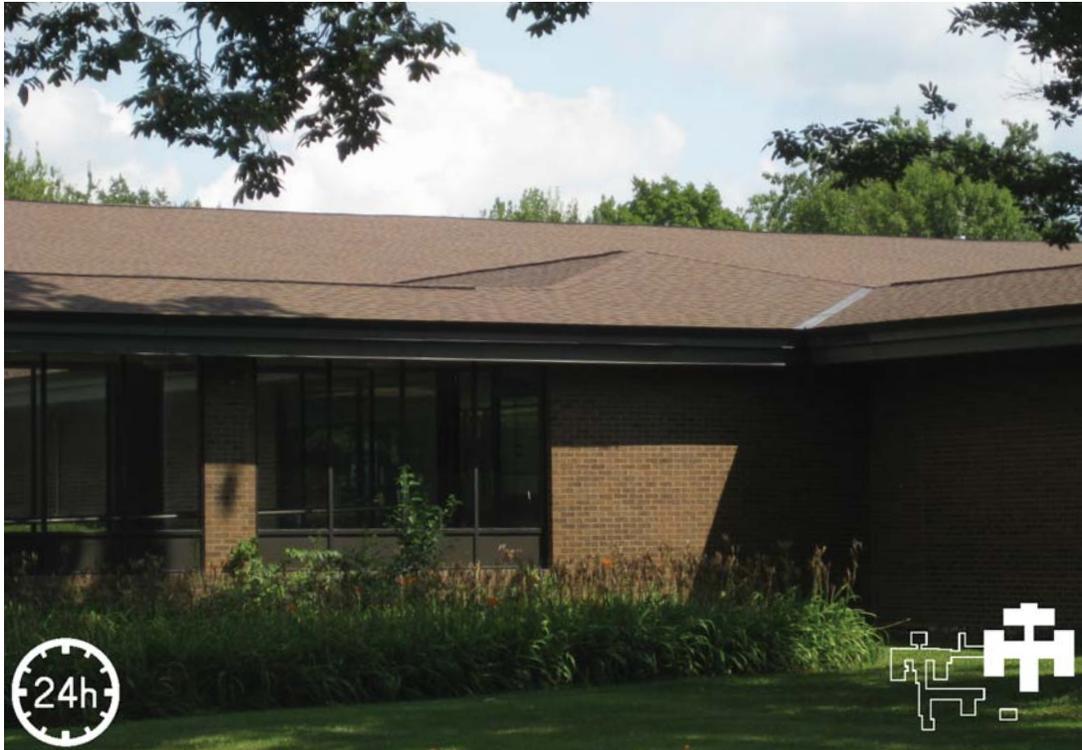
- This building has a back-up generator.
- Exterior brick planters are cracked.
- Some exterior walkways are cracked and pose tripping hazards.
- Two wings require interior finish upgrade.
- Grout in tile flooring is stained, some tile broken on walls.
- galvanized piping nearing the end of its useful life.
- VCT is stained and damaged at tactical areas.
- Exterior stone sealant is deteriorated, signs of water penetration.
- Exterior window storefront panels, mullion end caps missing and glass is cracked.
- Organic material found inside facility.
- Spaces served by 4 pipe fan coil units that are nearing end of useful life.

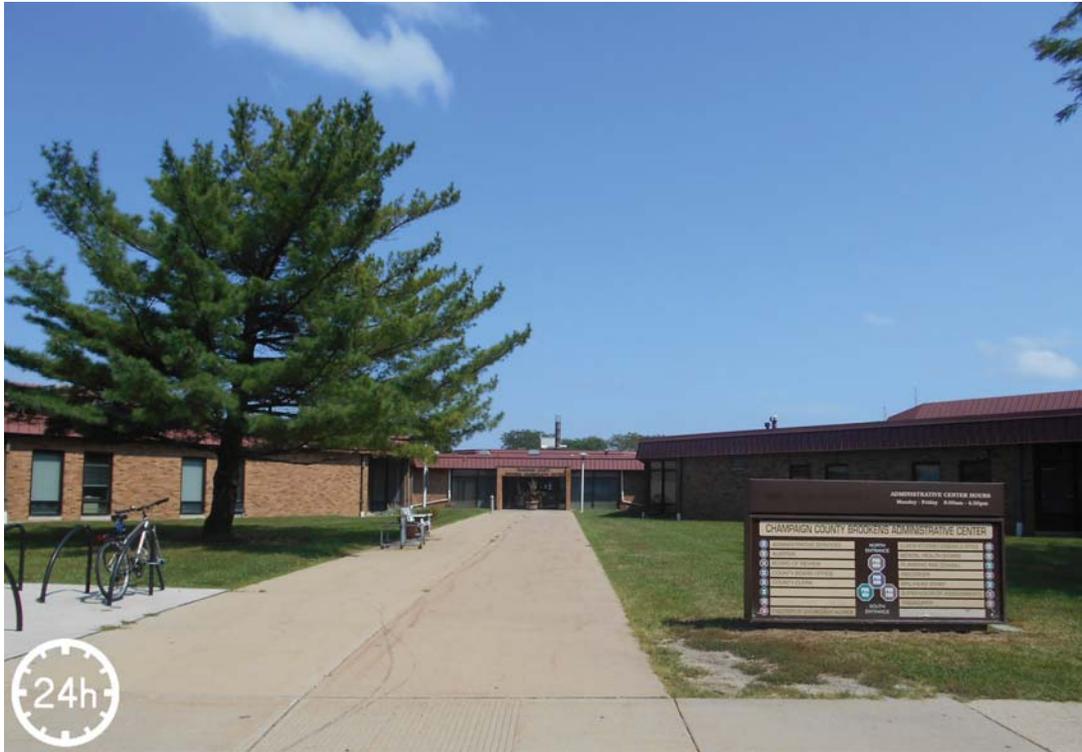
Brookens Administrative Center

- This building has a back-up generator.
- Roof and soffit replacement needed at portion of facility.
- Downspouts are in need of repair, many are dented or loose.
- Parking lot recently resurfaced and is in good condition.
- Minor brick repair and sealant replacement required.
- Sidewalks cracked and damaged in places.
- Interior wall finishes in generally good condition.
- Exterior insulation is heavily damaged or missing.
- Roofing membrane in fair condition, Pod 100 and 200 need to be replaced.
- Served by small DX cool, gas heat RTUs nearing end of useful life.

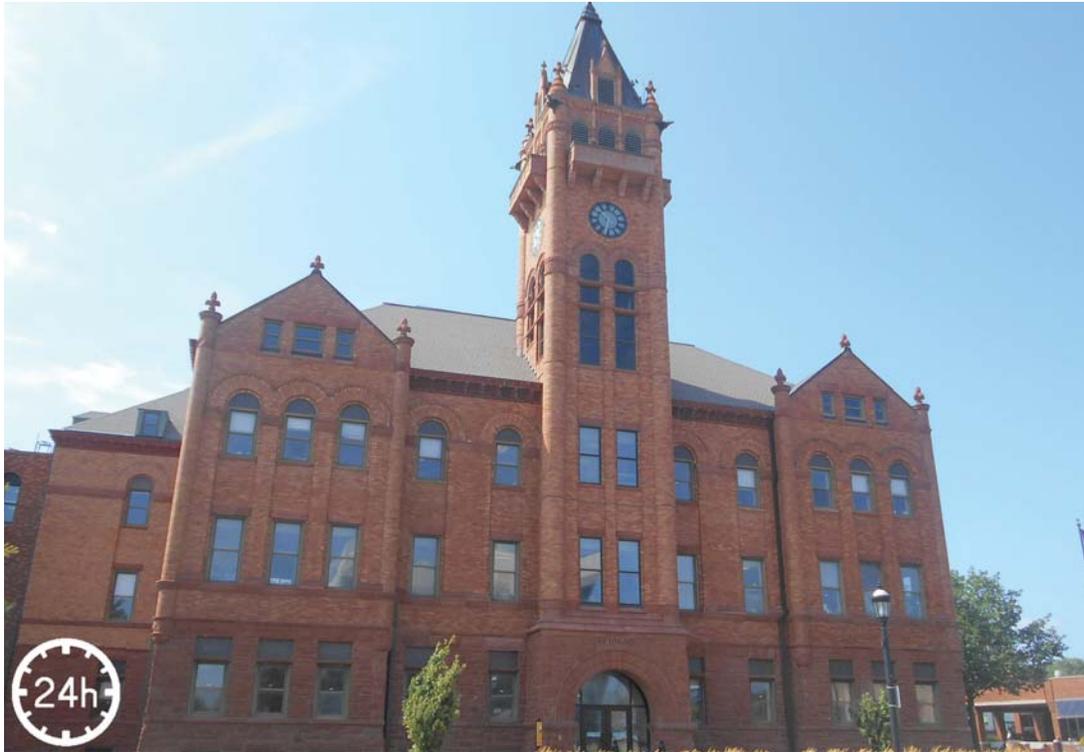
- This building has a back-up generator.
- Stair treads worn and damaged.
- Carpet in generally good condition, stained and worn in select locations.
- Decorative marble chair rail stained and shows signs of deteriorated grout.
- Drywall finishes in good condition, some damage at corners and window jambs.
- Asphalt shingles in good condition.
- Wood steps and platform on roof heavily deteriorated and need to be replaced.
- Roof ballast missing and uneven in locations.
- Exterior brick and stone in generally good condition, some cracks and damaged stone.
- EPDM roof requires replacement.
- HVAC provided by air handling units, boilers, and chillers. Shared with addition.

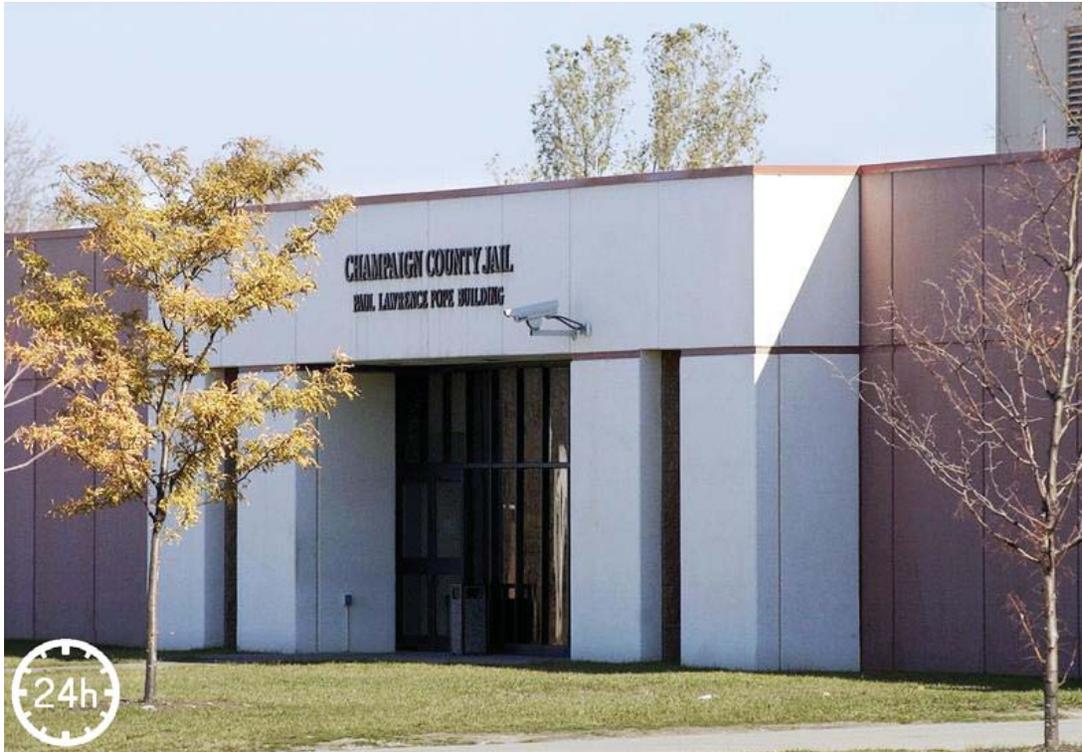
Adult Detention Facility

- This building has a back-up generator.
- Overall the building is in fair condition.
- Interior sealed concrete is heavily worn with some large cracks.
- Metal doors are scratched and dented.
- Cell doors show signs of deterioration and impact damage.
- Floor drains are heavily rusted and filled with debris.
- Sally port doors are oversized and prone to failure.
- Security system is outdated and needs to be replaced.
- Paint finishes are worn and deteriorating.
- Carpeting and millwork is heavily worn with some staining.
- Served by four mechanical units installed in two rooftop penthouses.

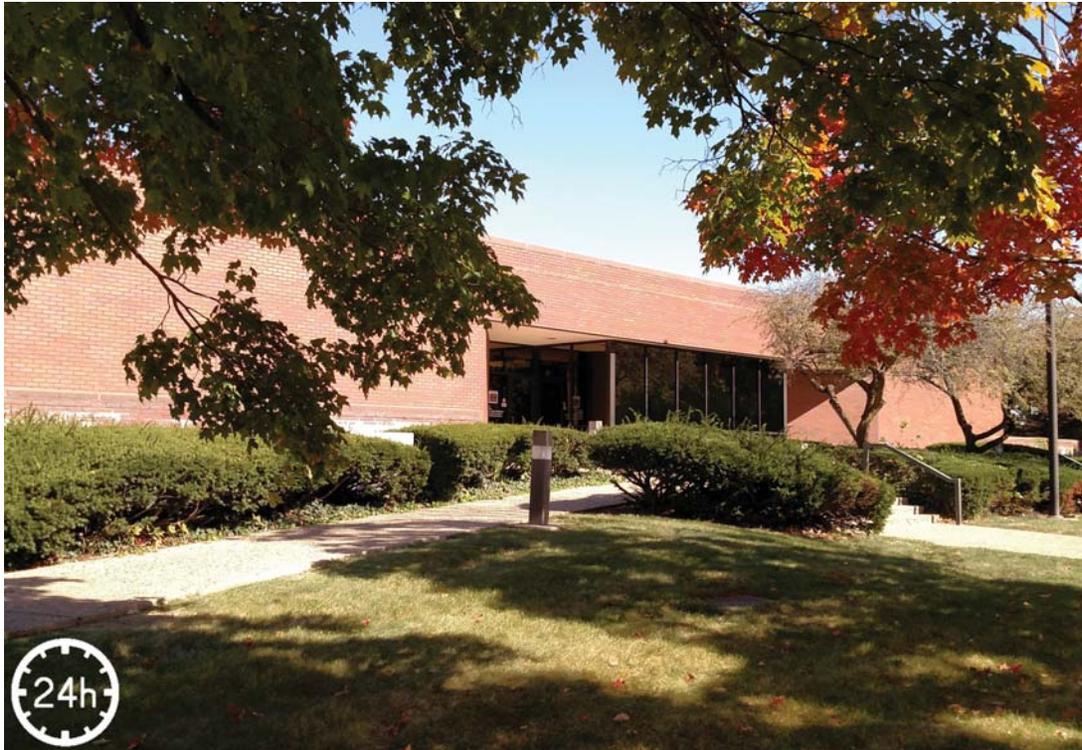
- This building has a back-up generator.
- Original mechanical equipment requires replacement.
- Masonry joint deterioration, minor cracking, and plant growth.
- Major brick efflorescence on walls around building and screen walls.
- Stone parapet stained, possible moisture penetration.
- Exterior metal doors have deteriorated.
- Sun screen at ceiling enclosure in recreation area is heavily damaged.
- VCT adhesive failed and tiles are missing.
- Interior CMU cracked in multiple locations.
- Served by two boilers and a chiller original to building.
- Cooling tower leaks and is not used.

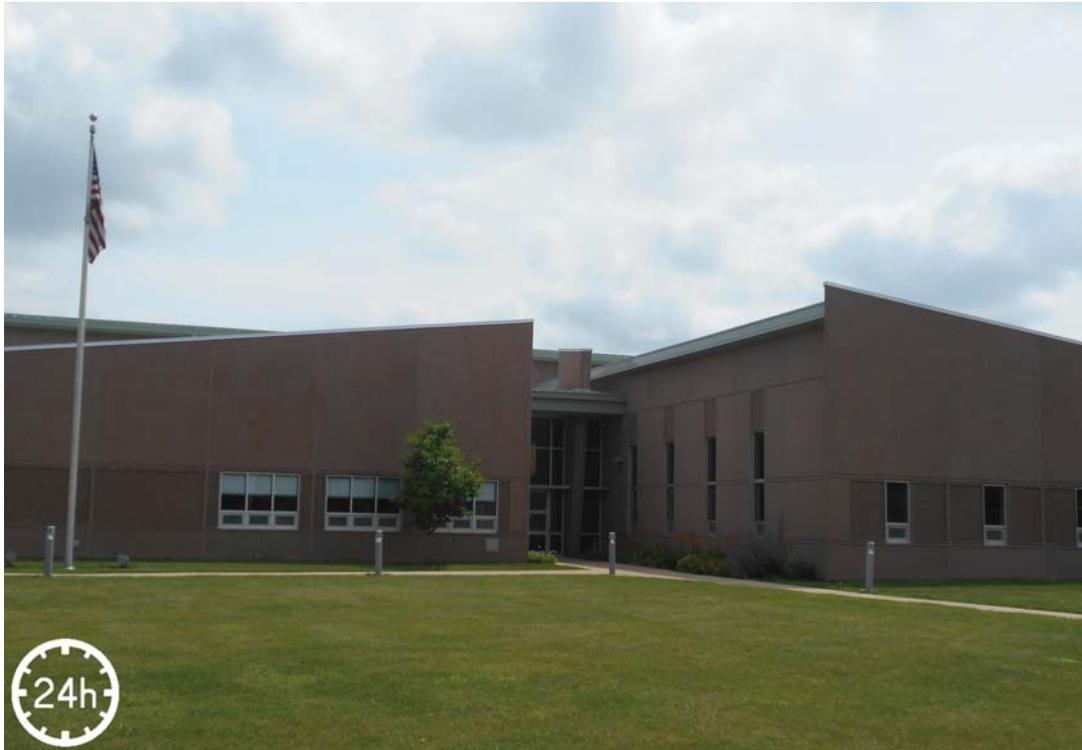
Highway Fleet Maintenance

- This building has a back-up generator.
- Overall, building is in very good condition.
- Minor cracking and efflorescence at exterior precast panels.
- Water infiltration at roof parapet walls due to exposed steel and cracked panels.
- Metal roof in good condition. Sealant replacement recommended.
- Mechanical systems in good condition with minor repairs needed.
- Power and data sufficient for current needs.
- Most interior finishes still in good condition. Minor updating and repairs recommended.
- Parking lot recently resealed. Concrete pathways in good condition.
- No deficiencies noted in structural system.
- Offices served by small blower coil units, maintenance exhausted by gas fired MAU's

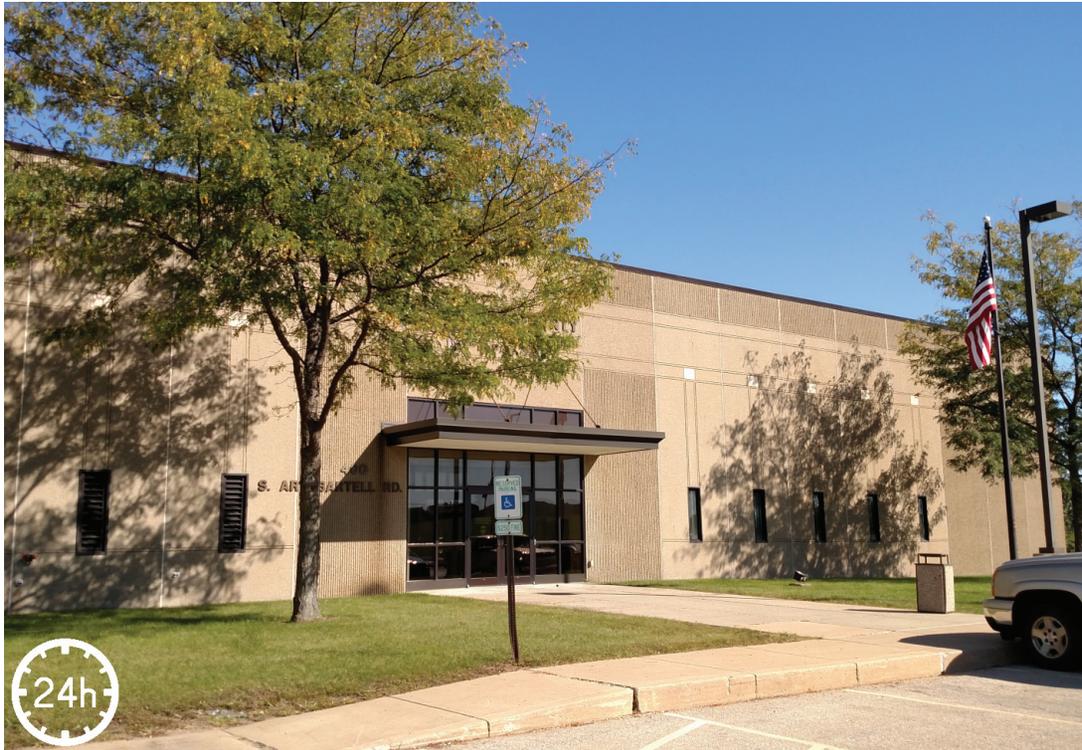
Juvenile Detention Facility

- This building has a back-up generator.
- Interior carpet in generally good condition, minor wear and stains from normal use.
- Paint peeling and flaking off interior window sills and jambs.
- Ceiling tiles stained around HVAC vents.
- Heavy wear and staining to VCT in bathrooms.
- Interior metal doors show signs of wear and rust. Trim and frame paint peeling in areas.
- Sealed concrete flooring stained in some places, mostly along walls.
- Vinyl wall base heavily damaged and worn.
- Main entrance threshold worn, VCT chipped.
- Exterior is in generally good condition, some water stains and minor cracks.
- Served by several small rooftop units and are in good condition.

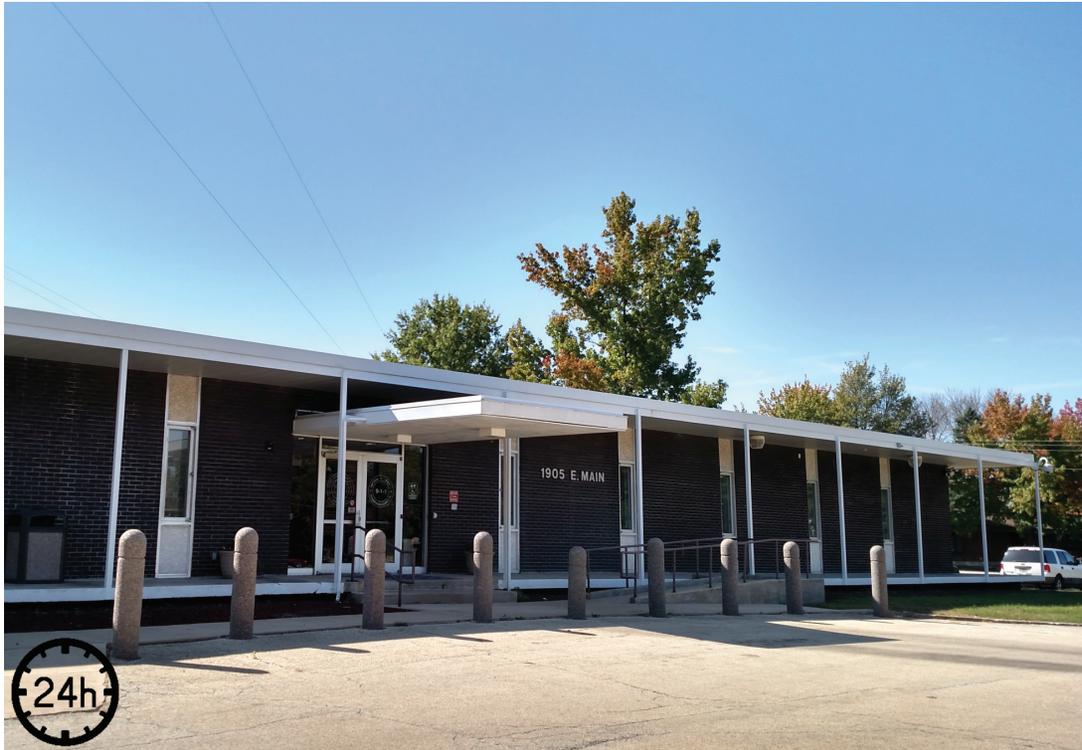
Emergency Operation Center (METCAD)

- This building has a back-up generator.
- AHU near the end of its useful life.
- Overall, the building is in good condition.
- The interior wall finishes are in generally good condition, normal use wear.
- Carpet and VCT surfaces are in good condition.
- Exterior brick is worn, some sealant damage at windows.
- Railings along accessible ramp are deteriorating.
- Minor cracks on ramp and walk.
- Gutters in good condition, some paint peeling.
- Roof will need replacement.
- Served by AHU's and condensing units, AHU's nearing end of useful life.

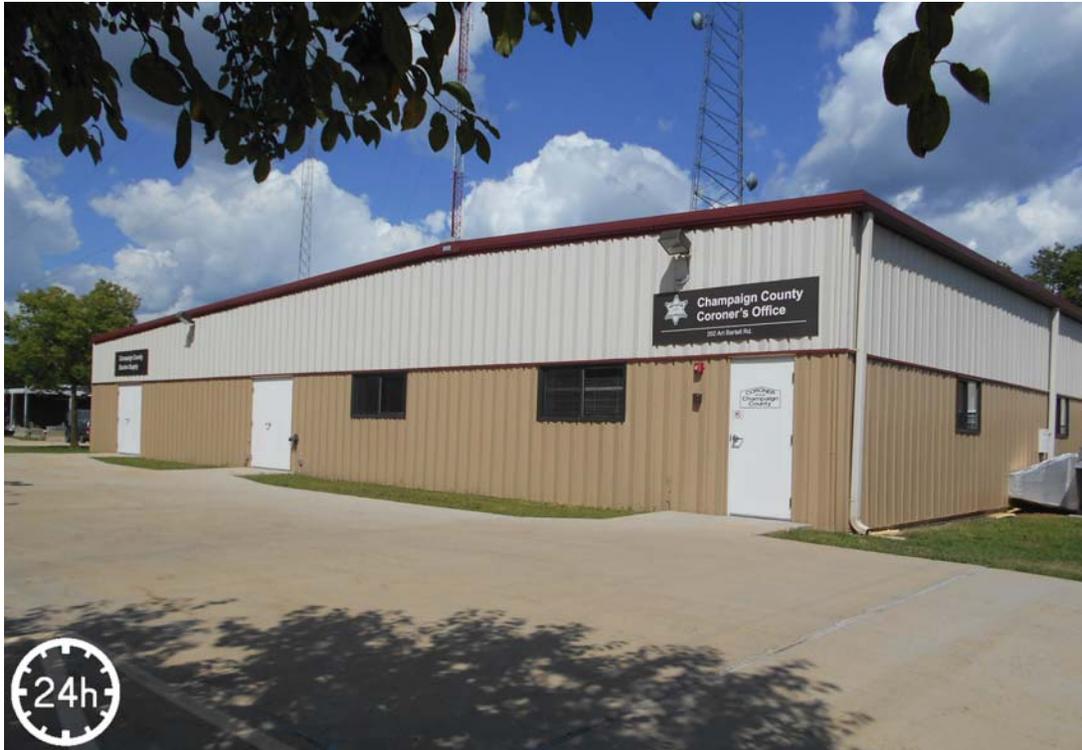
Coroner's Office

- This building has no back-up generator.
- The building is in generally good condition.
- Ceiling tiles show signs of minor water damage.
- VCT flooring is worn and scratched in places of heavy use. Some joints are separated.
- Drywall is in good condition, minor scratches and cosmetic damage.
- Interior doors show signs of wear and some damage to finishes.
- Exterior wall panels have minor surface damage.
- Insulation along foundation is damaged, missing in places.
- Windows are in good condition.
- Served by packaged AHU at grade. AHU is in good condition.

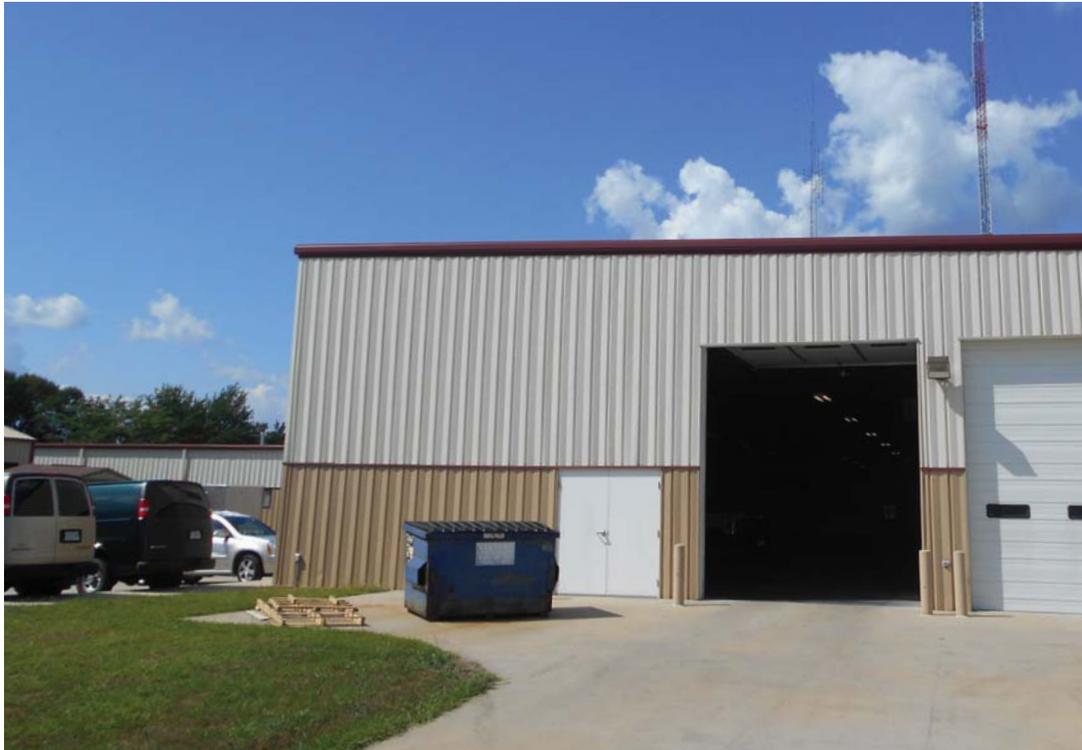
- Building is overall in good condition.
- Metal wall panels on exterior in generally good condition, minor damage.
- Interior sealed concrete flooring stained and worn.
- VCT flooring heavily scratched and worn, stained in some areas.
- Minor drywall damage, some impact damage and scratches.
- Insulation behind exposed structure stained in places on ceiling and walls.
- Insulation along foundation damaged and missing in places.
- Heavy water damage to landscaping at downspouts.
- Sealant failure along edge between metal panels and concrete.
- Ventilation provided by roof mounted exhaust fan in good condition.
- Heating provided by three gas fired unit heaters in good condition.

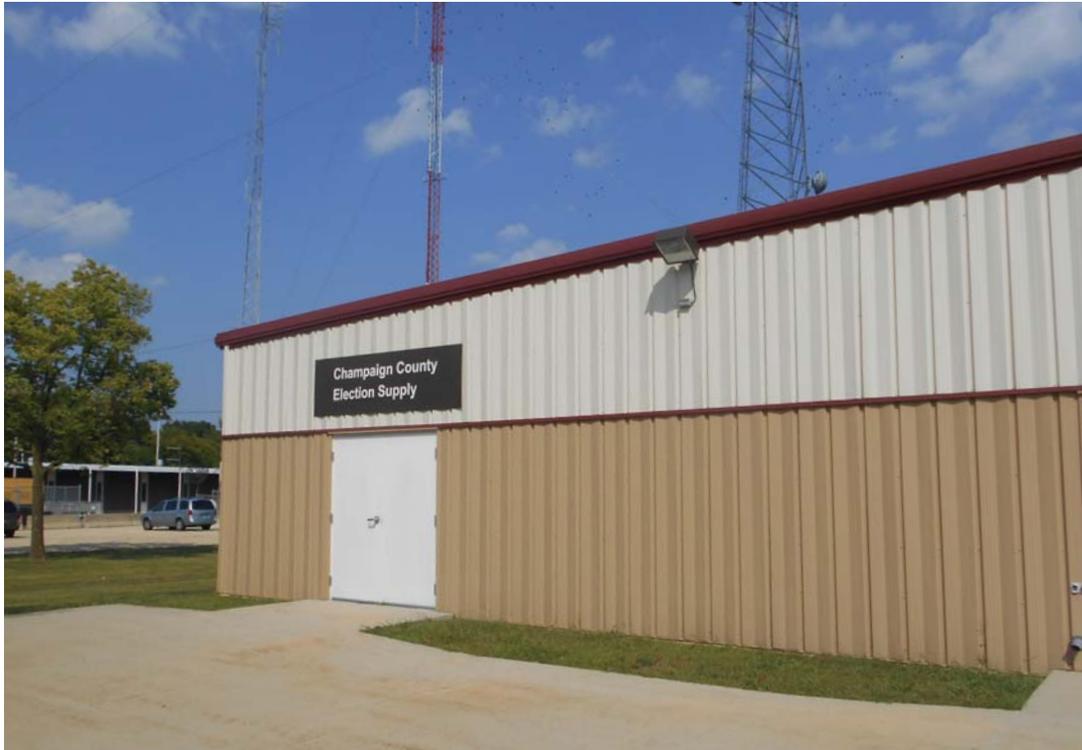
Election Supply

- This building is in good condition.
- Minor dents and cosmetic damage to exterior metal panels.
- Windows are in good condition.
- Foundation insulation is damaged and missing in places.
- Interior sealed concrete flooring is stained and worn.
- Ceiling tiles are in good condition, few missing or stained.
- Rubber wall base missing in places.
- VCT in bathroom worn and stained.
- Carpet tiles in good condition.
- Interior drywall and finishes in good condition.
- HVAC provided by unit mounted on grade

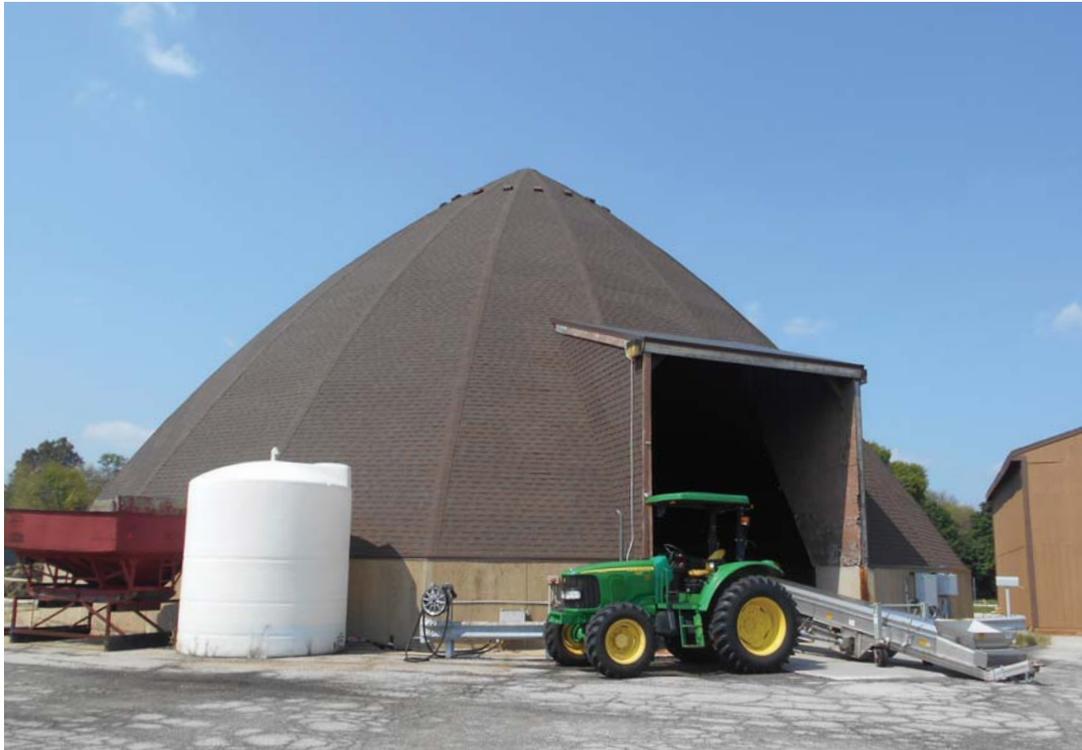
- Overall the building is in fair condition.
- All metal in the building is deteriorated, some has completely deteriorated.
- Rusty metal is staining surrounding concrete surfaces.
- Most concrete surfaces, mainly by the entrance, are pitted and have exposed aggregate.
- Exposed wood at entrance is deteriorated.
- Asphalt shingles are in generally good condition.
- Interior wood dome structure is in good condition.
- Concrete seals around exterior are worn and deteriorated.
- Standing water around foundations.

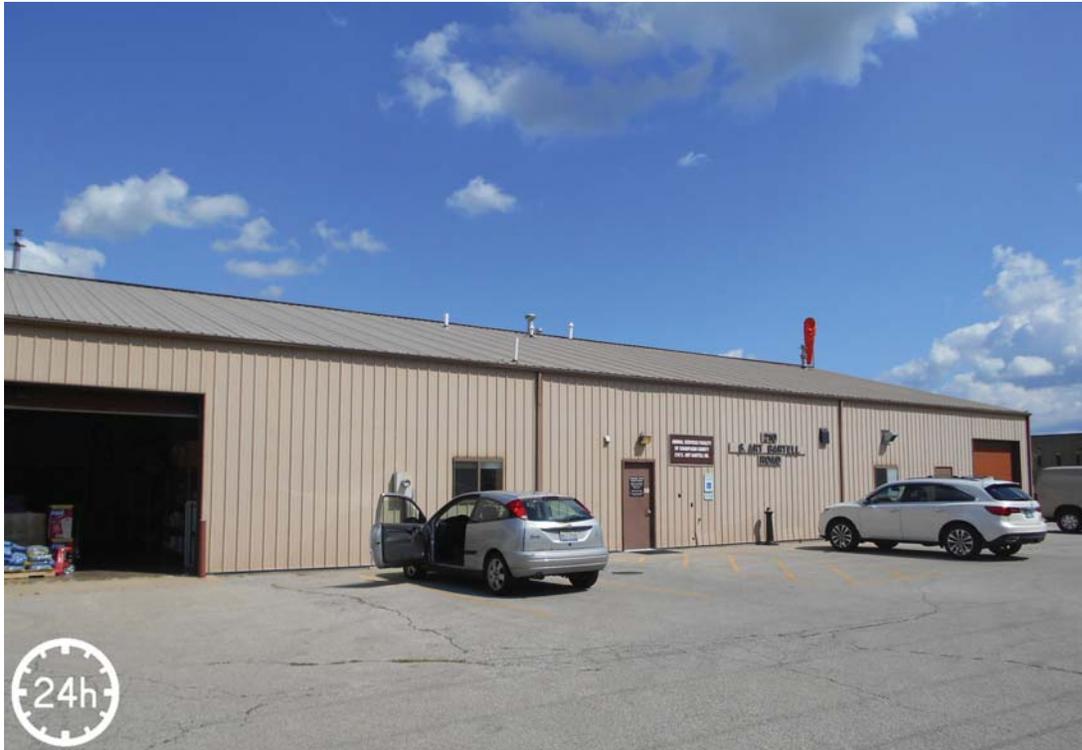
- This building has no back-up generator.
- Exterior metal wall panels have impact damage in multiple locations.
- Downspouts are in good condition, minor damage.
- Exterior wood door trim is deteriorated, paint peeling.
- Threshold sealants are failed.
- Metal doors are scratched and worn.
- Ceiling tiles are in fair condition, some large stains in places.
- Sealed concrete flooring is stained and worn.
- Overhead doors have impact damage on the exterior.
- Windows are in fair condition, some deterioration around edges of window frames.
- HVAC provided by two packaged AHU's on grade and are in good condition.

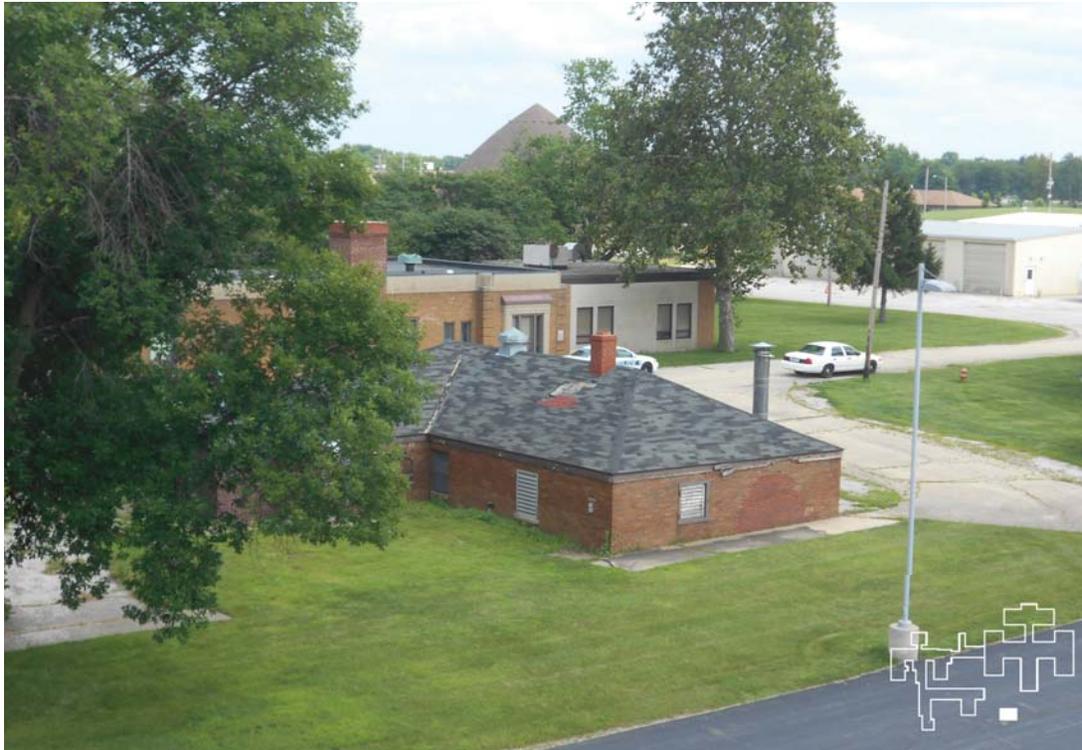
ILEAS Boiler House

- The building envelope is severely deteriorated and requires reconstruction.
- Landscaping is overgrown and encroaching on the building.
- There is water infiltration and efflorescence on exterior brick.
- Gutters contain organic material.
- With the exception of one boiler, the mechanical systems should be completely replaced.
- Adjacent concrete and paving is cracked and deteriorated.
- Brick joints are deteriorated or missing; bricks are loose in places.
- Wood trim is heavily damaged and deteriorated.
- Asphalt shingles are damaged and missing.
- Roofing and roof structure require replacement.

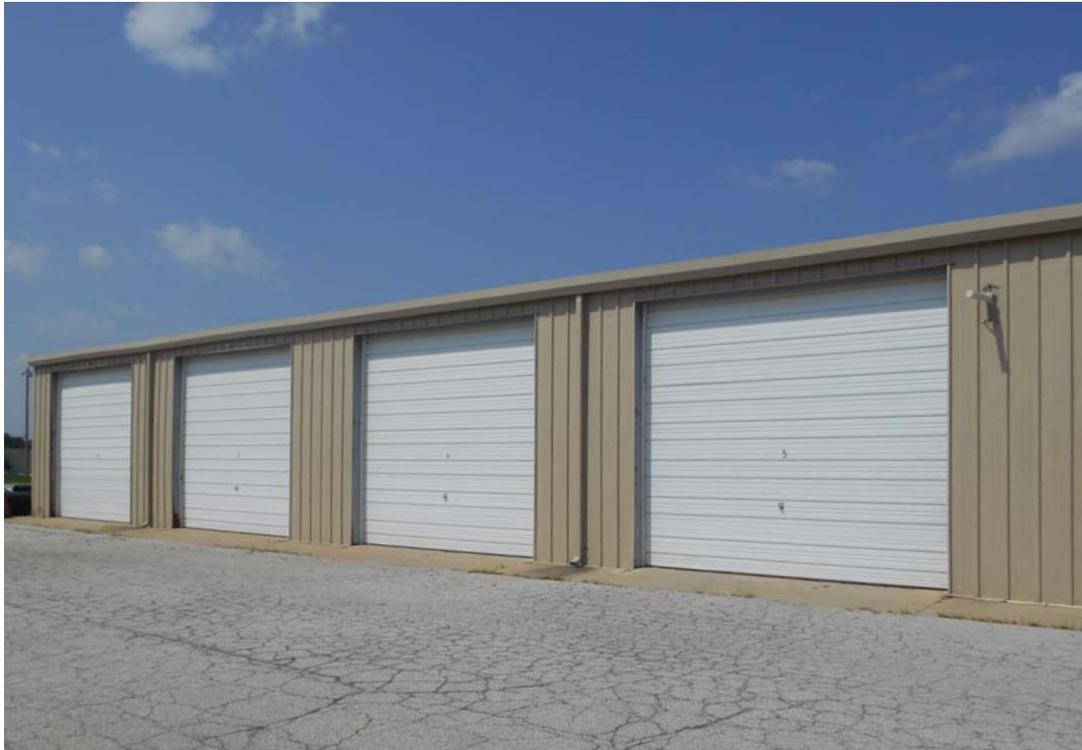
- Exterior door finishes deteriorated at base of doors.
- Exterior wall panels in fair condition, minor damage and deterioration.
- Downspouts damaged, finish worn and integrity compromised.
- Soffits and gutters rusted, paint deteriorated.
- Perimeter sealant/patch at concrete joints failed.
- Weatherstripping at overhead doors failed. Trim broken and missing.
- Windows are in good condition.
- Gaps in metal panels at penetration locations, require sealant.
- Interior insulation panels worn, some impact damage.
- Concrete flooring heavily worn and pitted.

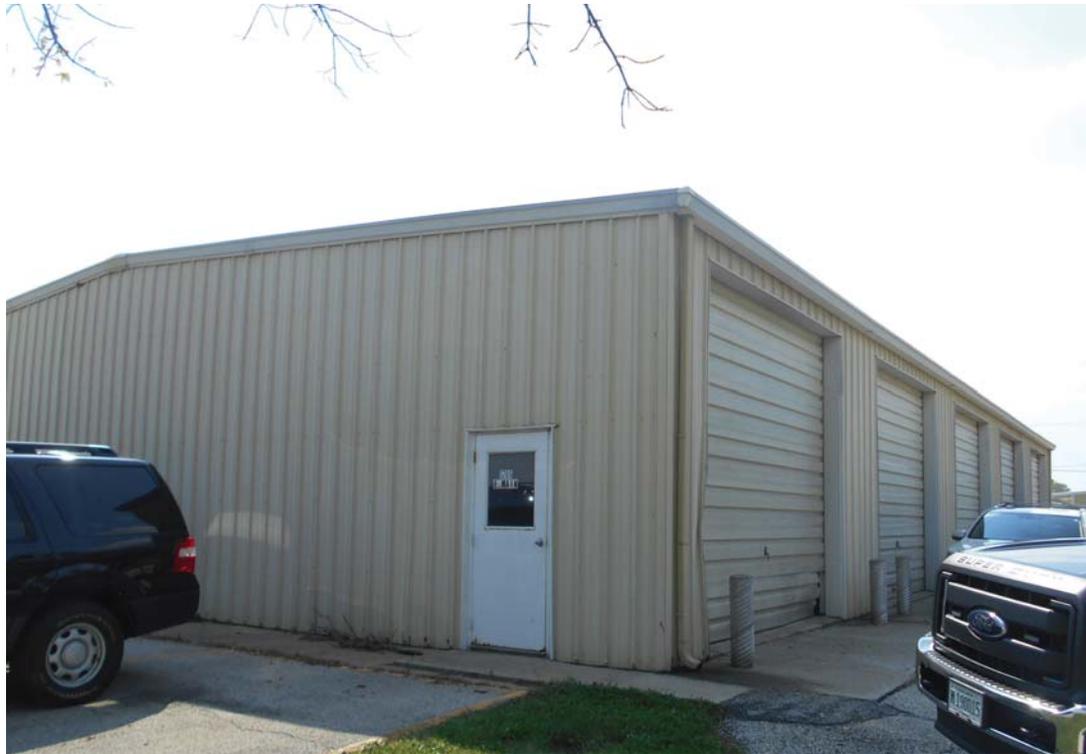
County Highway Garage

- The garage overall is in fair condition.
- Concrete flooring stained and worn, minor cracks.
- Exterior door finishes and frames are deteriorated and rusted at base.
- Fiberglass overhead doors are damaged, panels cracked and kicked-in at base of frame.
- Overhead door jambs are dented and warped.
- Moisture damage and rust at base of metal wall panels.
- Metal wall panel seams dented and peeling apart.
- Several large tears in metal wall panels.
- Sealant at base of metal wall panels along concrete deteriorated.
- Bollards damaged from impact.
- No ventilation or heating present. No oil interceptor at trench drains.

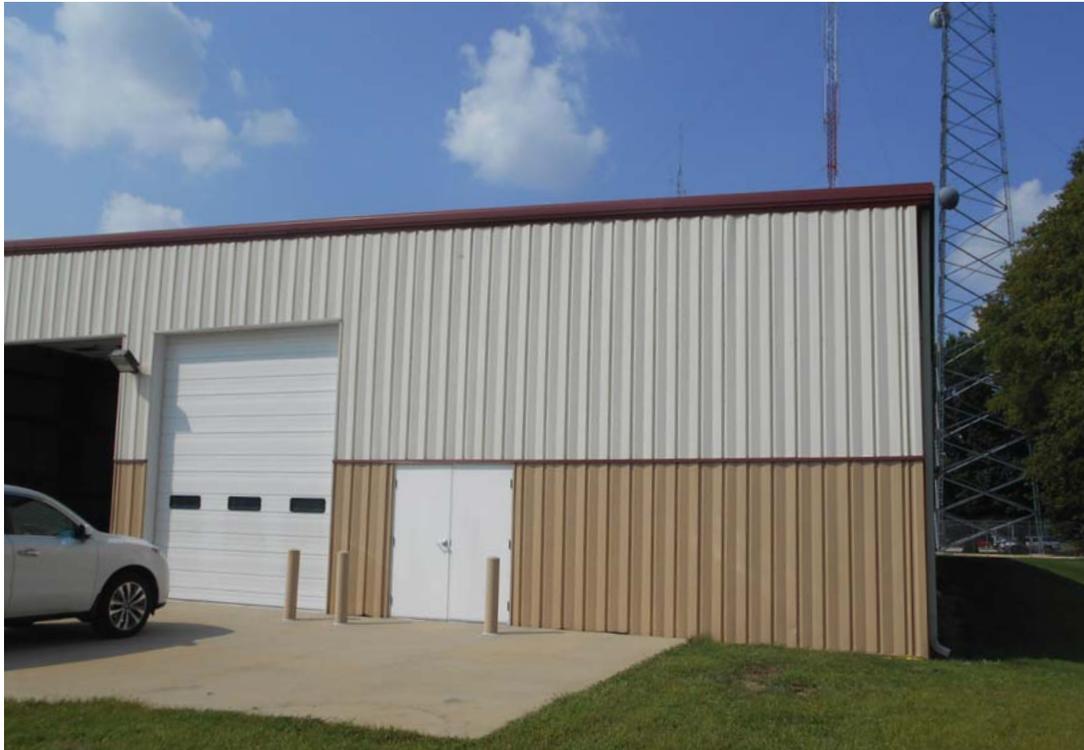
- Building is in overall good condition.
- Sealant failure at base of metal wall panels along concrete.
- Insulation along foundation broken, damaged and missing in places.
- Metal panels dented at corner.
- Interior drywall in fair condition, minor scratches; one puncture found.
- Sealed concrete flooring in good condition, minor wear.
- Interior cage in good condition.
- No rubber base at bottom of drywall.
- Exterior door in good condition.
- Exposed structure and insulation in good condition.
- No ventilation. Heat provided by ceiling mounted gas fired unit heater.

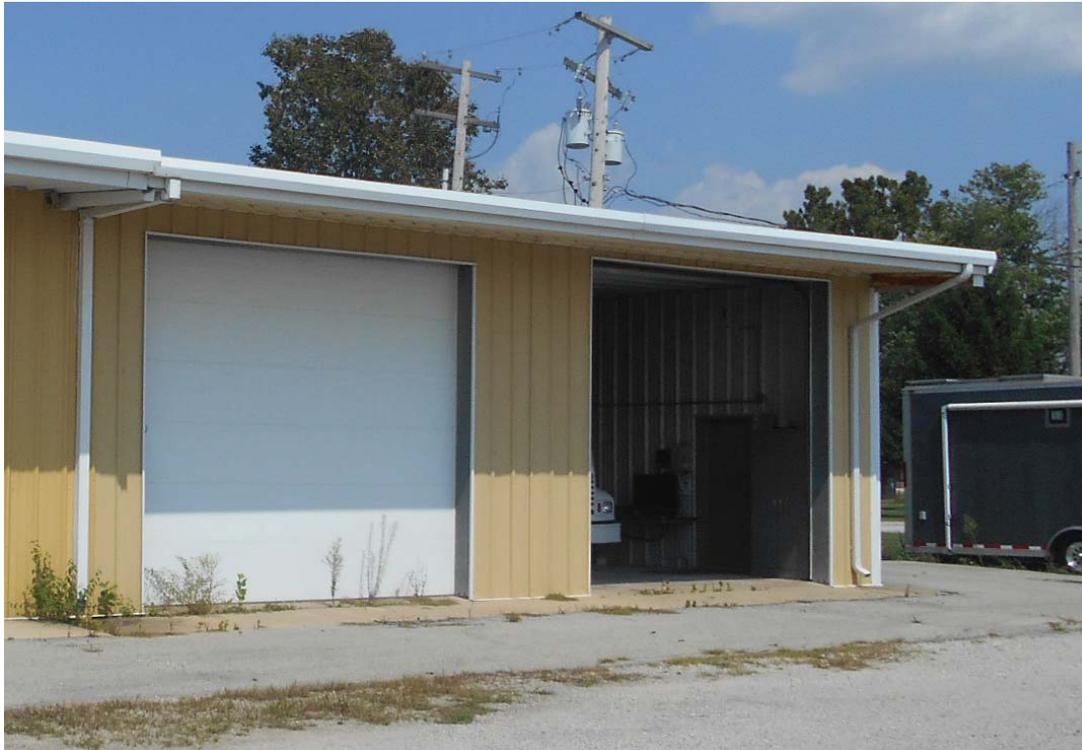
- Concrete flooring is in fair condition, some stains and wear from use.
- A few large cracks in concrete flooring.
- Interior and exterior deterioration on metal panel.
- Metal downspouts deteriorated, leaks found at joints.
- Exterior trim bent and damaged at door openings.
- Exterior doors deteriorated and damaged at base.
- Interior steel structure worn and deteriorated.
- Punctures, bent and damaged metal panels along base of exterior.
- Oil interceptor at trench drains and exhaust fan installed.
- No ventilation. Ceiling mounted gas fired unit heater nearing end of useful life

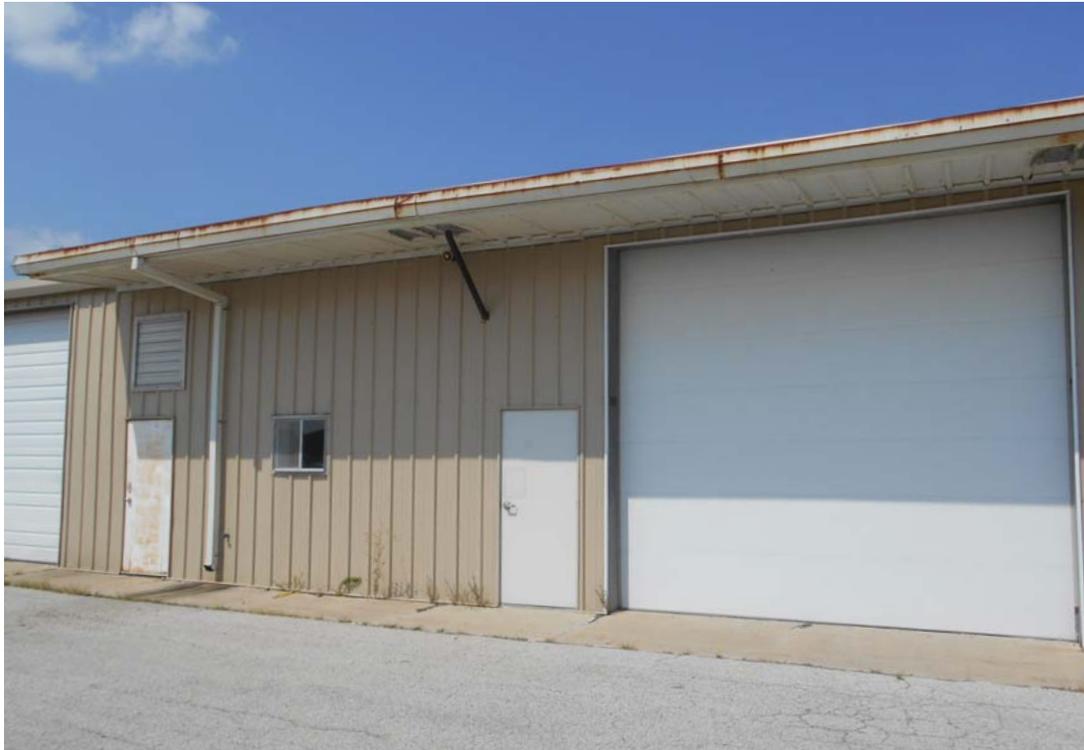
- ILEAS Garage 2 is connected to Sheriff's Garage.
- The building is in overall fair condition.
- Sealed concrete flooring is scratched and worn in places.
- Doors are worn with some deterioration.
- Finish on interior exposed structure is worn and deteriorated.
- Metal wall panels are in fair condition.
- Gutters and downspouts are deteriorated.
- Roof overhang is deteriorated and has impact damage.
- Organic plant growth in cracks along exterior concrete and base of building.
- Sealant deterioration in places along concrete.
- No ventilation. Heat provided by ceiling mounted gas fired unit heater.

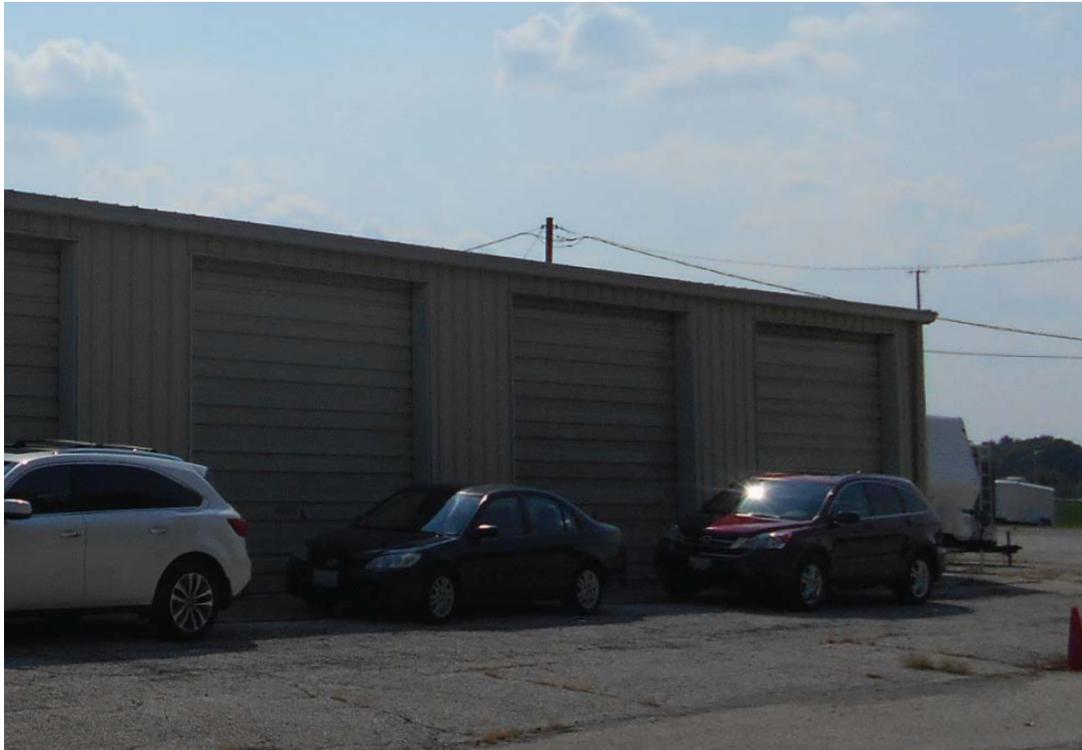
- ILEAS Garage 3 is connected to County Highway Garage.
- The building is in overall fair condition.
- Sealed concrete flooring is scratched and worn in places.
- Finish on interior exposed structure is worn and deteriorated.
- Metal wall panels are in fair condition.
- Doors have some deterioration and are in fair condition.
- Interior structure is in good condition, some deterioration.
- Overhead door is in fair condition, minor impact damage.
- Organic plant growth in cracks along exterior concrete.
- Sealant deterioration in places along concrete.
- No ventilation. Heat provided by ceiling mounted gas fired unit heater.
