Facilities Assessment Report

November 3, 2015

County of Champaign, Illinois

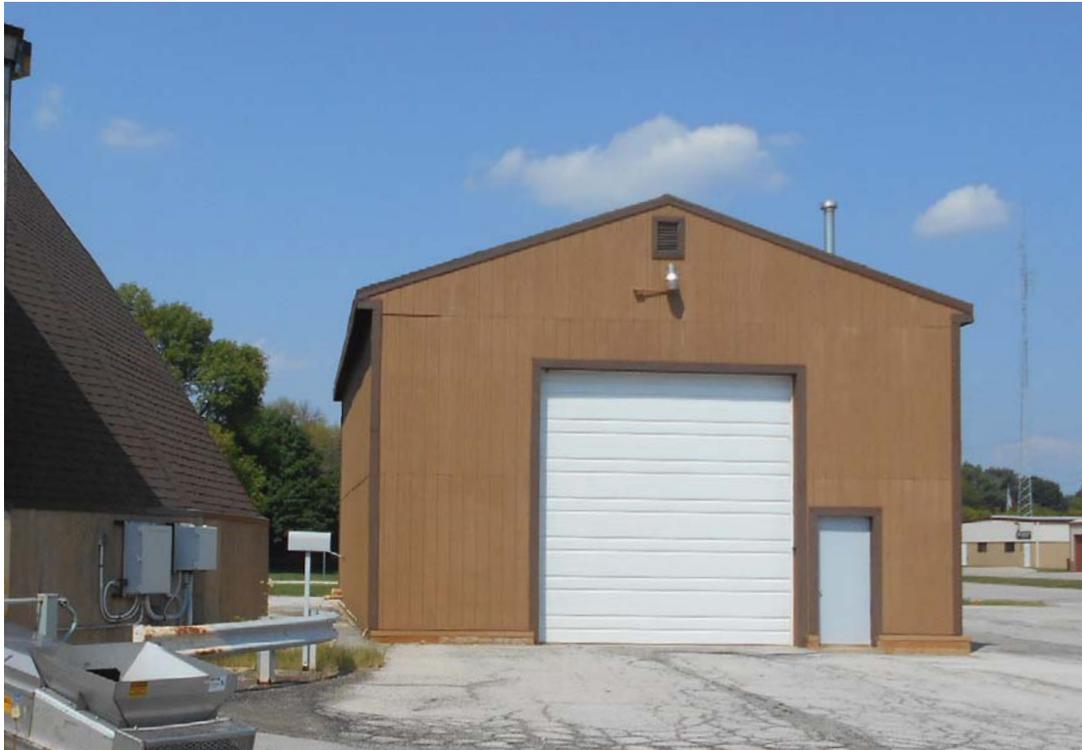
- The building overall is in fair condition.
- Soffits are not protected, raw wood exposed to elements.
- Asphalt shingles are in fair condition.
- Worn and deteriorated paint at roof edge trim.
- Paint overall is in fair condition.
- Overhead door is in good condition, minor impact damage.
- Some cracks in concrete surfaces.
- Interior concrete flooring is heavily worn.
- No ventilation. Heat provided by ceiling mounted gas fired unit heater in good condition.

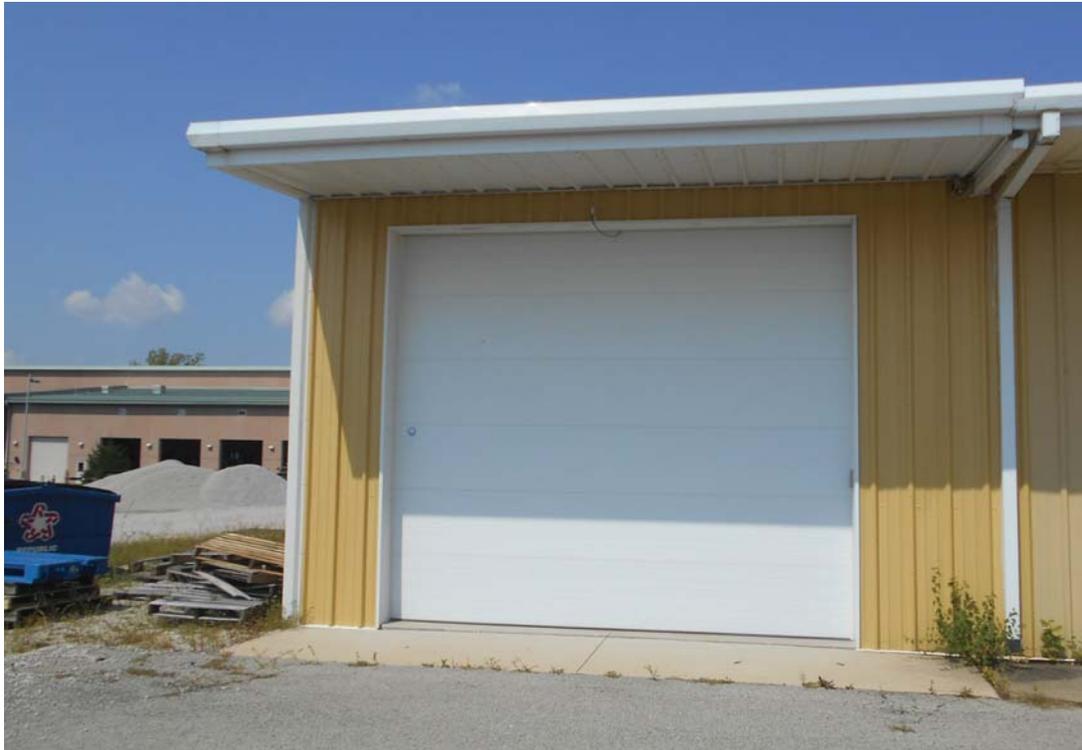
- ILEAS Garage 1 is connected to EMA Garage.
- The building is in overall good condition.
- Sealed concrete flooring is scratched and worn in places.
- Finish on interior exposed structure is worn and deteriorated.
- Overhead door and frame is in fair condition.
- Metal wall panels are in good condition.
- Roof system is in good condition.
- Gutters and downspouts are in good condition.
- Some plant growth in cracks along exterior concrete and pavement.
- Sealant deterioration in places along concrete.
- No ventilation. Heat provided by ceiling mounted gas fired unit heater.
