Facility Condition Assessment Summary of Results November 19, 2015

Champaign County

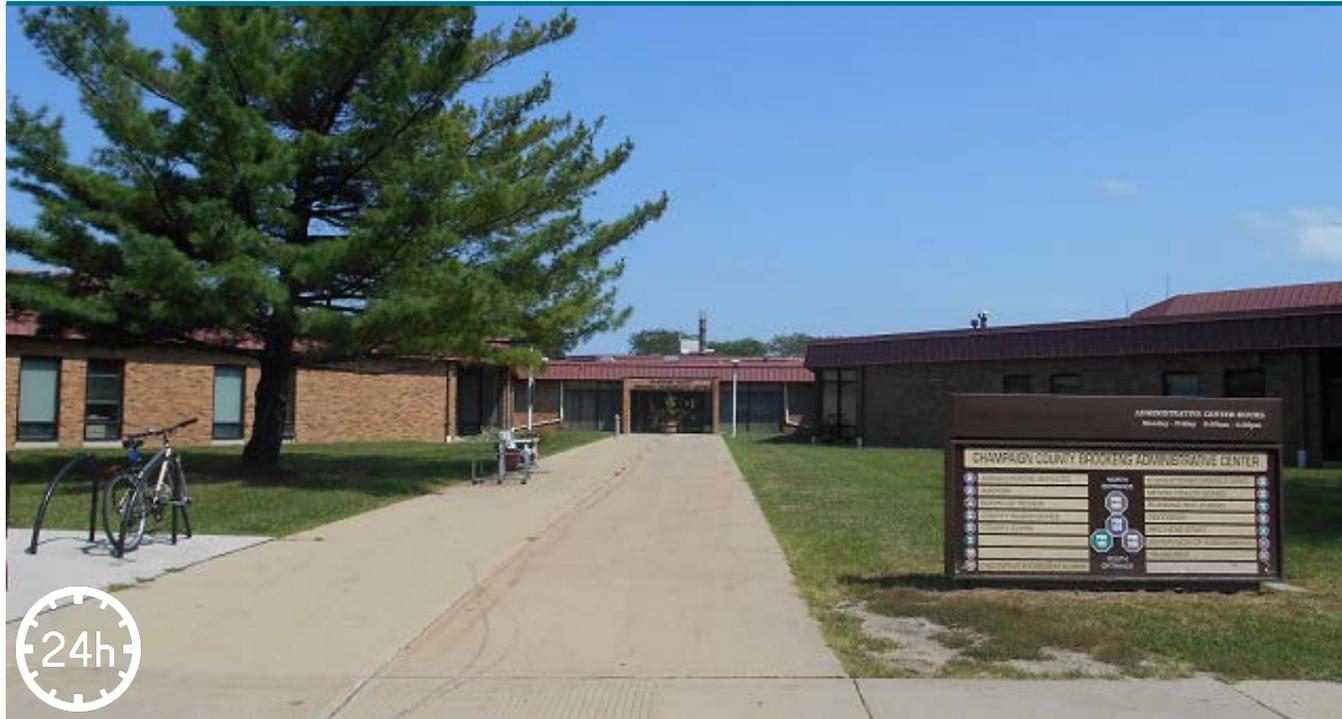
- This building has a back-up generator
- Roof and soffit replacement needed at portion of facility
- Downspouts are in need of repair, many are dented or loose
- Parking lot recently resurfaced and is in good condition
- Minor brick repair and sealant replacement required
- Sidewalks cracked and damaged in places
- Exterior insulation is heavily damaged or missing
- Exterior Lighting and controls require replacement

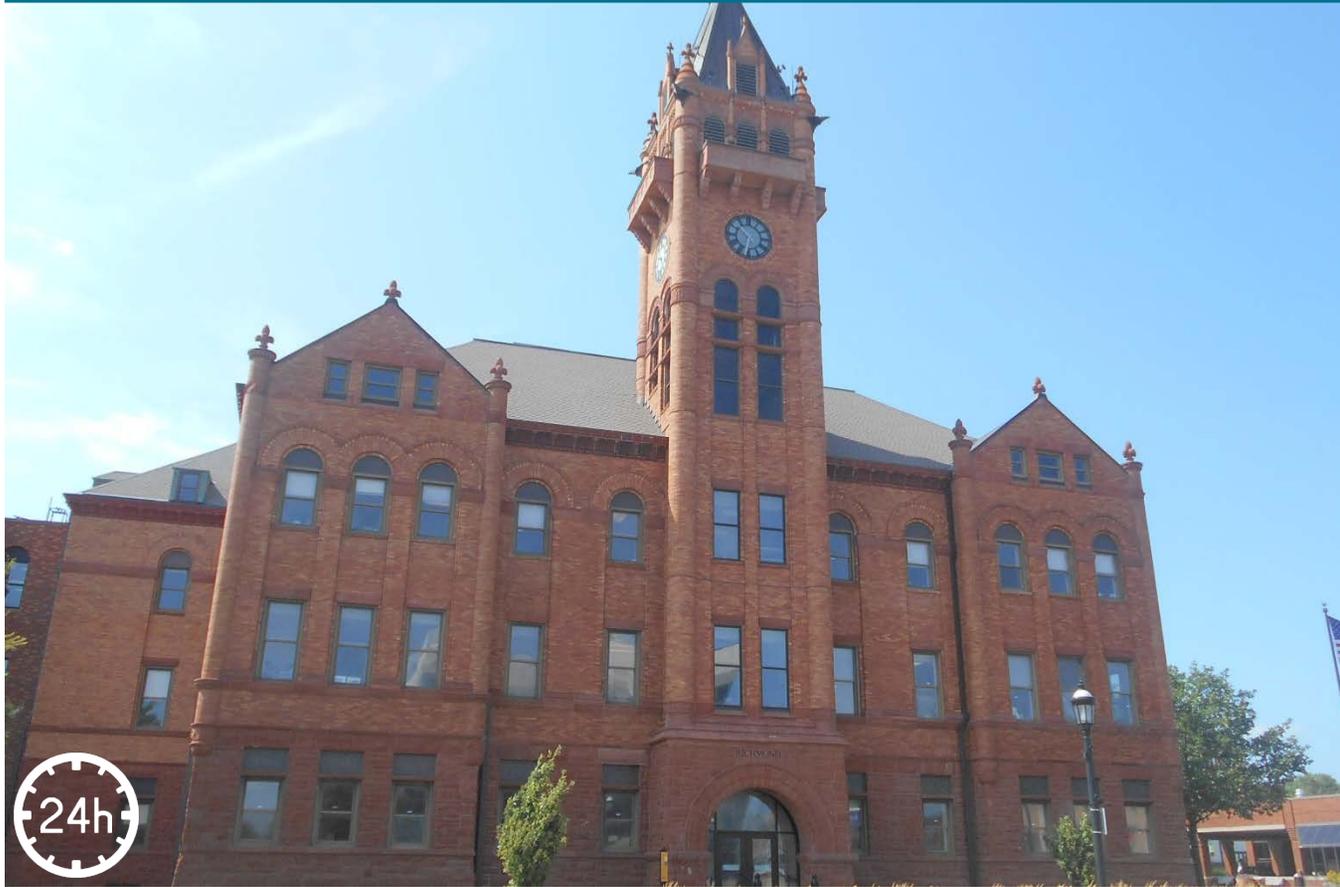
- EPDM Roof in poor condition and needs replacement
- Wood steps and walkway access at roof deteriorated
- Efflorescence, deteriorated mortar at foundation walls
- Exterior lighting and controls require replacement

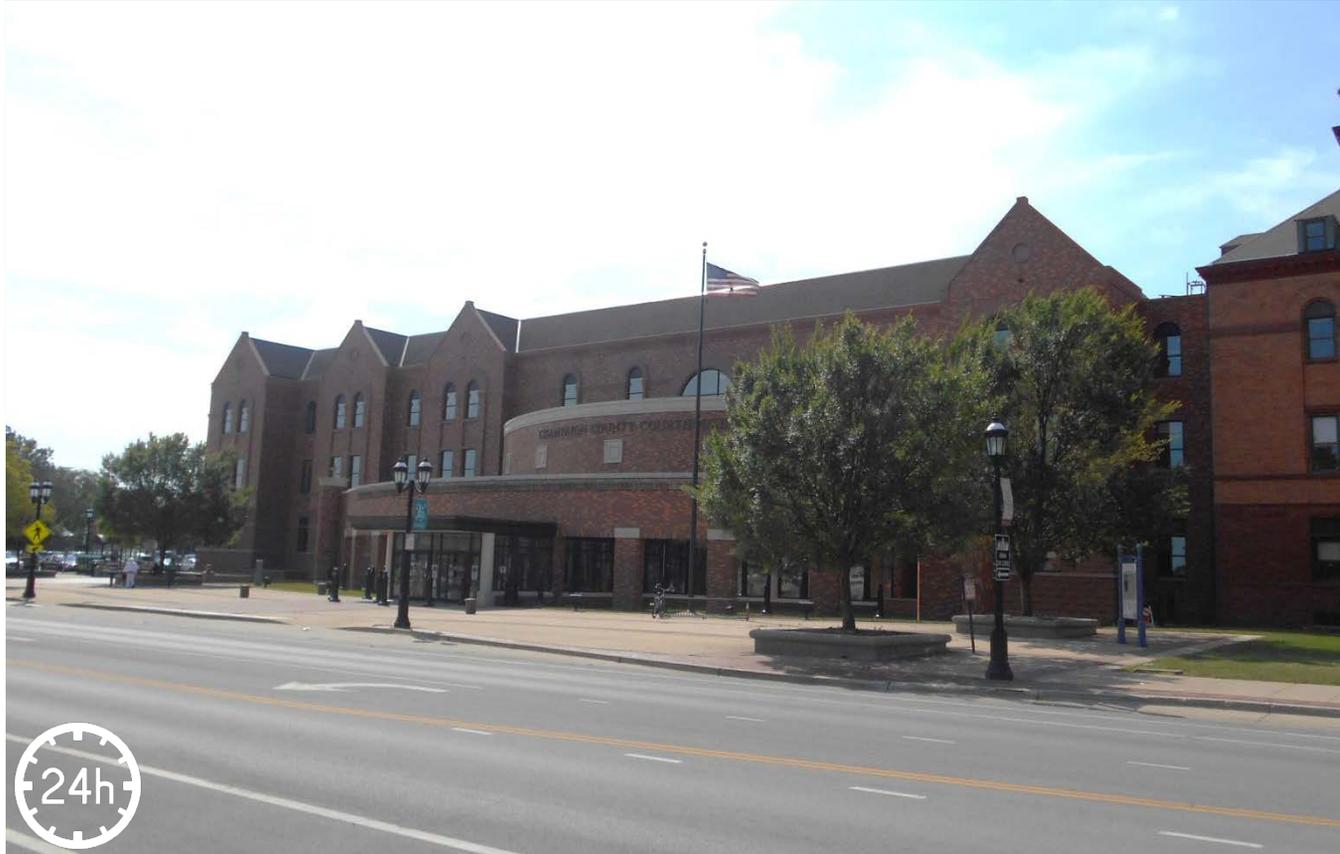
Courthouse Addition

- Exterior steel needs painted
- Wall covering in courtrooms needs replacing
- Courtroom carpet tiles need to be replaced.
- Epoxy coating heavily worn and masonry crack in holding cells.
- Outdated breakers on the motor control center
- DDC controllers need to be replaced

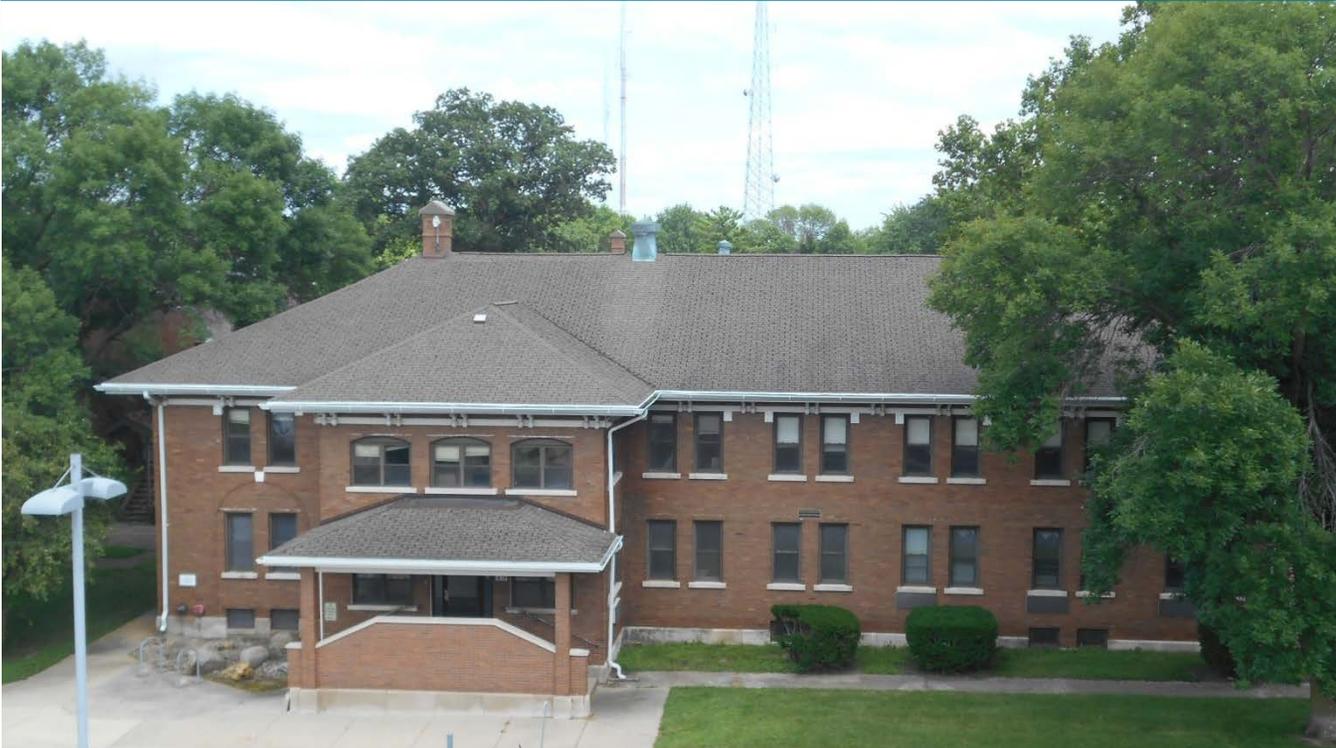
ILEAS Original Building

- The building is in various states of disrepair as a result of limited use/abandonment
- All MEP infrastructure and equipment requires replacement
- Most of the flooring is damaged or missing
- Interior finishes require replacement
- Ceilings have collapsed and there is mold present
- There is water penetration and efflorescence on exterior brick
- Roof requires complete replacement

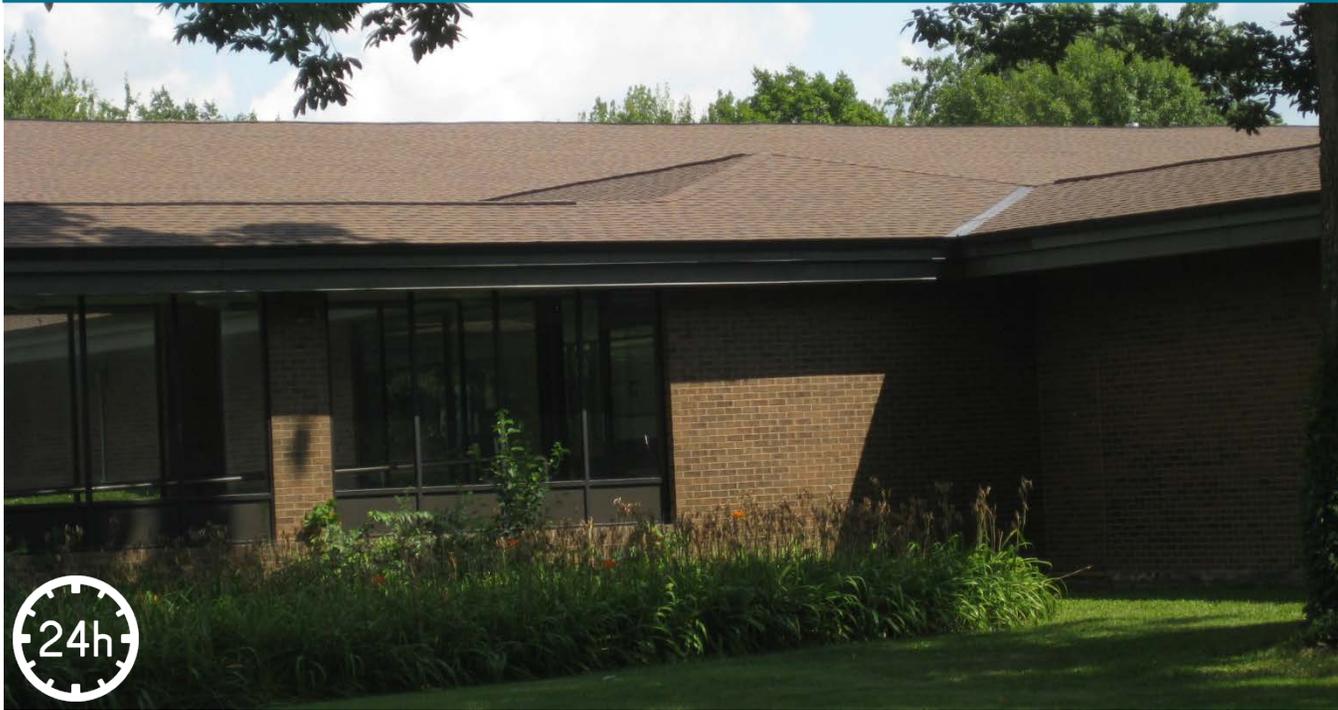
- This building has a back-up generator
- Distribution panels require replacement
- Airflow to fan coils is deficient, due to inadequate filtration
- Exterior brick planters are cracked and heavily damaged
- Some exterior walkways are heavily cracked and warped
- There is minor staining on ceiling tiles, rust in places
- Grout in tile flooring is stained, some tile broken on walls
- A few glass cracks were found in windows
- VCT is stained and damaged
- Exterior window storefront panels are failing, mullion caps missing

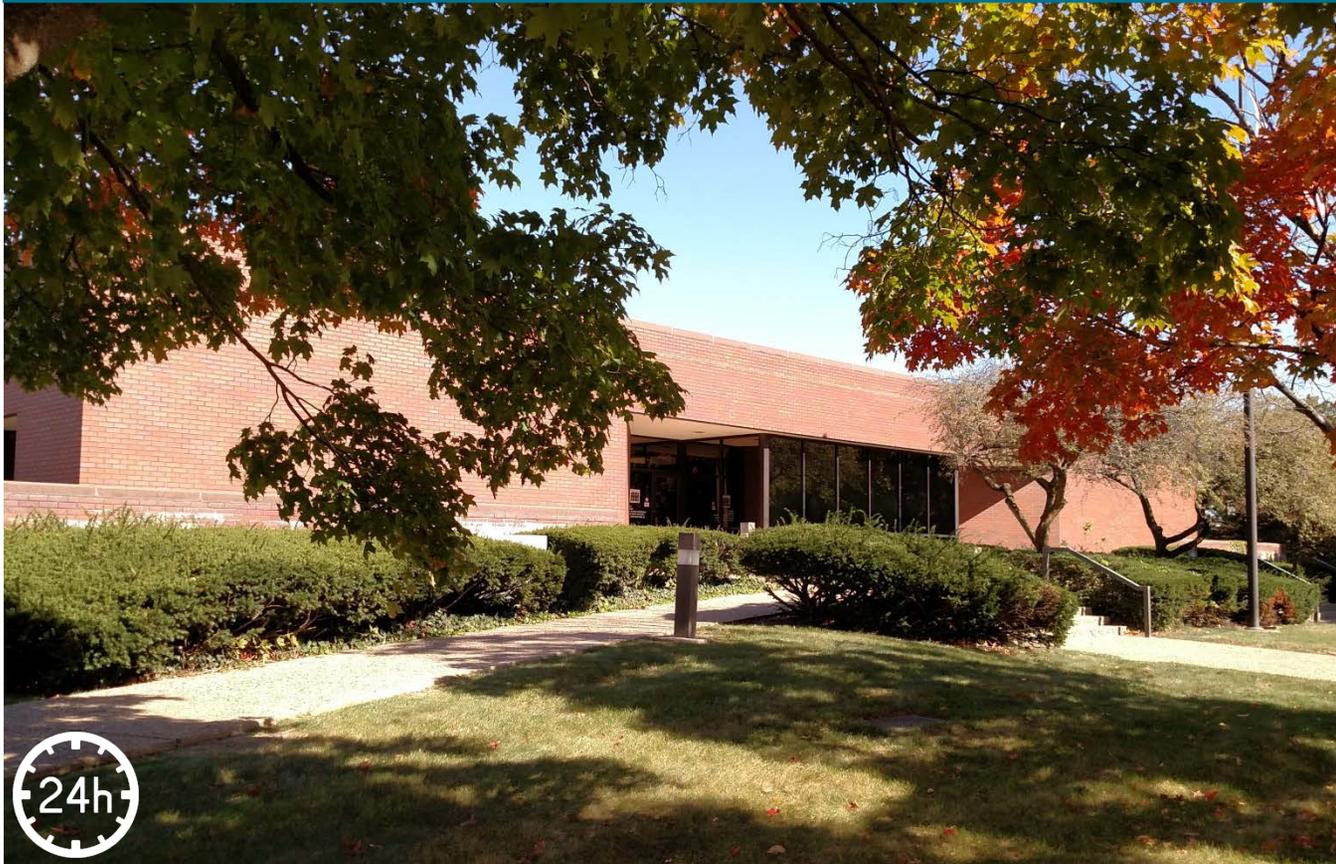
- Water infiltration at exterior walls/ parapet
- Mechanical/ Electrical equipment requires replacement
- Damaged netting at basketball court
- Deteriorated interior finishes throughout
- Roof requires replacement
- Window systems/ exterior doors require replacement

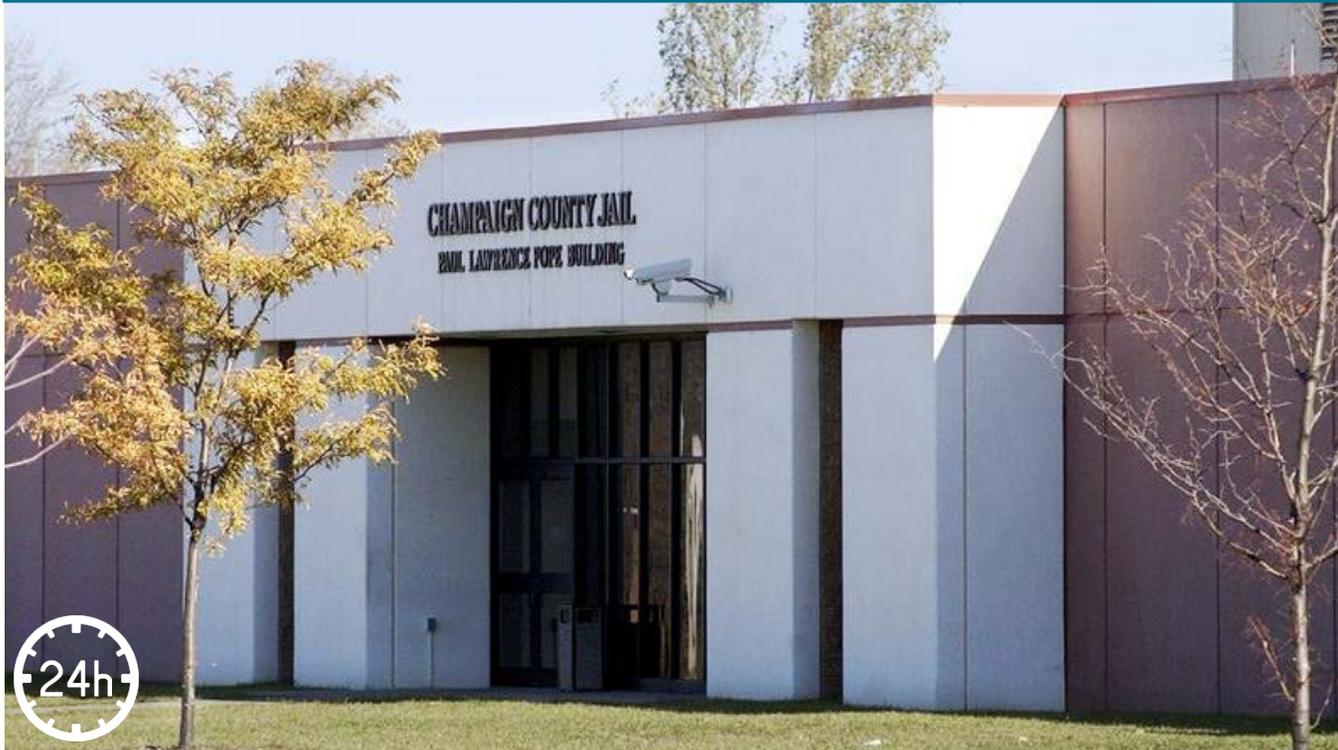
- HVAC systems need to be replaced.
- Interior sealed concrete is heavily worn with some large cracks.
- Vinyl wrapped columns are peeling and scratched.
- Metal doors are scratched and dented.
- Cell doors show signs of rust and impact damage.
- Floor drains are heavily rusted and filled with debris.
- Sally port doors are oversized and prone to failure.
- Security system is outdated and needs to be replaced.
- Paint finishes are worn and deteriorating.
- Carpeting is heavily worn with some staining.

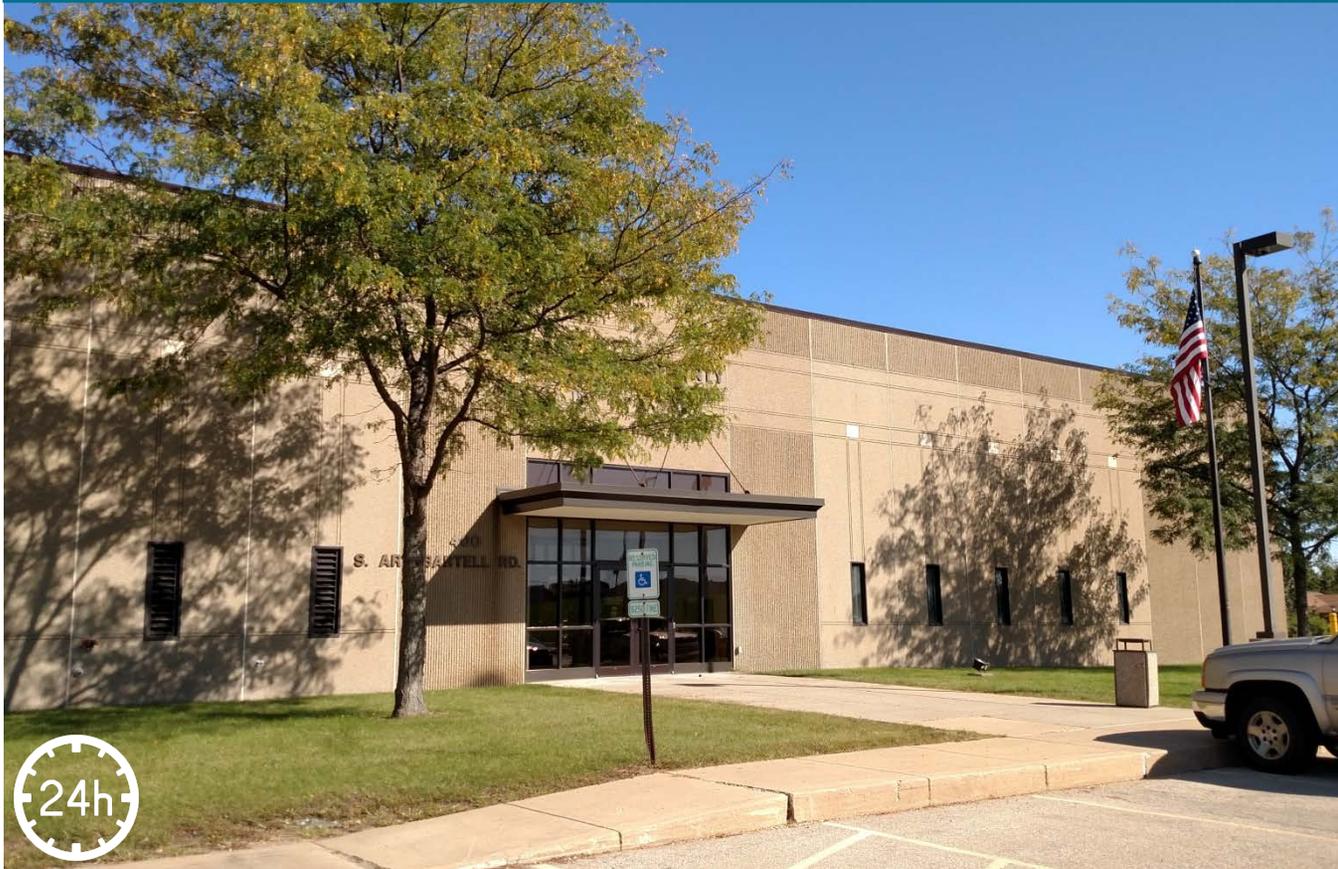
- Roof in poor condition and needs replacement
- Paint peeling from interior windows and sills
- Ceiling tiles stained at HVAC vents
- Deteriorated floor finishes require replacement
- Incandescent lighting needs replaced
- Combustion fan motors periodically fail

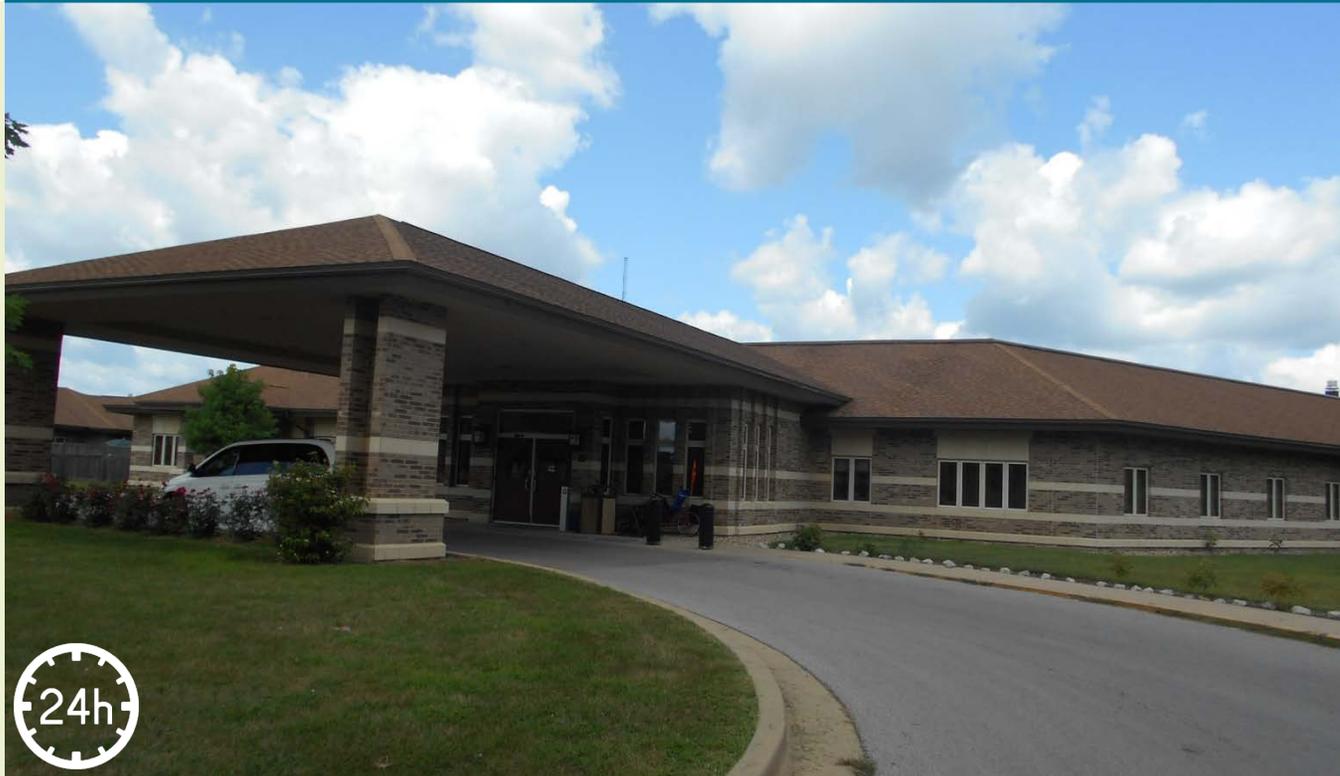
- Return side of HVAC system is inadequate.
- Exterior soffit panels missing,
- Interior flooring in good condition, some repair required
- Wall/ finishes in generally good condition, some repair required
- Wall base missing at several locations
- Nurses call system should be replaced
- Outside air intake location for the boilers causes boiler failure

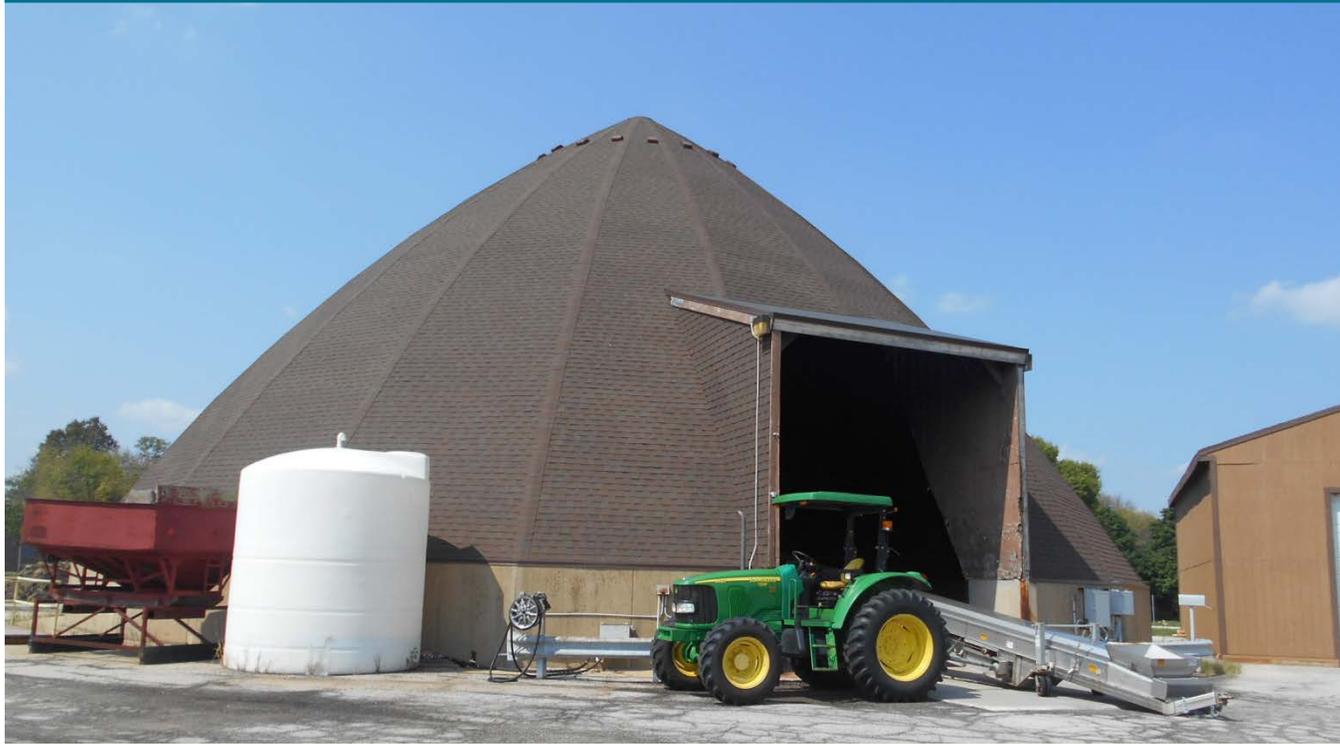
- All metal in the building is deteriorated, some has completely deteriorated.
- Most concrete surfaces, mainly by the entrance, are pitted and have exposed aggregate.
- Exposed wood at entrance is deteriorated.
- Asphalt shingles are in generally good condition.
- Interior wood dome structure is in good condition.
- Concrete seals around exterior are worn and deteriorated.
- Standing water around foundations.

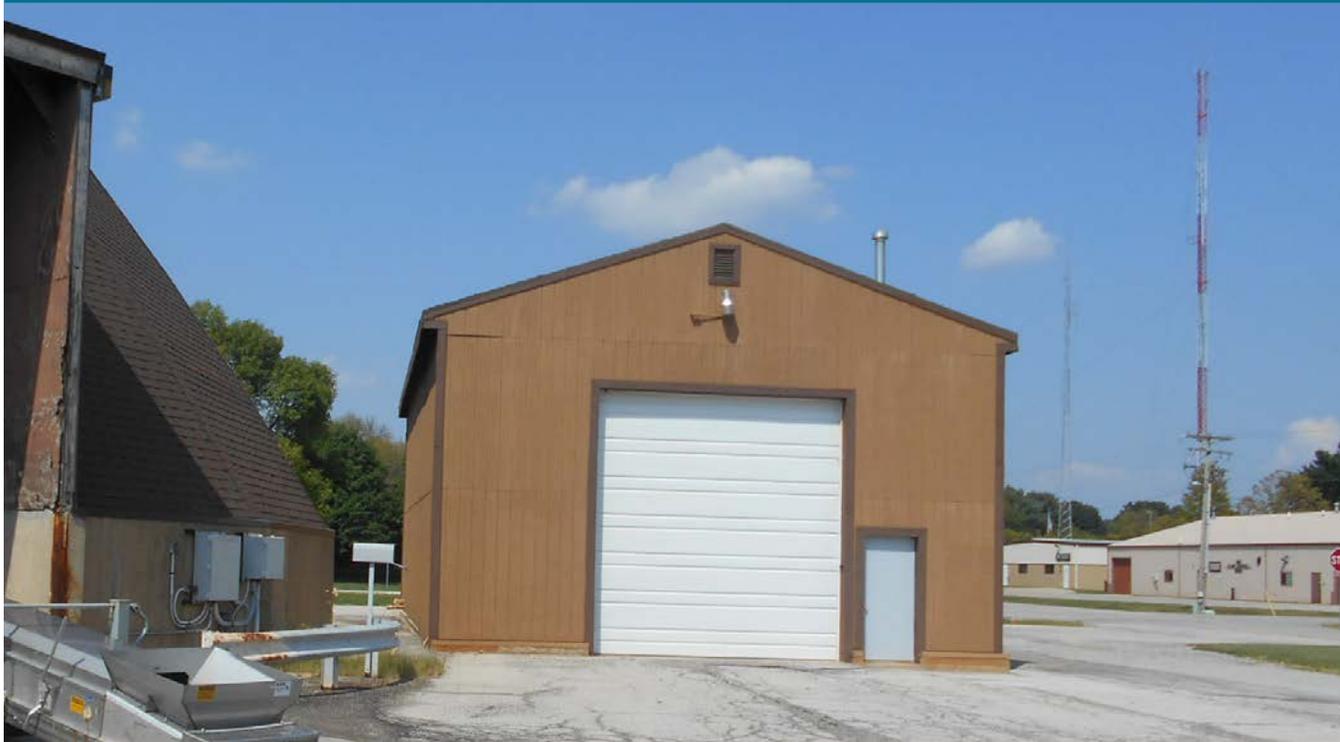
- The building overall is in poor condition.
- Interior wood is deteriorated from age.
- Minor exterior trim damage, missing or broken pieces.
- Soffits are not protected, raw wood exposed to elements.
- Asphalt shingles are in good condition.
- Worn and deteriorated paint at roof edge trim.
- Paint overall is in fair condition.
- Overhead door is in good condition, minor impact damage.

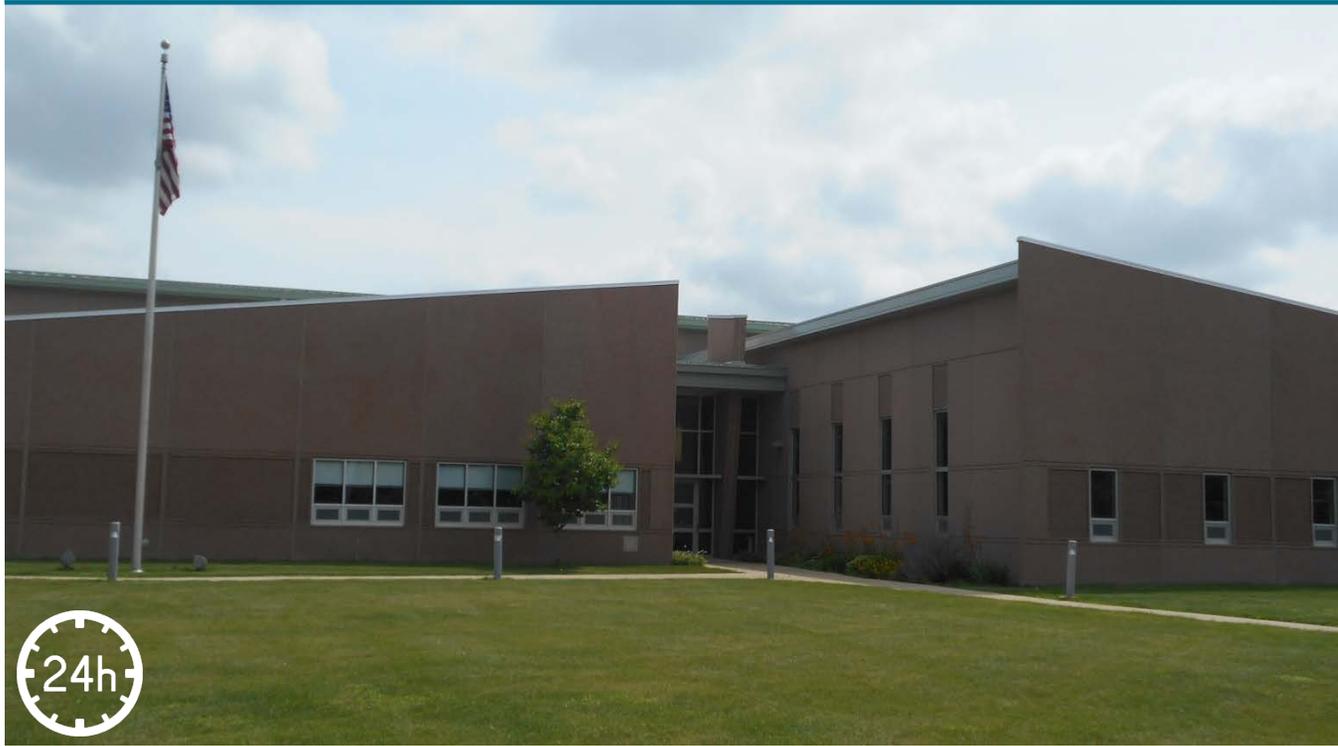
- Overall, building is in very good condition.
- Minor cracking and efflorescence at exterior precast panels.
- Water infiltration at roof parapet walls due to exposed steel and cracked panels.
- Mechanical systems in good condition with minor repairs needed.
- Power and data sufficient for current needs.
- Parking lot recently resealed. Concrete pathways in good condition.
- Offices served by small blower coil units, maintenance exhausted by gas fired MAU's

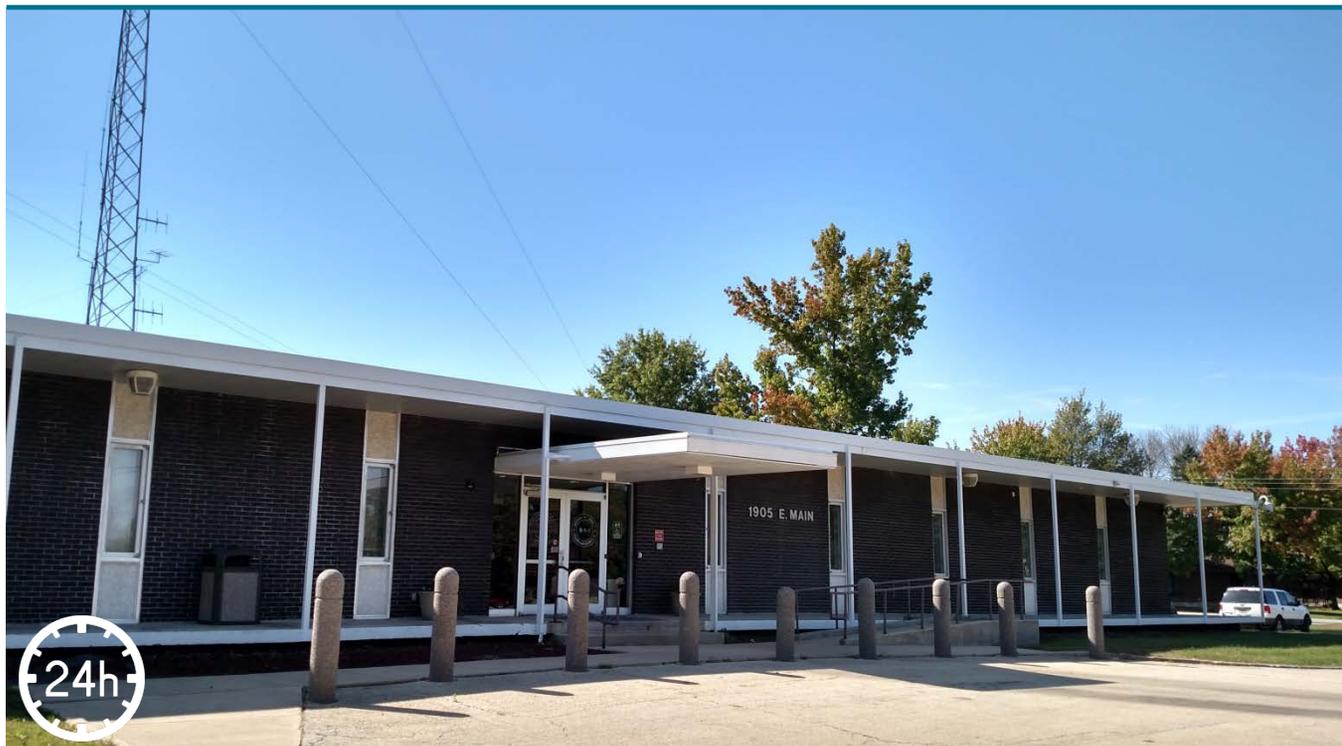
- This building has a back-up generator.
- Overall, the building is in good condition.
- Exterior brick is worn, some sealant damage at windows.
- Railings along accessible ramp are deteriorating.
- Minor cracks on ramp and walk.
- Gutters in good condition, some paint peeling.
- Roof will need replacement.
- Served by AHU's and condensing units, AHU's nearing end of useful life.

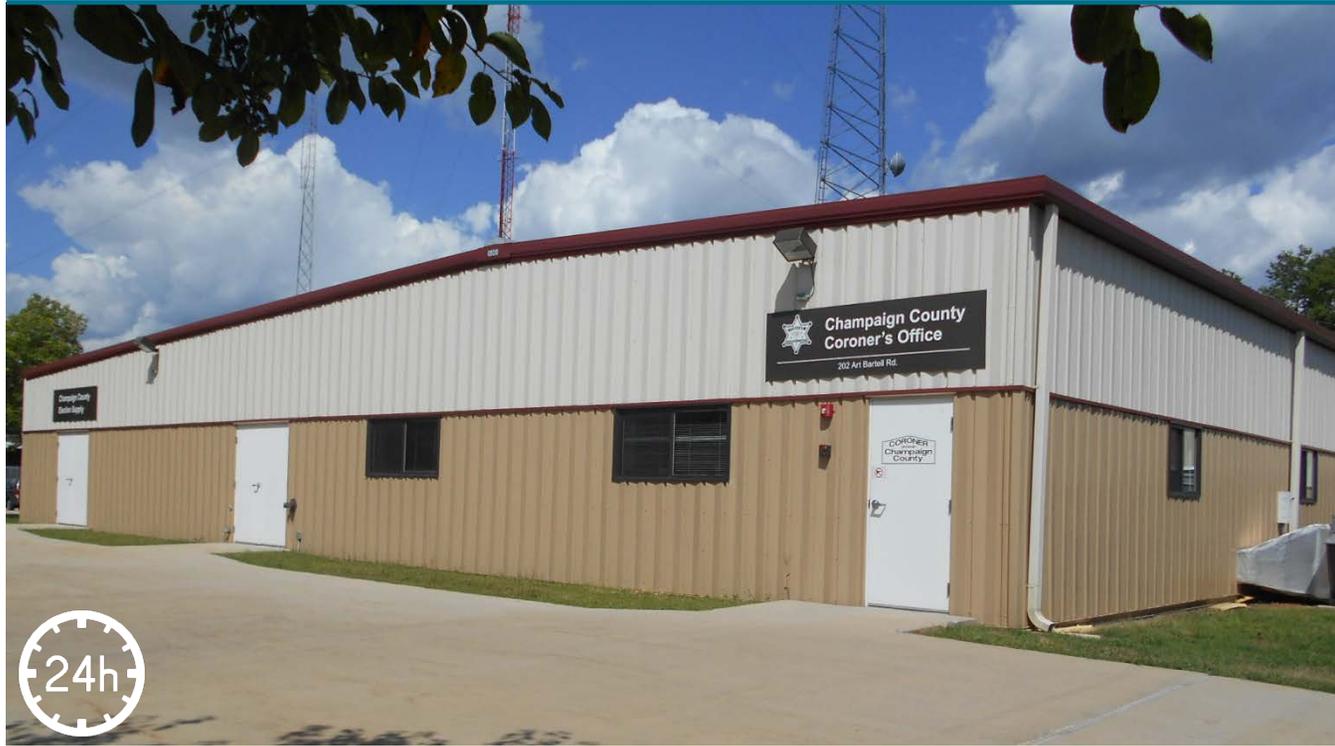
- This building has no back-up generator.
- The building is in generally good condition.
- Ceiling tiles show signs of minor water damage.
- VCT flooring is worn and scratched in places of heavy use.
- Drywall is in good condition, minor scratches and cosmetic damage.
- Interior doors show signs of wear and some damage to finishes.
- Exterior wall panels have minor surface damage.
- Insulation along foundation is damaged, missing in places.
- Served by packaged AHU at grade. AHU is in good condition.

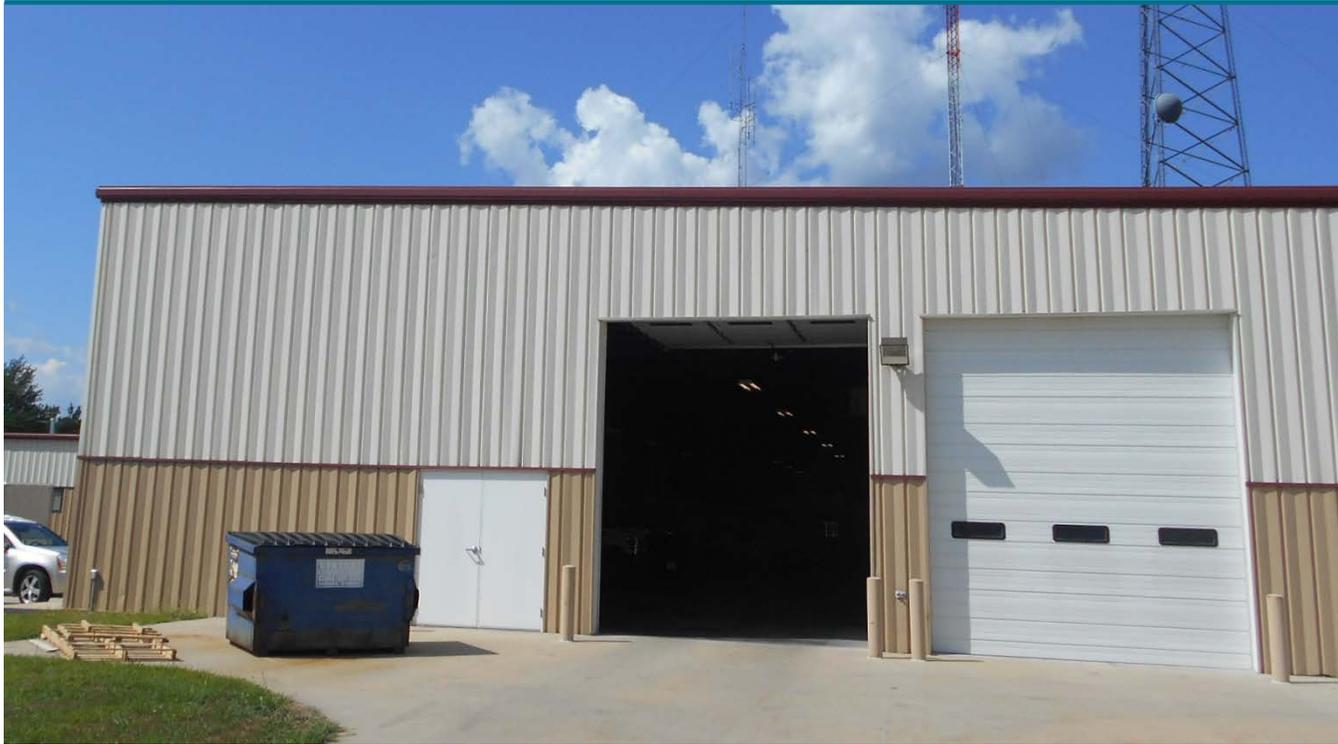
- Building is overall in good condition.
- Metal wall panels on exterior in good condition, minor damage.
- VCT flooring heavily scratched and worn, stained in some areas.
- Minor drywall damage, some impact damage and scratches.
- Insulation along foundation damaged and missing in places.
- Heavy water damage to landscaping at downspouts.
- Sealant failure along edge between metal panels and concrete.
- Ventilation provided by roof mounted exhaust fan in good condition.
- Heating provided by three gas fired unit heaters in good condition.

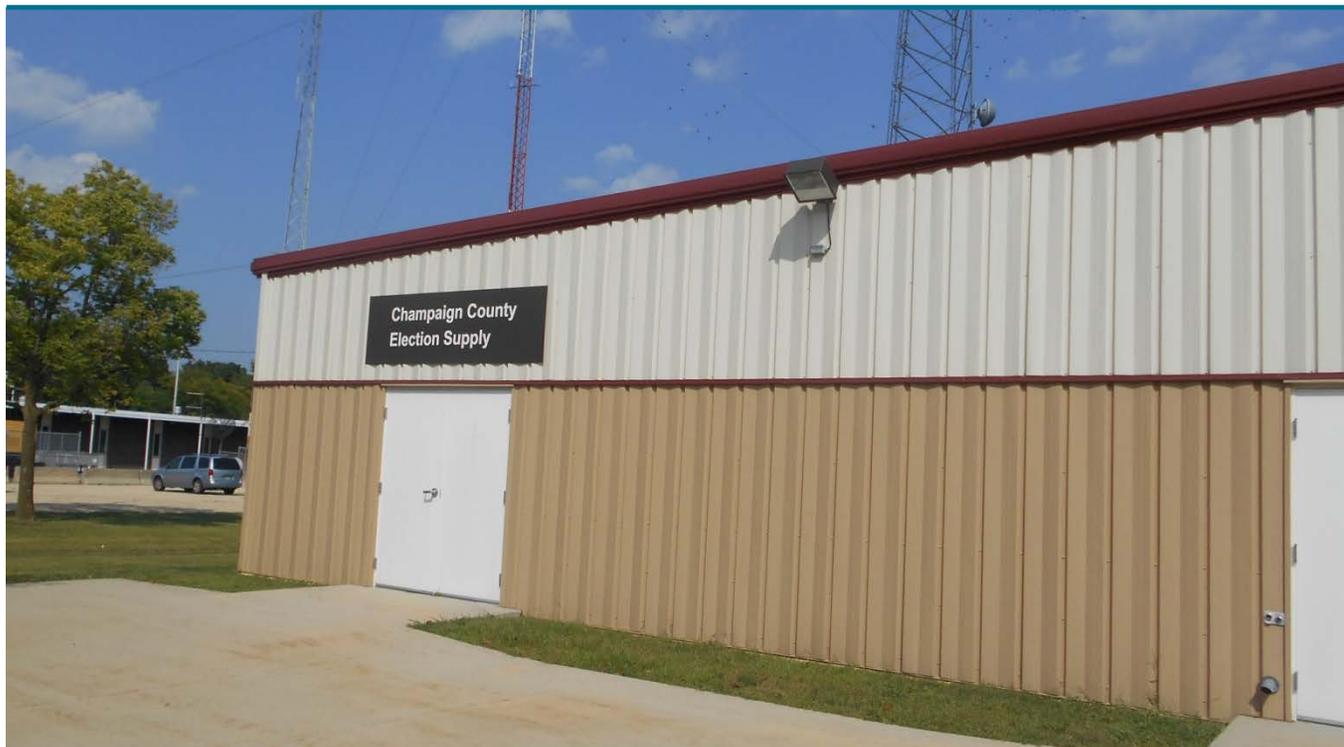
- This building is in good condition.
- Minor dents and cosmetic damage to exterior metal panels.
- Foundation insulation is damaged and missing in places.
- Interior sealed concrete flooring is stained and worn.
- Ceiling tiles are in good condition, few missing or stained.
- Rubber wall base missing in places.
- VCT in bathroom worn and stained.
- Interior drywall and finishes in good condition.
- HVAC provided by unit mounted on grade.

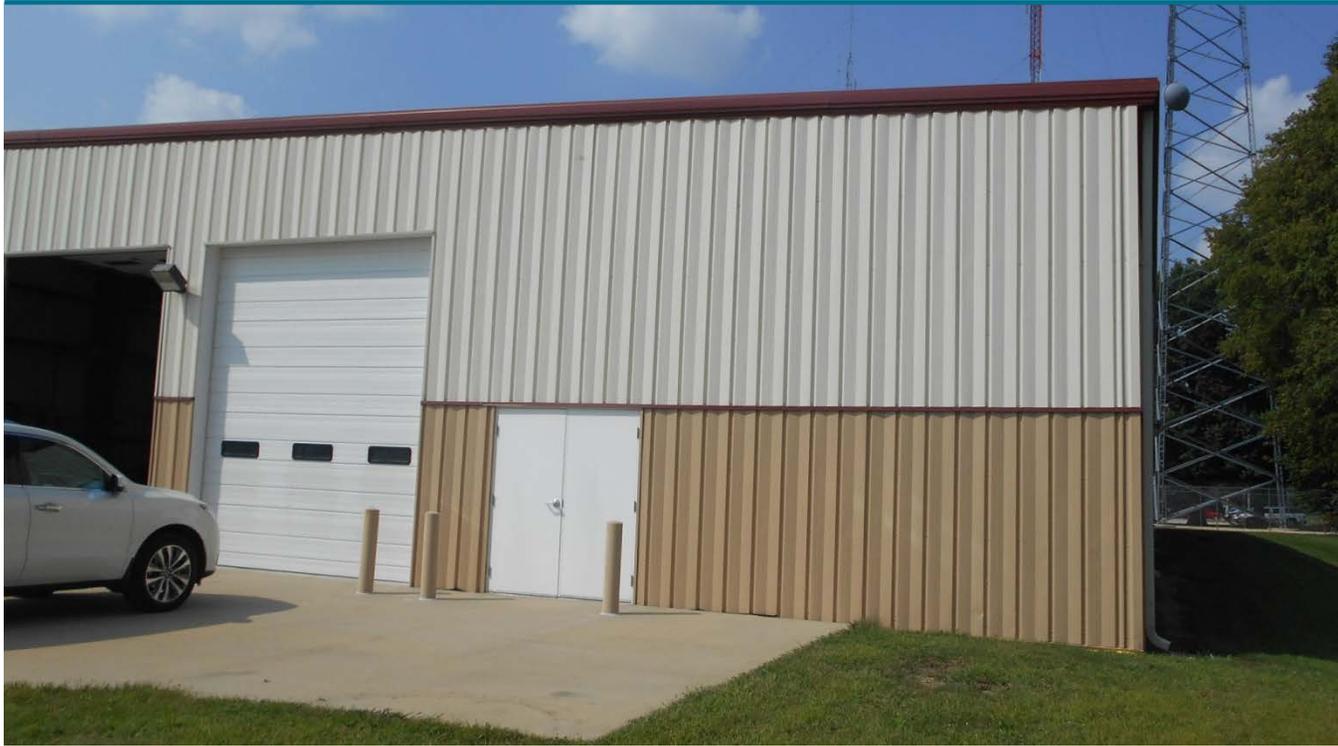
- Building is in overall good condition.
- Sealant failure at base of metal wall panels along concrete.
- Insulation along foundation broken, damaged and missing in places.
- Metal panels dented at corner.
- Interior drywall in fair condition, minor scratches; one puncture found.
- Sealed concrete flooring in good condition, minor wear.
- No rubber base at bottom of drywall.
- Exterior door in good condition.
- No ventilation. Heat provided by ceiling mounted gas fired unit heater.

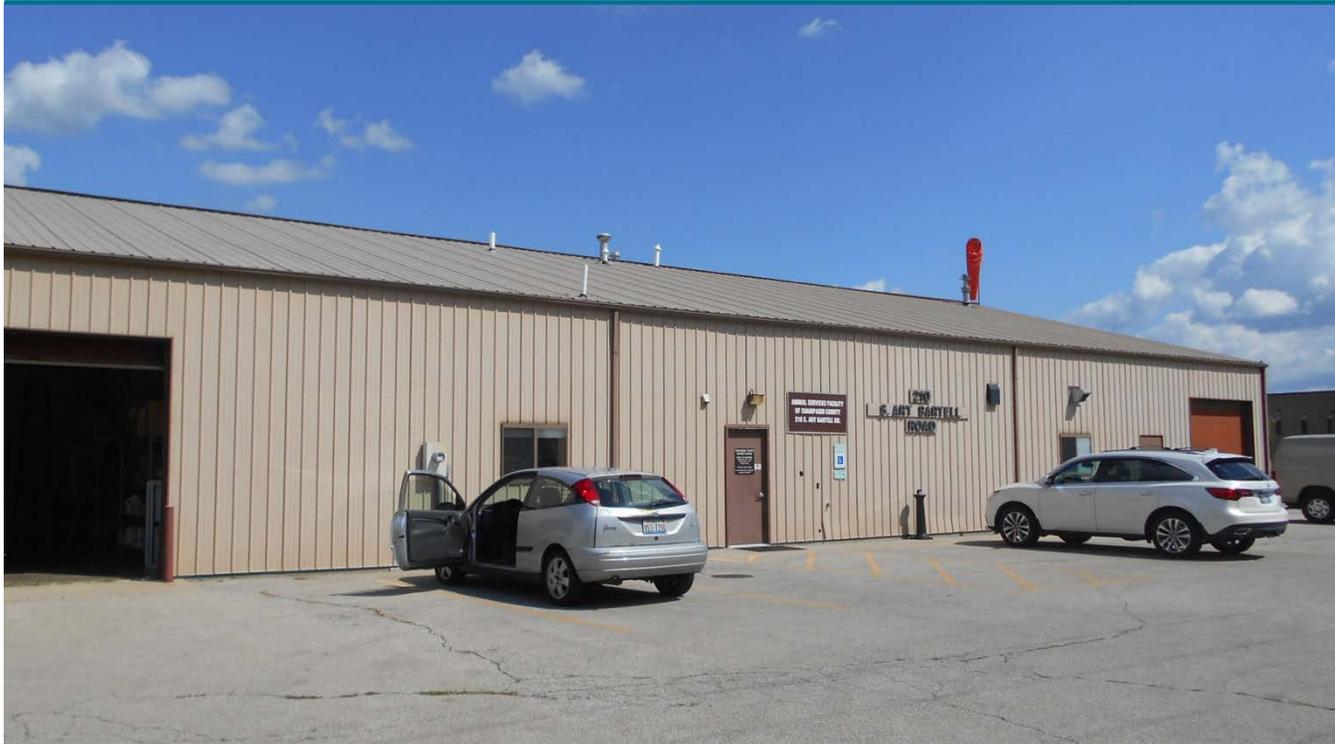
- This building has no back-up generator.
- Exterior metal wall panels have impact damage in multiple locations.
- Downspouts are in good condition, minor damage.
- Exterior wood door trim is deteriorated, paint peeling.
- Threshold sealants are failed.
- Ceiling tiles are in fair condition, some large stains in places.
- Overhead doors have impact damage on the exterior.
- Windows are in fair condition, some.
- HVAC provided by two packaged AHU's on grade in good condition.

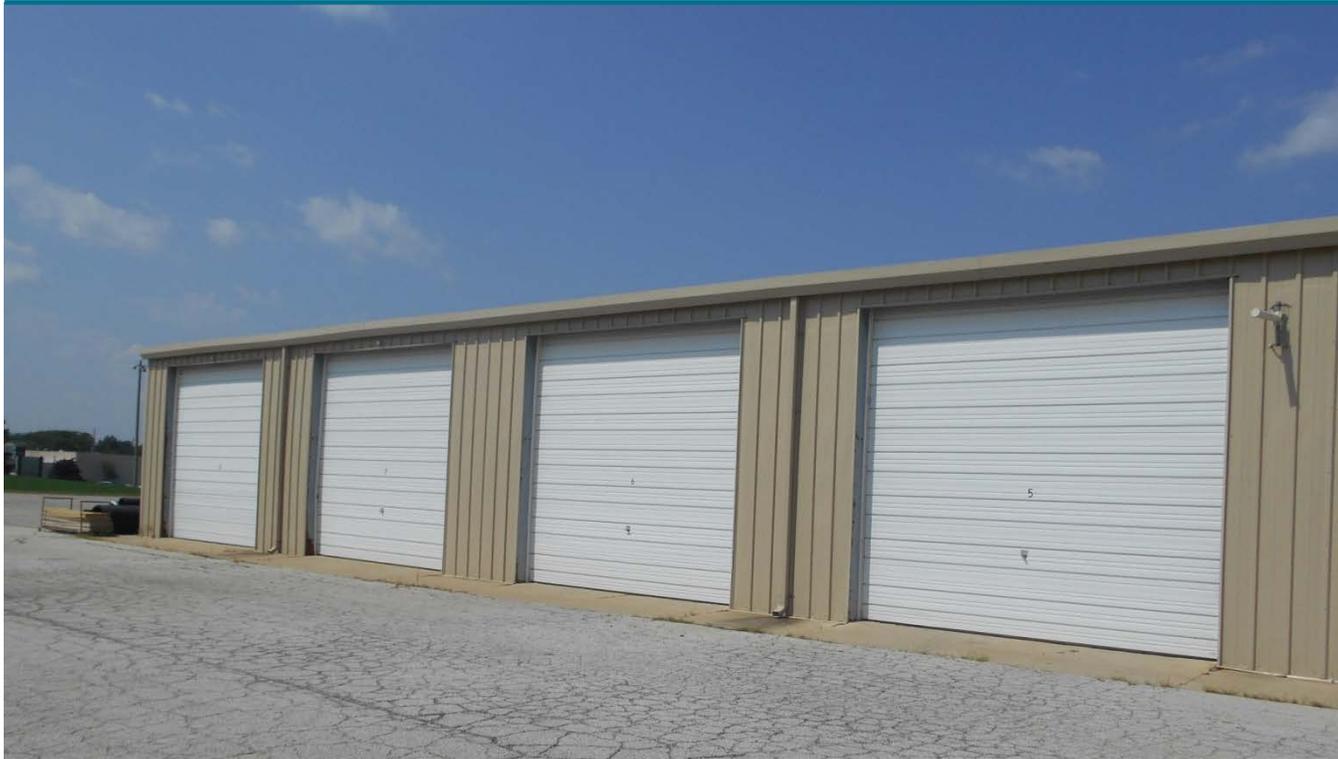
- Exterior door finishes deteriorated at base of doors.
- Exterior wall panels in fair condition, minor damage and deterioration.
- Downspouts damaged, finish worn and integrity compromised.
- Soffits and gutters rusted, paint deteriorated.
- Perimeter sealant/patch at concrete joints failed.
- Weatherstripping at overhead doors failed. Trim broken and missing.
- Gaps in metal panels at penetration locations, require sealant.
- Interior insulation panels worn, some impact damage.
- Concrete flooring heavily worn and pitted.

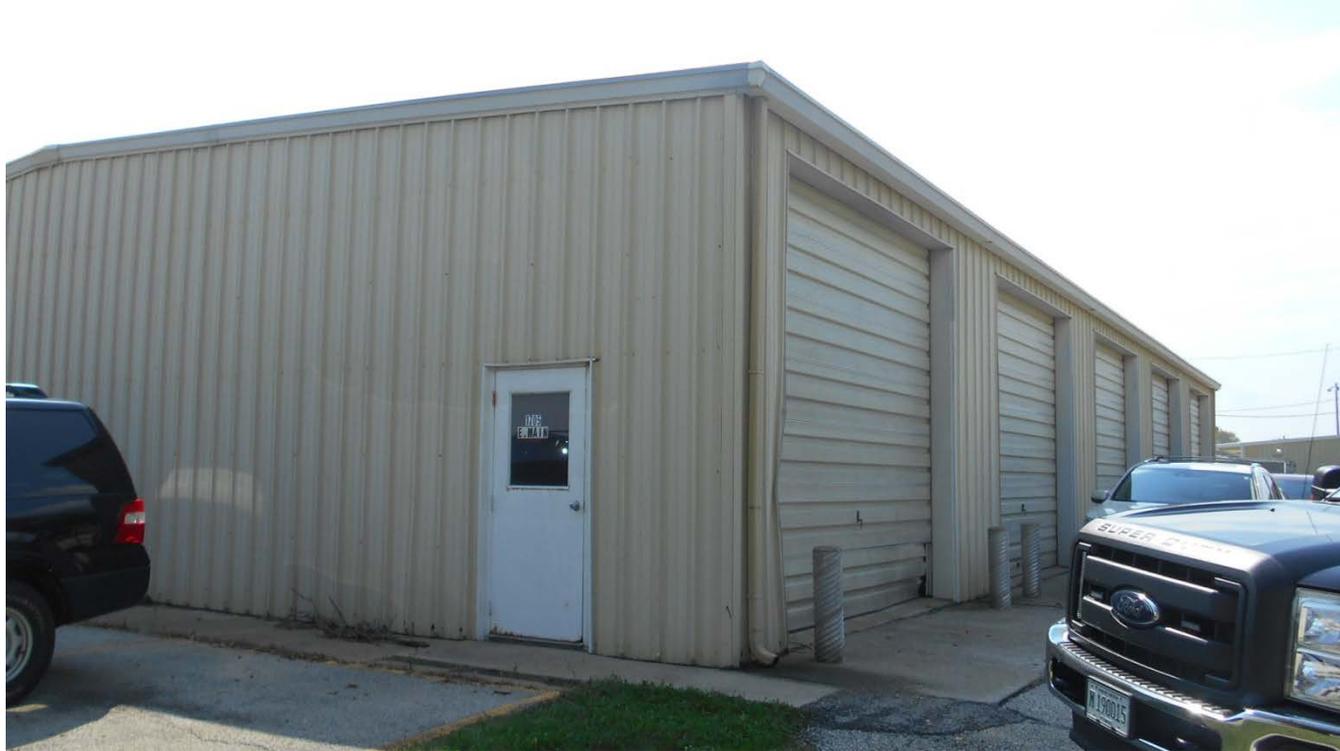
- The garage overall is in fair condition.
- Concrete flooring stained and worn, minor cracks.
- Exterior door finishes and frames are deteriorated and rusted at base.
- Fiberglass overhead doors and frames are damaged.
- Moisture damage and rust at base of metal wall panels.
- Metal wall panel seams dented, peeling apart, several large tears.
- Sealant at base of metal wall panels along concrete deteriorated.
- Bollards damaged from impact.
- No ventilation or heating present. No oil interceptor at trench drains.
