Facility Condition Assessment Summary of Results November 19, 2015

Champaign County

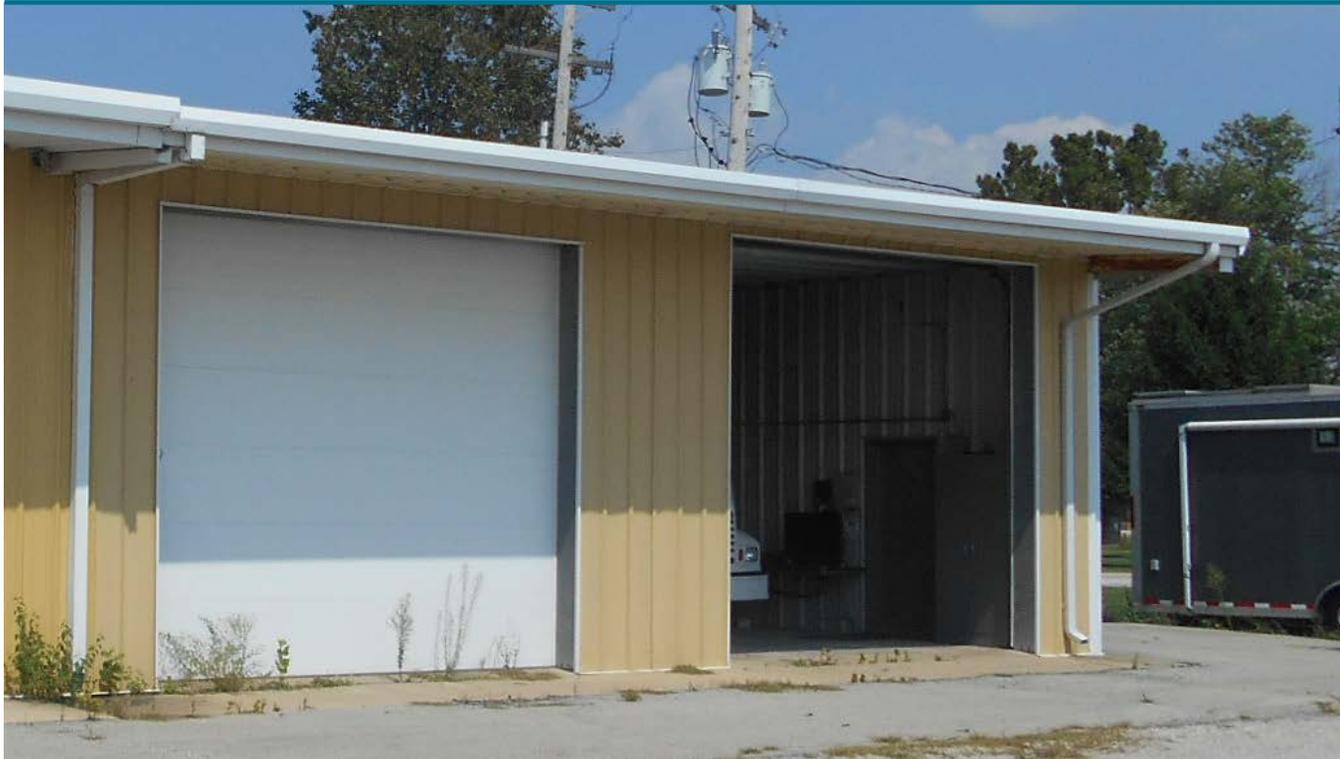
- A few large cracks in concrete flooring.
- Interior and exterior deterioration on metal panel.
- Metal downspouts deteriorated, leaks found at joints.
- Exterior trim bent and damaged at door openings.
- Interior steel structure worn and deteriorated.
- Punctures, bent and damaged metal panels along base of exterior.
- Oil interceptor at trench drains and exhaust fan installed.
- No ventilation. Ceiling mounted gas fired unit heater nearing end of useful life.

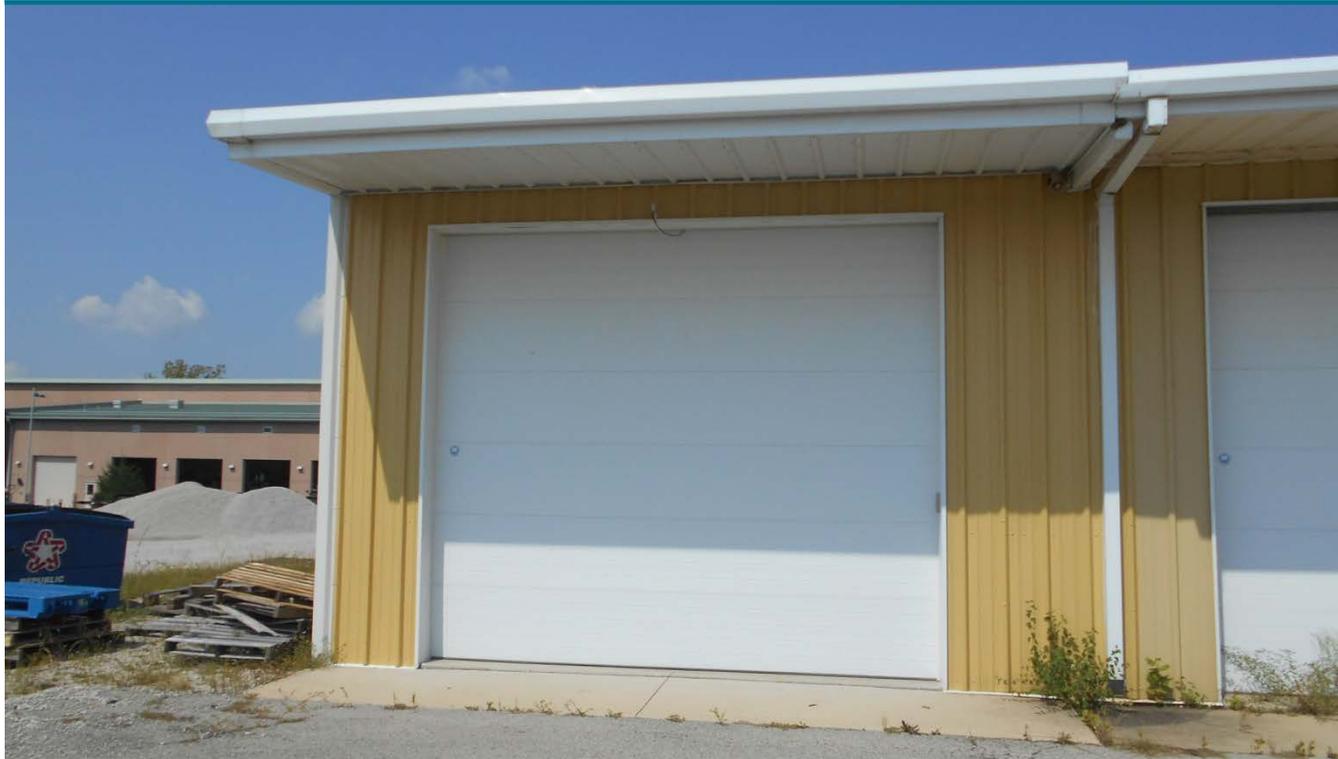
- ILEAS Garage 1 is connected to EMA Garage.
- The building is in overall good condition.
- Sealed concrete flooring is scratched and worn in places.
- Finish on interior exposed structure is worn and deteriorated.
- Overhead door and frame is in fair condition.
- Gutters and downspouts are in good condition.
- Some plant growth in cracks along exterior concrete and pavement.
- Sealant deterioration in places along concrete.
- No ventilation. Heat provided by ceiling mounted gas fired unit heater.

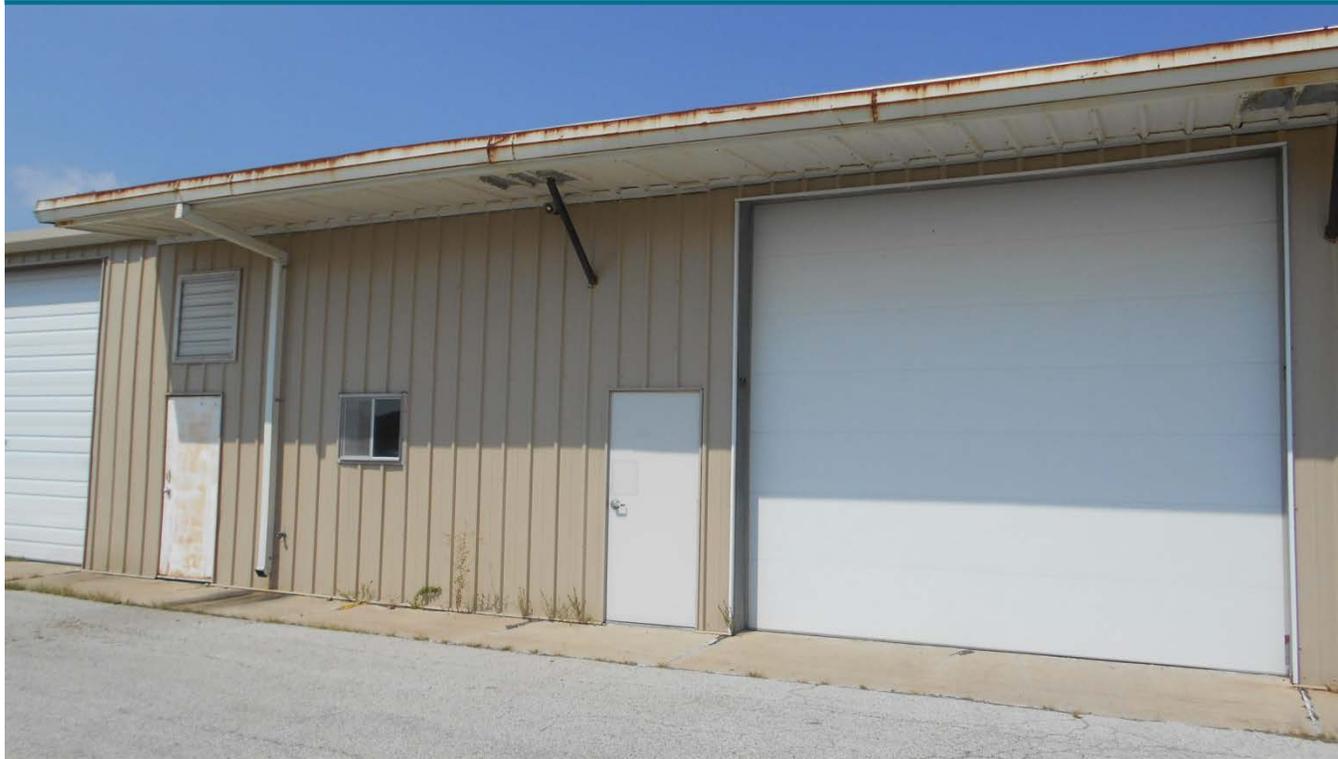
- ILEAS Garage 2 is connected to Sheriff's Garage.
- The building is in overall fair condition.
- Sealed concrete flooring is scratched and worn in places.
- Doors are worn with some deterioration.
- Finish on interior exposed structure is worn and deteriorated.
- Gutters and downspouts are deteriorated.
- Roof overhang is deteriorated and has impact damage.
- Organic plant growth in cracks along exterior concrete.
- No ventilation. Heat provided by ceiling mounted gas fired unit heater.

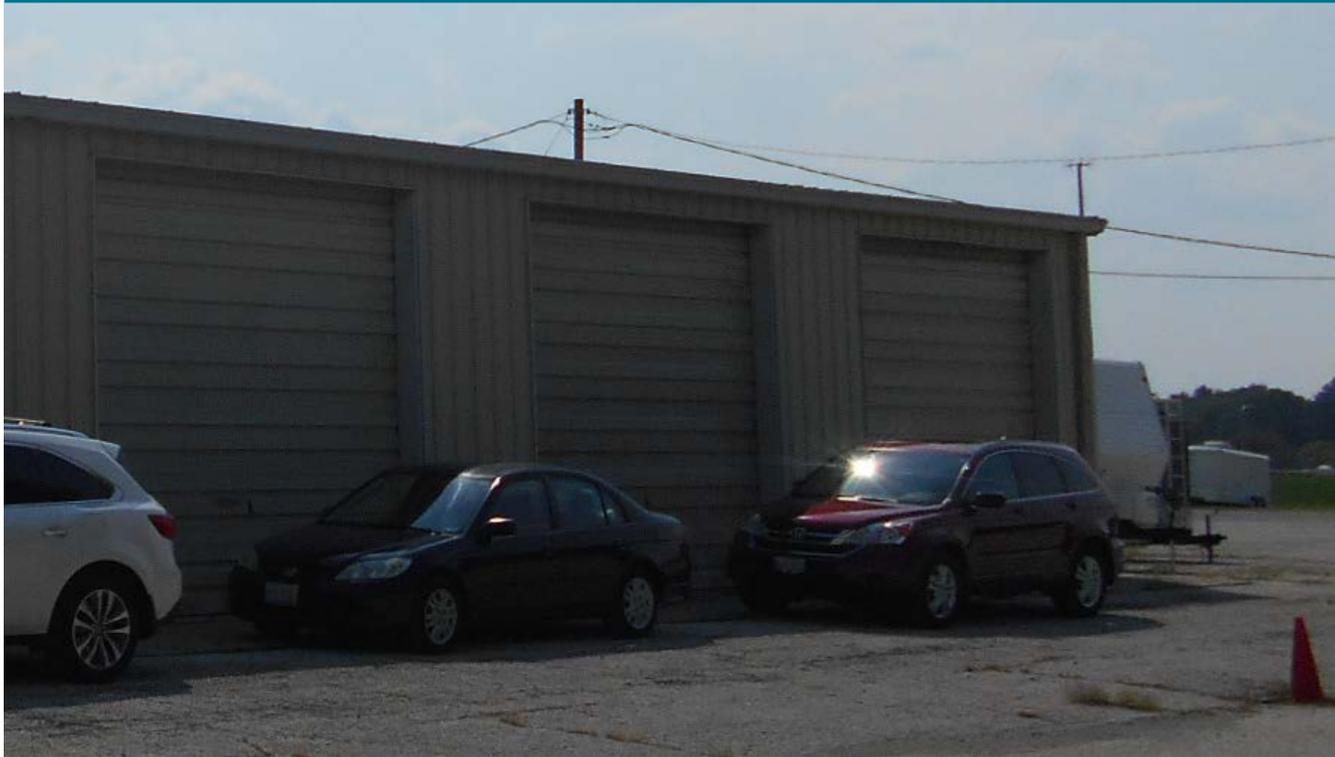
- ILEAS Garage 3 is connected to County Highway Garage.
- The building is in overall fair condition.
- Sealed concrete flooring is scratched and worn in places.
- Finish on interior exposed structure is worn and deteriorated.
- Doors have some deterioration and are in fair condition.
- Interior structure is in good condition, some deterioration.
- Overhead door is in fair condition, minor impact damage.
- Sealant deterioration in places along concrete.
- No ventilation. Heat provided by ceiling mounted gas fired unit heater.
