CHAMPAIGN COUNTY BOARD FACILITIES COMMITTEE AGENDA

**Champaign County
Capital Asset Project**

Satellite Jail – Hot Water System Replacement Project

Scope of Work / Cost Estimates
Domestic Water Heater Replacement
Satellite Jail

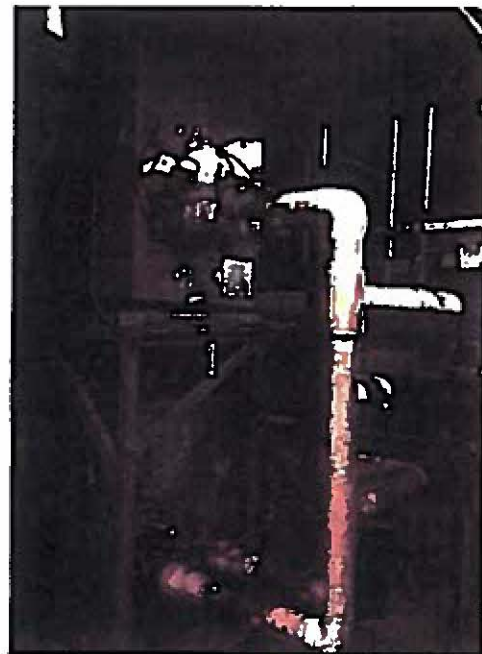
Pod A (North) Penthouse

Two (2) AO Smith gas fired domestic hot water boilers installed in 2007.

AO Smith Model GW-1300
Input BTU / hr at 1,300,000
GPH recover at 100°F rise – 1,324
Hot water delivery set at 145°F

Removal of the existing two (2) AO Smith gas-fired hot water boilers will involve some minor demolition of inlet and outlet piping, gas supply piping, control wiring and air intake and exhaust flues.

Similar Bradford White boilers would be installed within the same "footprint" of the removed boilers. New equipment stand will need to be installed as well as controls and wiring. Inlet and outlet water piping will connect to the existing piping system.

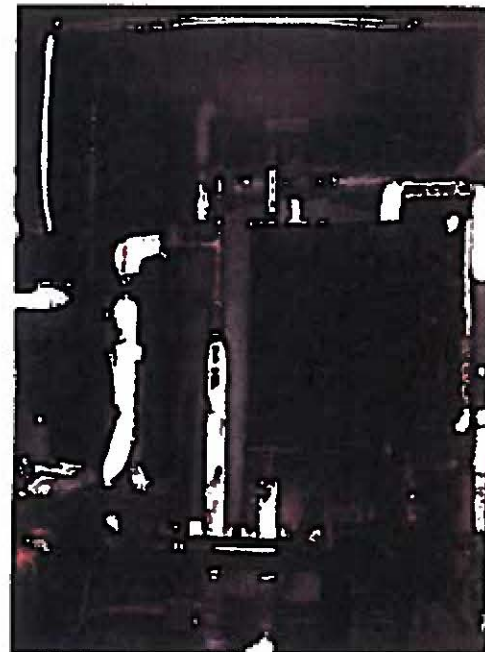
One (1) 600 gallon storage tank installed in 1996 original building construction.

A master thermostatic mixing valve, Leonard "Hi-Lo" model in a valve cabinet. Tempered water supply from TMV is approximately 125°F.

Note: Illinois Plumbing Code mandates a maximum temperature of 115°F at the lavatory faucet.

Replacement of the existing 600 gallon storage tanks will also require removal and replacement of water and gas piping, recirc pumps, TMV, valves, etc., all of which are installed in front of the storage tank.

Due to lack of space in the Mechanical Penthouse, a new 600 gallon storage tank with new water piping, gas piping, recirc pumps, valves and TMV will be installed in similar location as existing system.

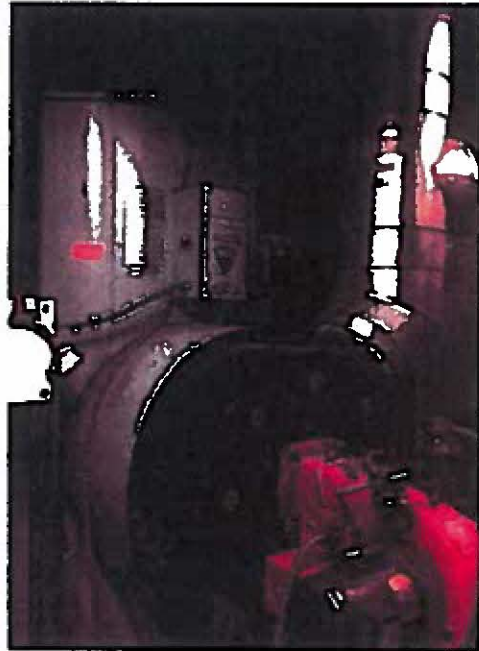
Pod B (South) Penthouse

One (1) 600 gallon "turbopower" gas water heater.

PVI Model 3000P 600A-TP
Input BTU / hr at 2,400,000
GPH recover at 80°F rise – 3,000
Hot water delivery set at 145°F

Remove of the existing 600 gallon PVI "TurboPower" gas water heater will require some minor demolition of inlet and outlet piping, gas supply piping, controls and wiring and removal of air intake and exhaust flues.

The new Bradford White domestic hot water boilers will be installed, stacked on new equipment stand. New air intake and exhaust flues will require two new penetrations through the existing roof. Inlet and outlet water piping will reconnect to the existing piping system. New controls and wiring will be provided.
