**CHAMPAIGN COUNTY BOARD
FACILITIES COMMITTEE**
County of Champaign, Urbana, Illinois
Tuesday, June 2, 2015 6:30 pm

| IX. | Engineering Resources & Associates Report, Findings and Recommendations from the Satellite Jail Pre-Cast Concrete Study Direct County Administration to Negotiate a Contract with Engineering Resources Associates to develop the drawings, specifications and bid documents necessary to replace the pre-cast concrete panel joints for the following three Champaign County Buildings: County Highway Maintenance Facility; Juvenile Detention Facility; and, the Adult Detention Facility (Satellite Jail) and to make the necessary repairs to the Satellite Jail's pre-cast concrete panels as indicated by ERA's May 11, 2015 report. | 13 |

Concrete Wall Panel Cracking Investigation Champaign County Satellite Jail

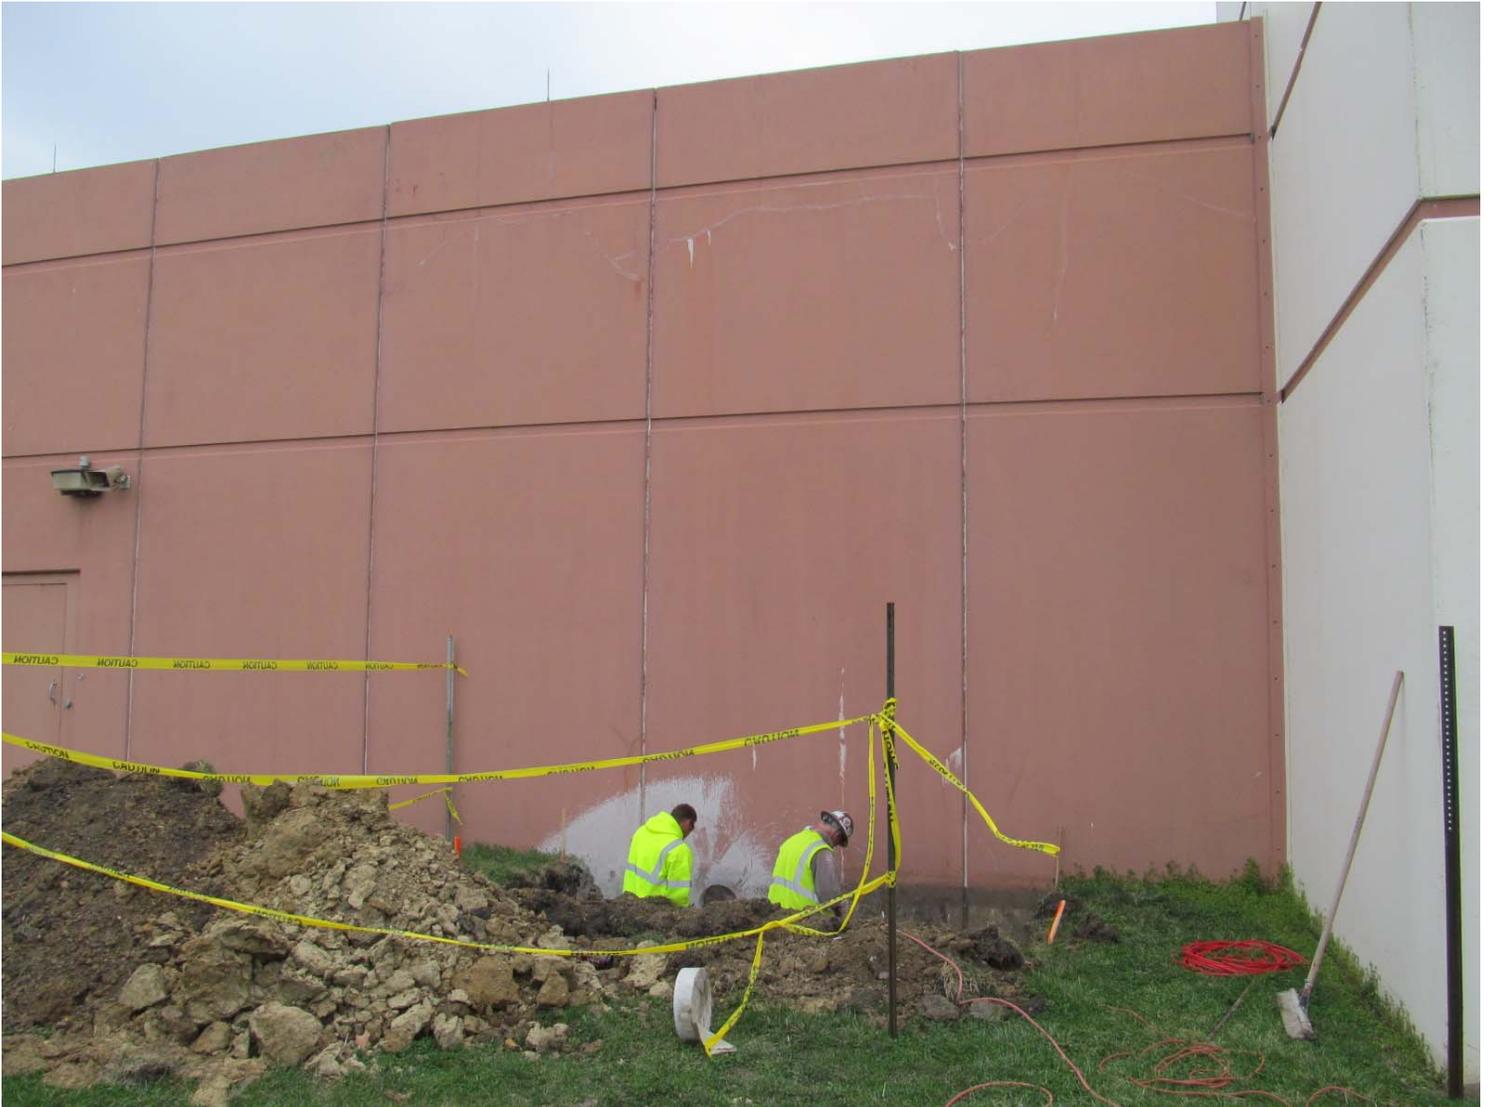
**Photograph #1: East Wall at Exterior Jail Exercise Yard
Horizontal Cracking near Top of Wall Panel
Vertical Cracking near Bottom of Wall Panel
Free Lime is leaching out of the cracks, evidenced by the white stains draining
from the cracks.**

Most of the wall panel cracking can be defined in two categories:

1. Vertical Cracking: Typically one or two cracks appear to propagate from the bottom of the panel, disappearing below the ground line. To a much lesser degree at the corners, vertical cracking can be seen at panel edges.
2. Horizontal Cracking: Typically the cracks occur near the top or the bottom of the wall panels and can meander across the wall panel joints. Some vertical cracks intersect horizontal cracks.

1A. Repair and Seal Cracks: Where feasible, inject the wall panel cracks with epoxy. Where infeasible, rout the cracks and seal. This is important to reduce wind driven rain intrusion and **critical to preserving the prestressing strands.**

1B. Replace the Vertical Panel Joints: For all precast concrete wall panel buildings, wall panel joint repair and/or replacement is required maintenance. This recommendation has the same importance as Recommendation #1.

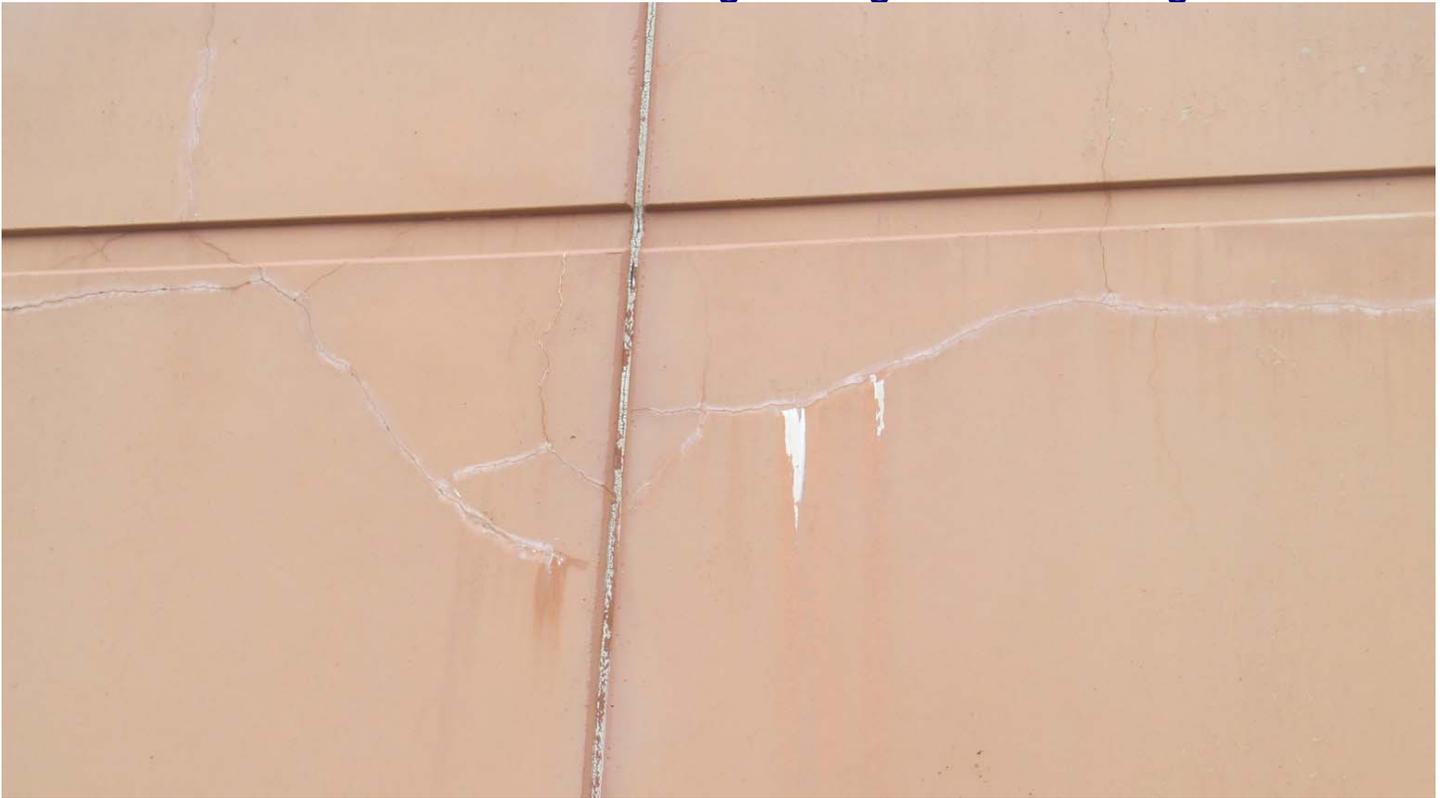
Photograph #2: Close-up of Photograph #1 near Top of Wall Panel

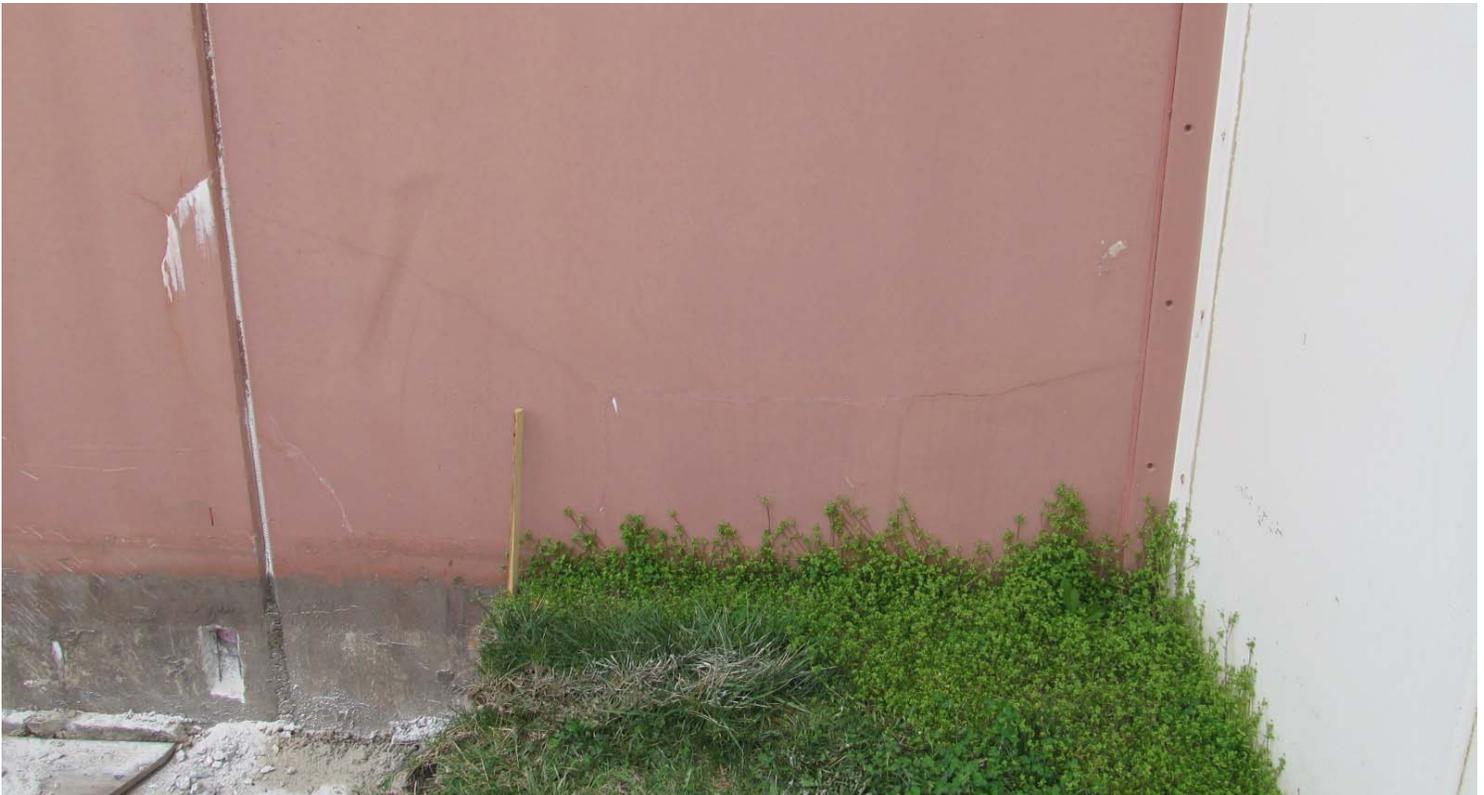
Photograph #3: Close-up of Photograph #1 near Bottom of Wall Panel

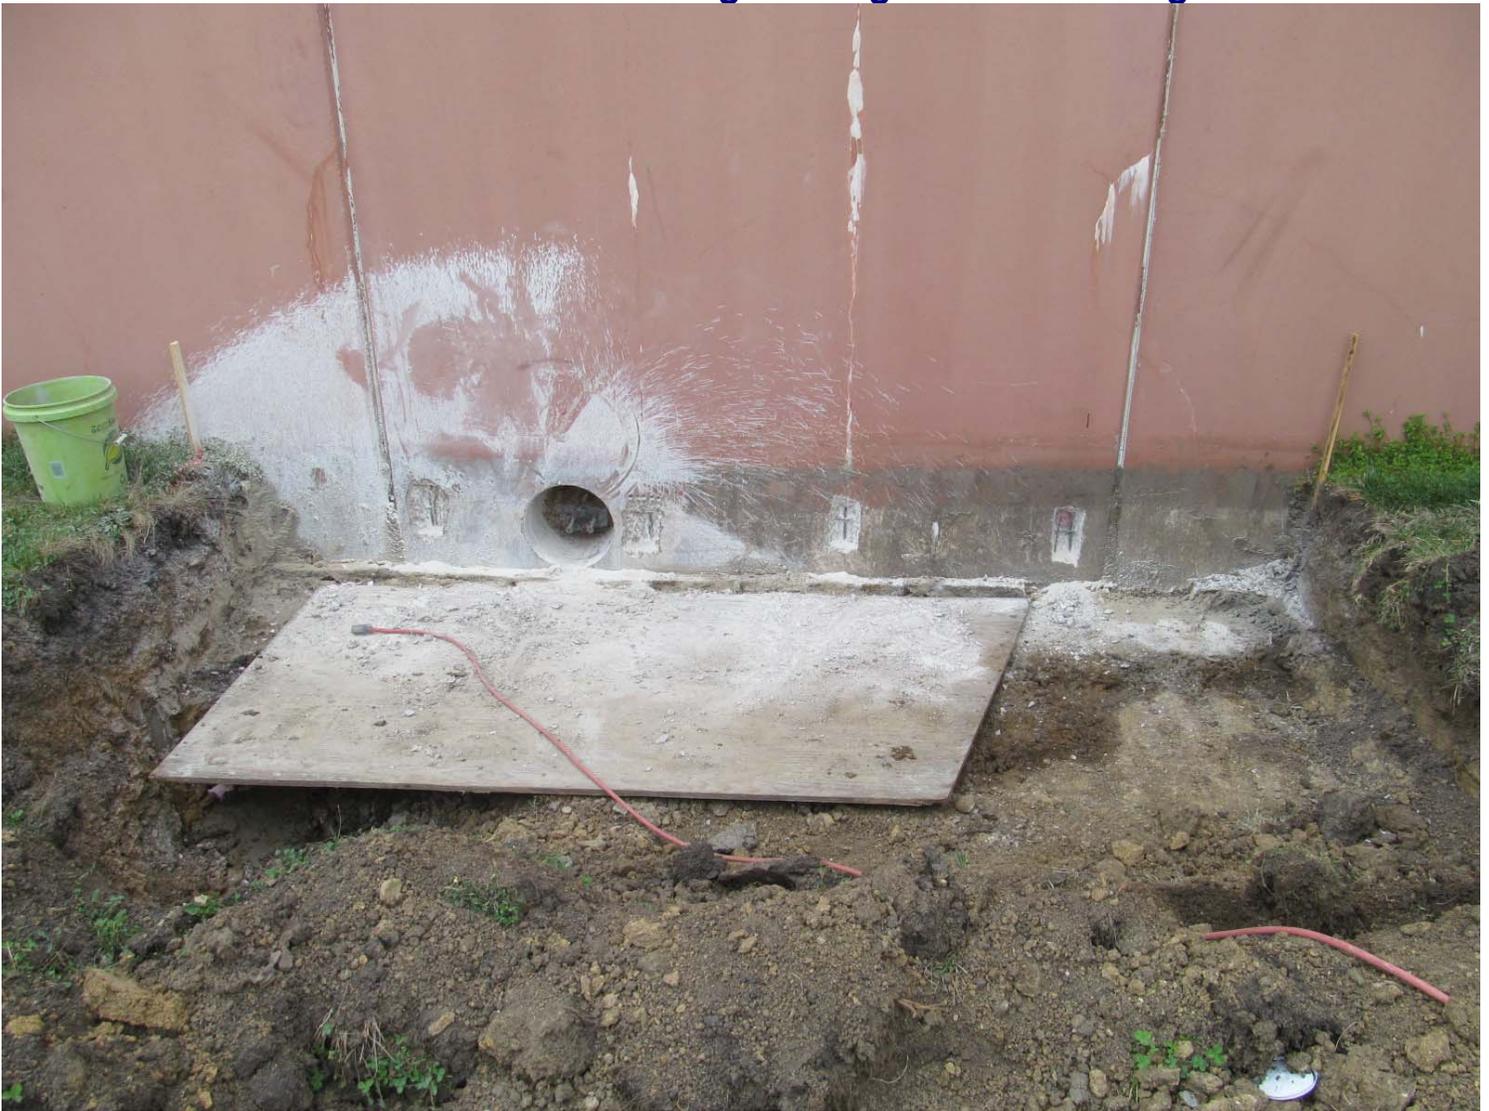
Photograph #4: Close-up of Photograph #1 showing Vertical Cracking The Wall Panel was cored at the Base Connection, and the Prestressing Strands were exposed. The Base Connection was buried in moist sand and exhibited surface rust. One strand exhibited surface rust. The other three strands were in good condition.

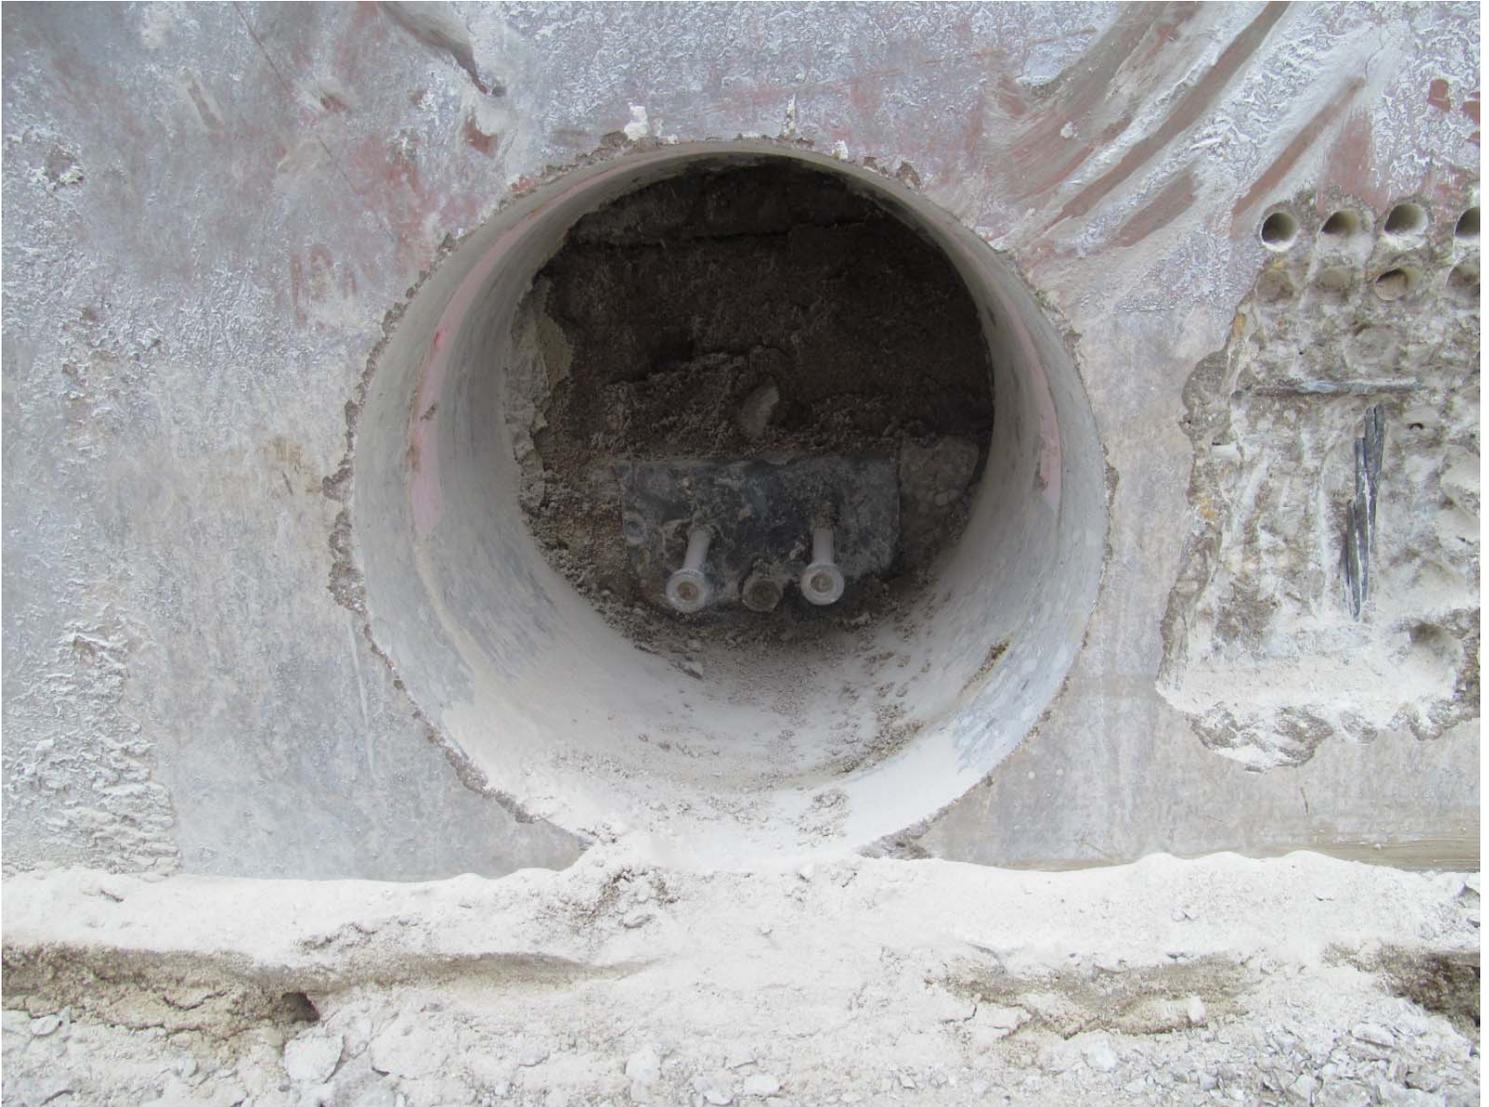
Photograph #5: The Wall Panel Base connection exhibited surface corrosion. The steel connection is buried in sand below the floor slab. The sand was moist. The adjacent prestressing strand was corrosion free. The wall panel cracking does not extend to the bottom.

Welded Steel Connection Corrosion: The wall panel base welded steel connection exhibited only surface corrosion and is not the cause of the wall panel cracking. The connection is buried in sand that was found moist. Depending upon the time of the year and the precipitation amounts, this sand could be found wet, moist, or dry. **As long as there is moisture and oxygen present, the base connection can be expected to continue to corrode.**

3A. Replace the Bottom Wall Panel Connection: The bottom connections of the Wall Panels to the Footing exhibit surface corrosion and are buried in wet sand. The Wall Panel Bottom Connection can be replaced on the outside of the building. The new connection must be encased in concrete.

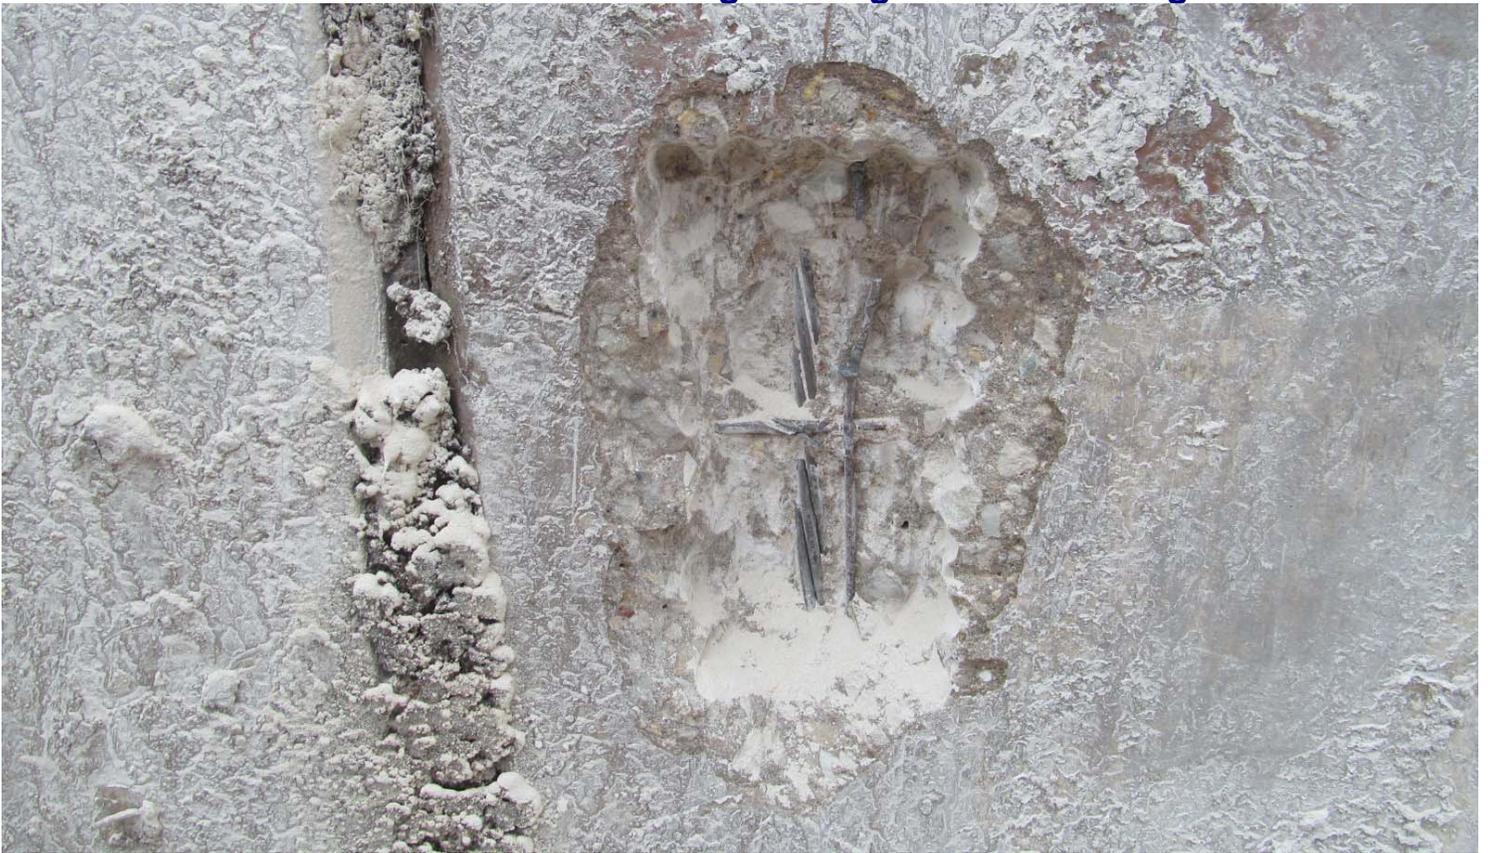
Photograph #6: The strand on the left side of the panel was corrosion free.

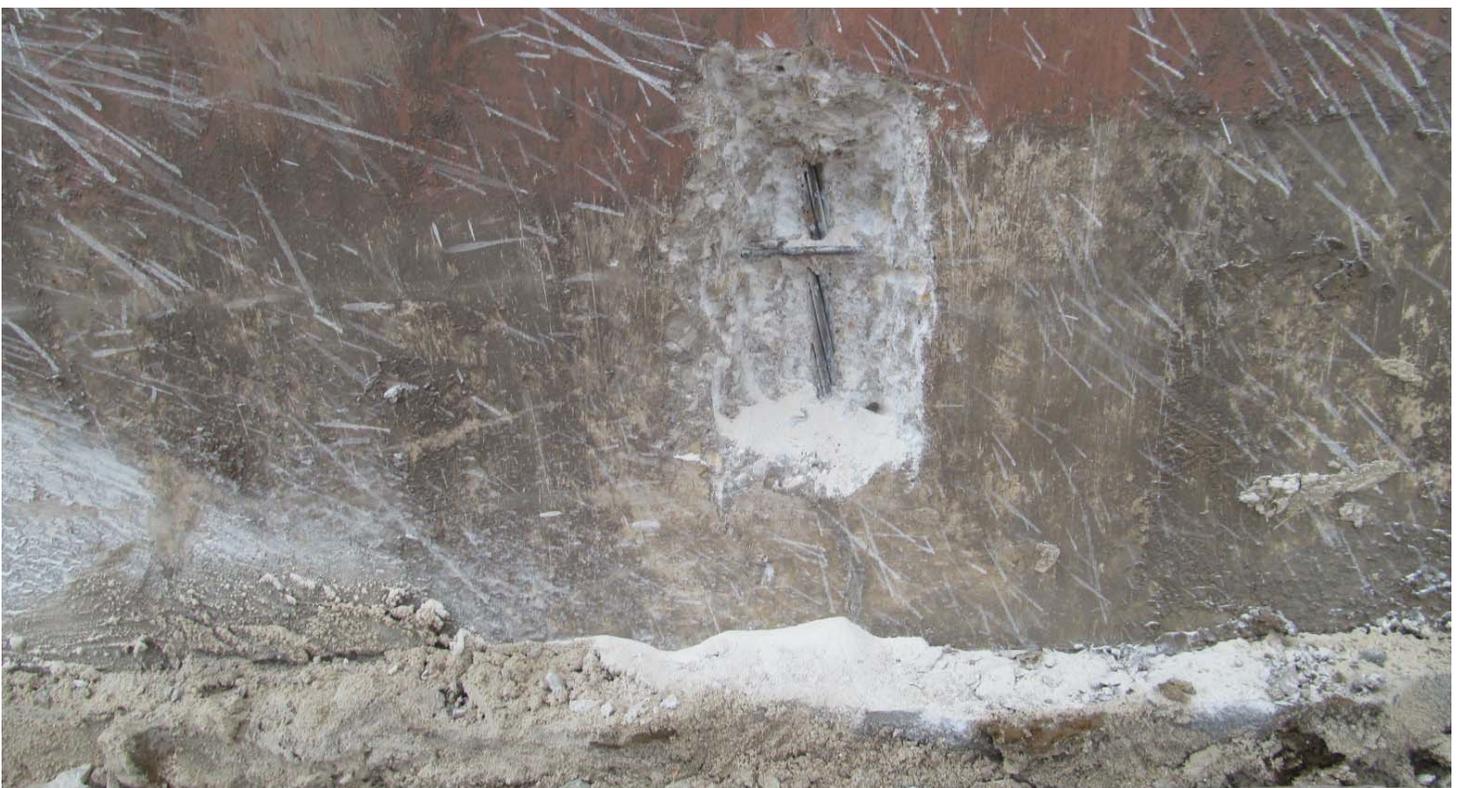
Photograph #7: The right-center strand exhibited surface corrosion.

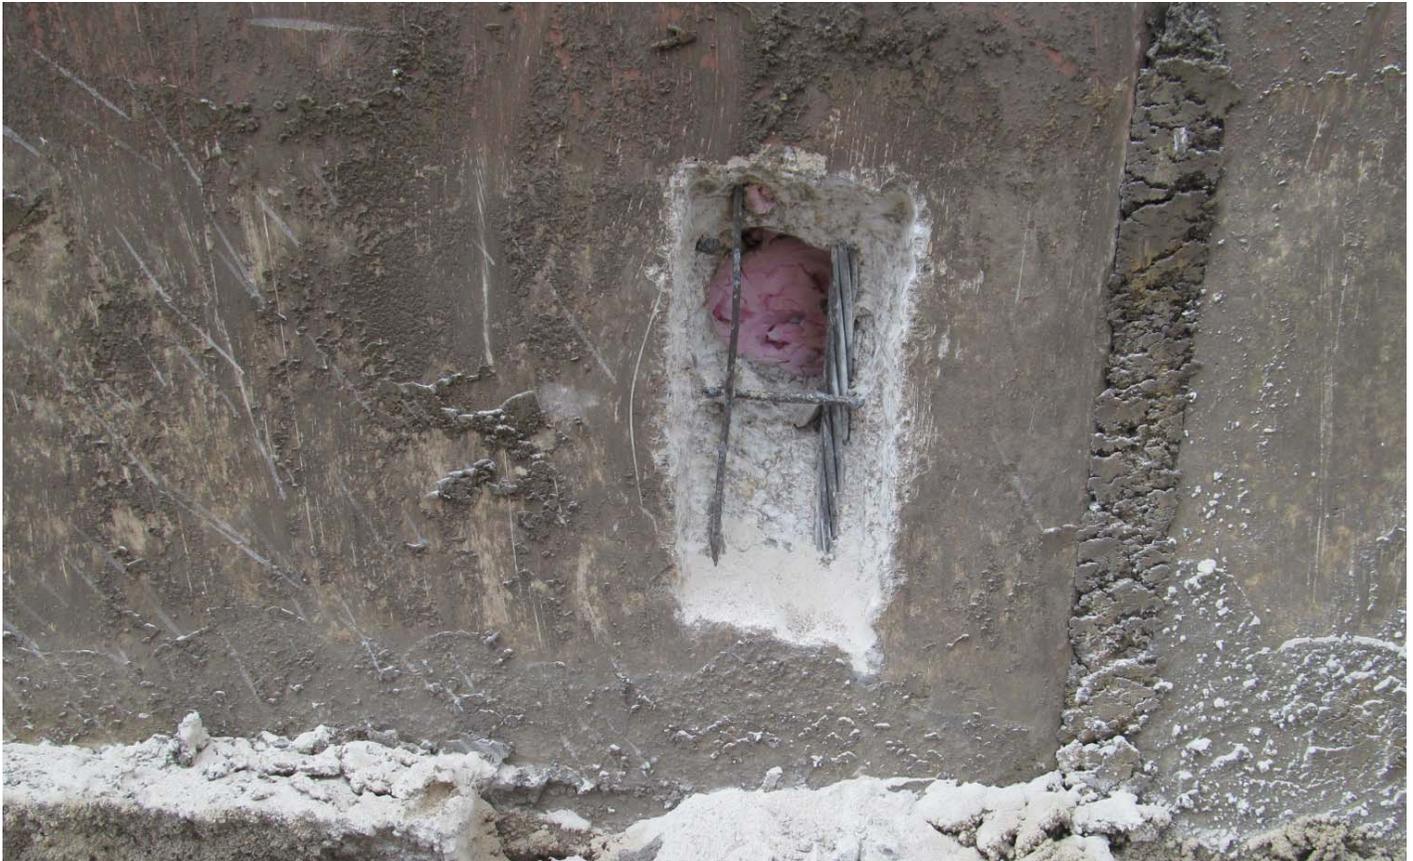
Photograph #8: The strand on the right side of the panel was corrosion free.

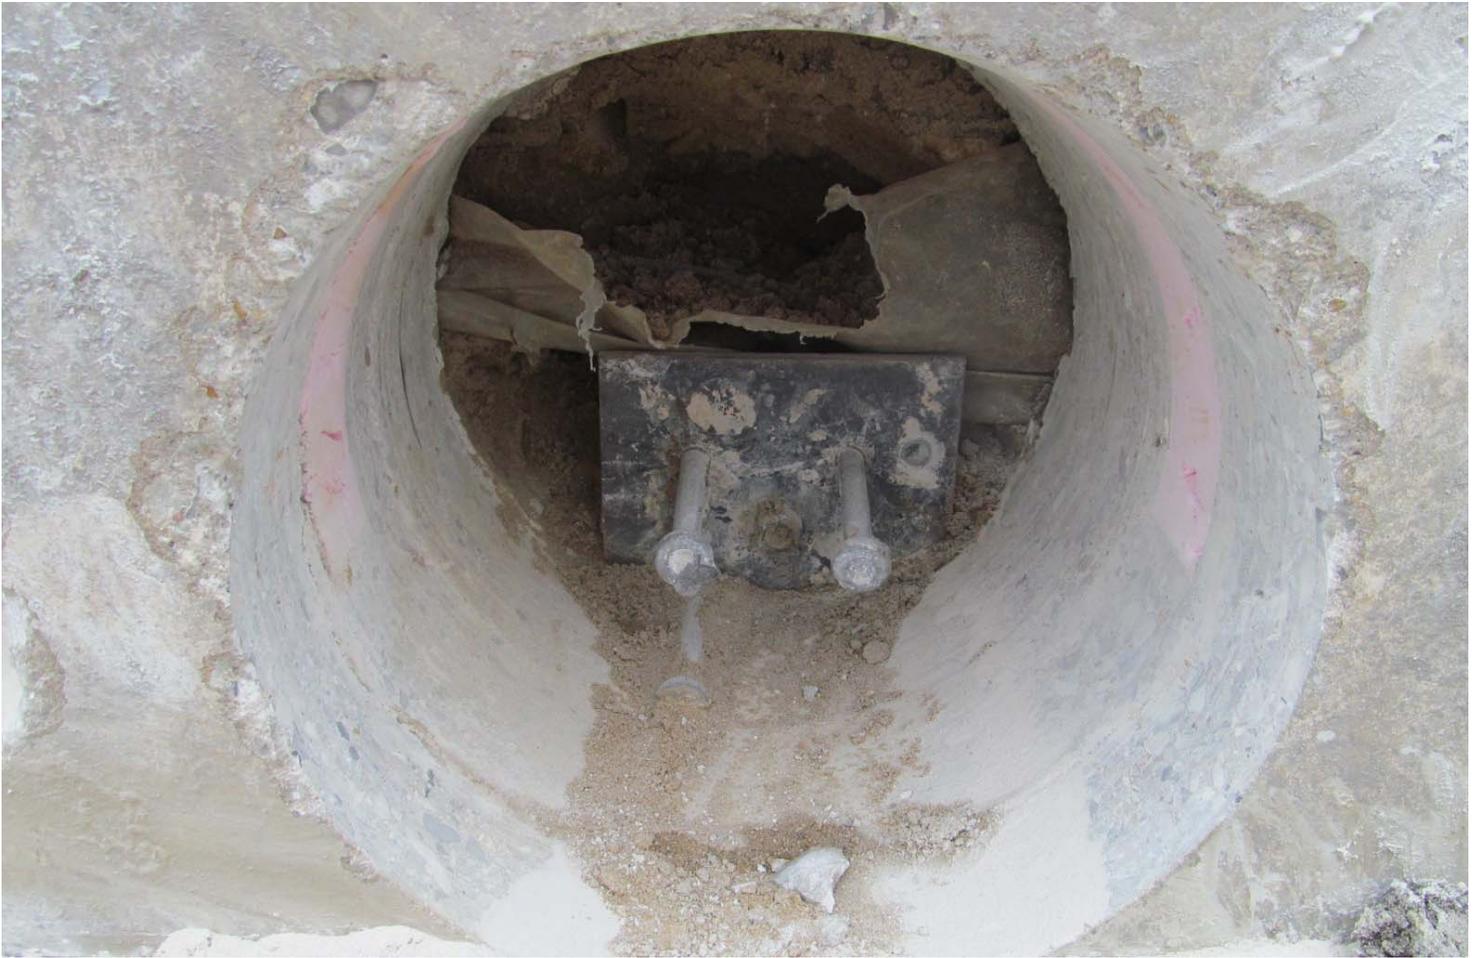
Photograph #10: The Wall Panel Base connection exhibited surface corrosion on the buried face. The steel connection is buried in moist sand below the floor.

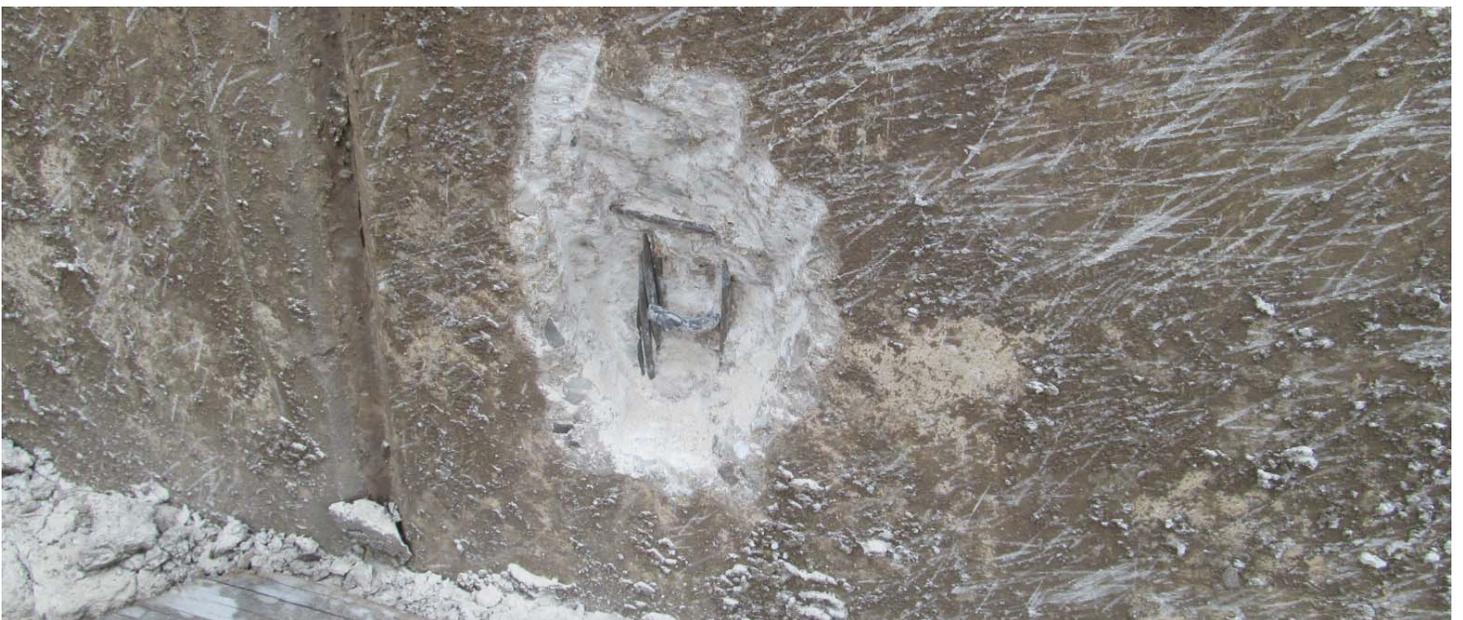
Photograph #11: The strand on the left side of the panel was corrosion free.²⁰

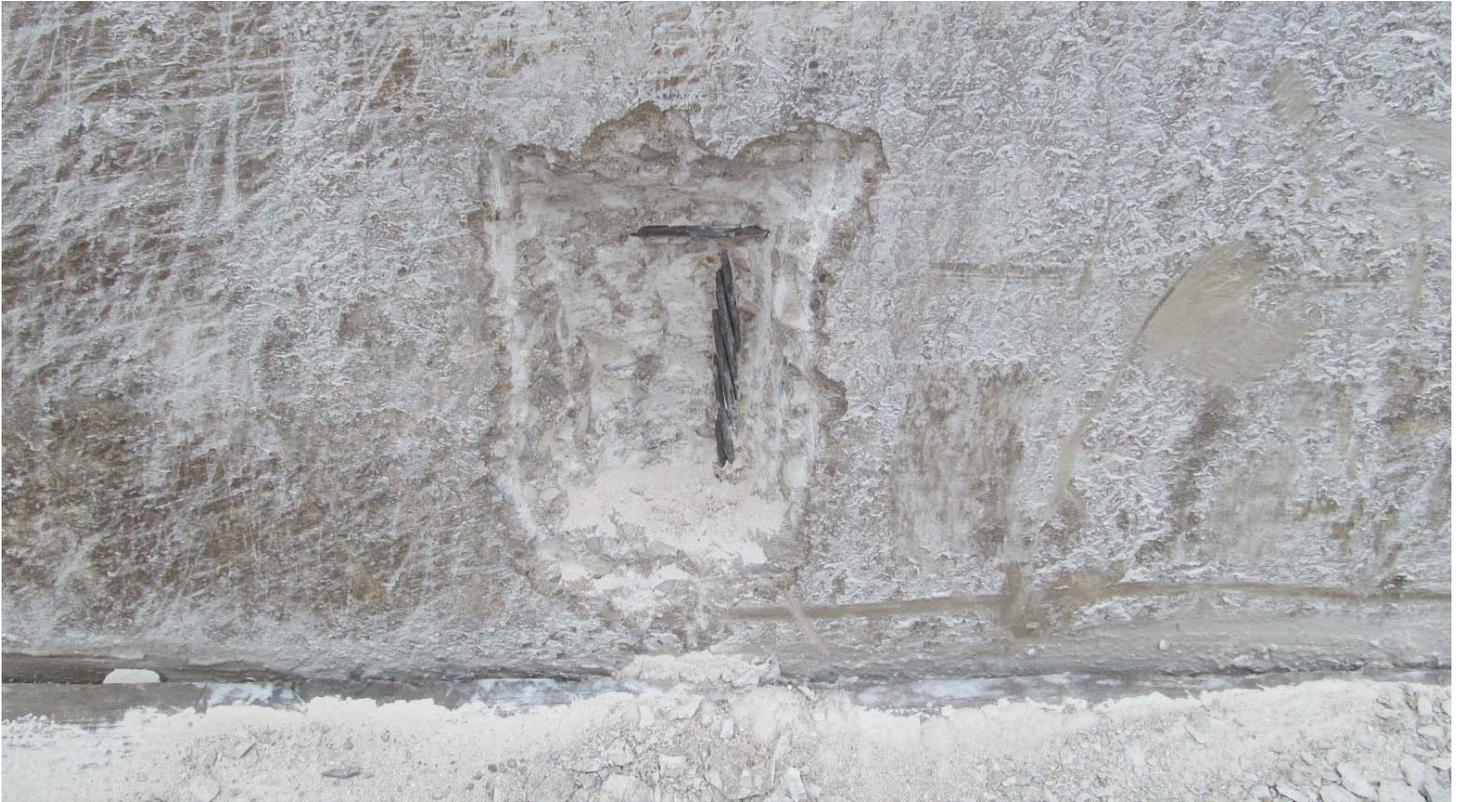
Photograph #12: The left-center prestressing strand was corrosion free.

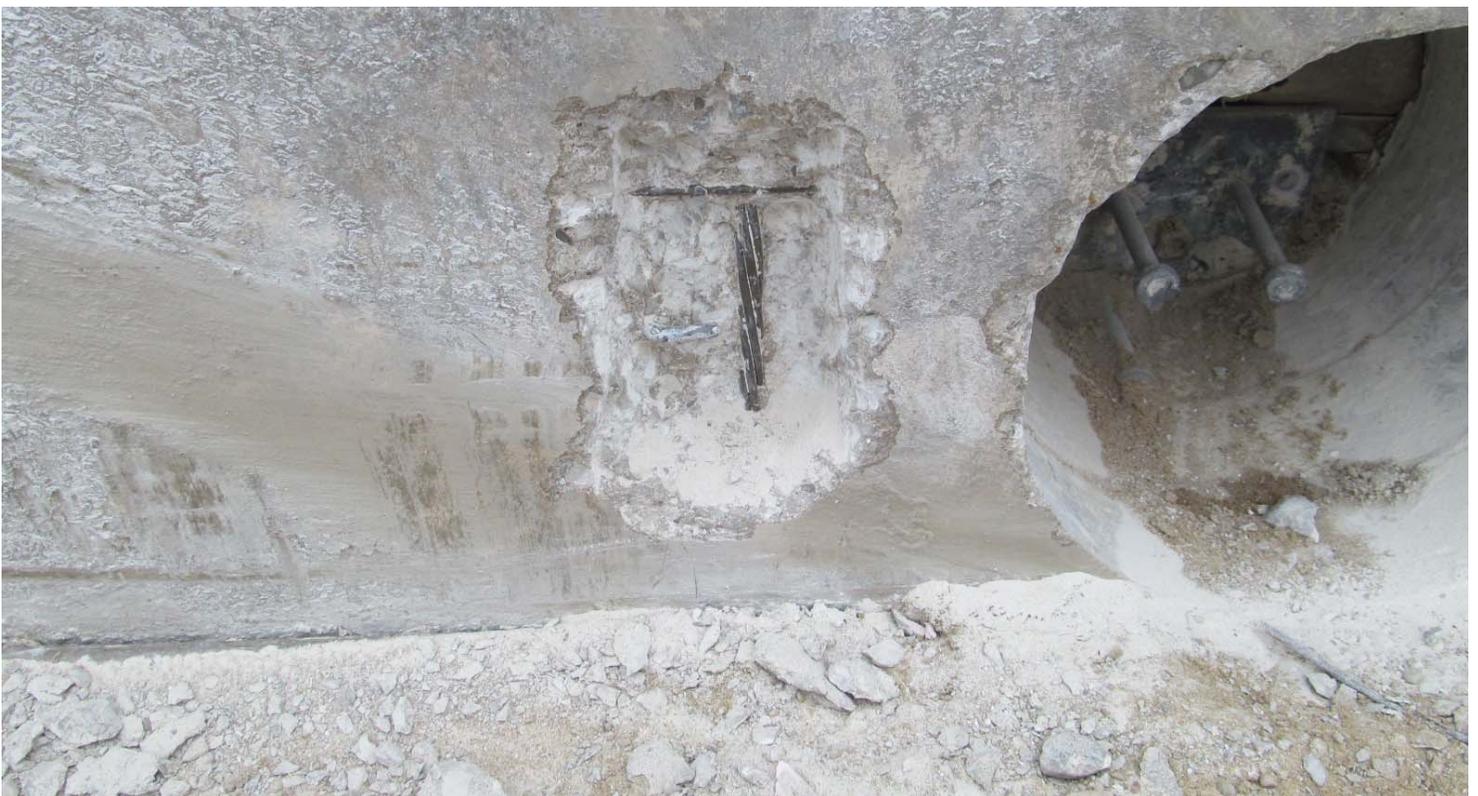
Photograph #13: The right-center prestressing strand was corrosion free. 21

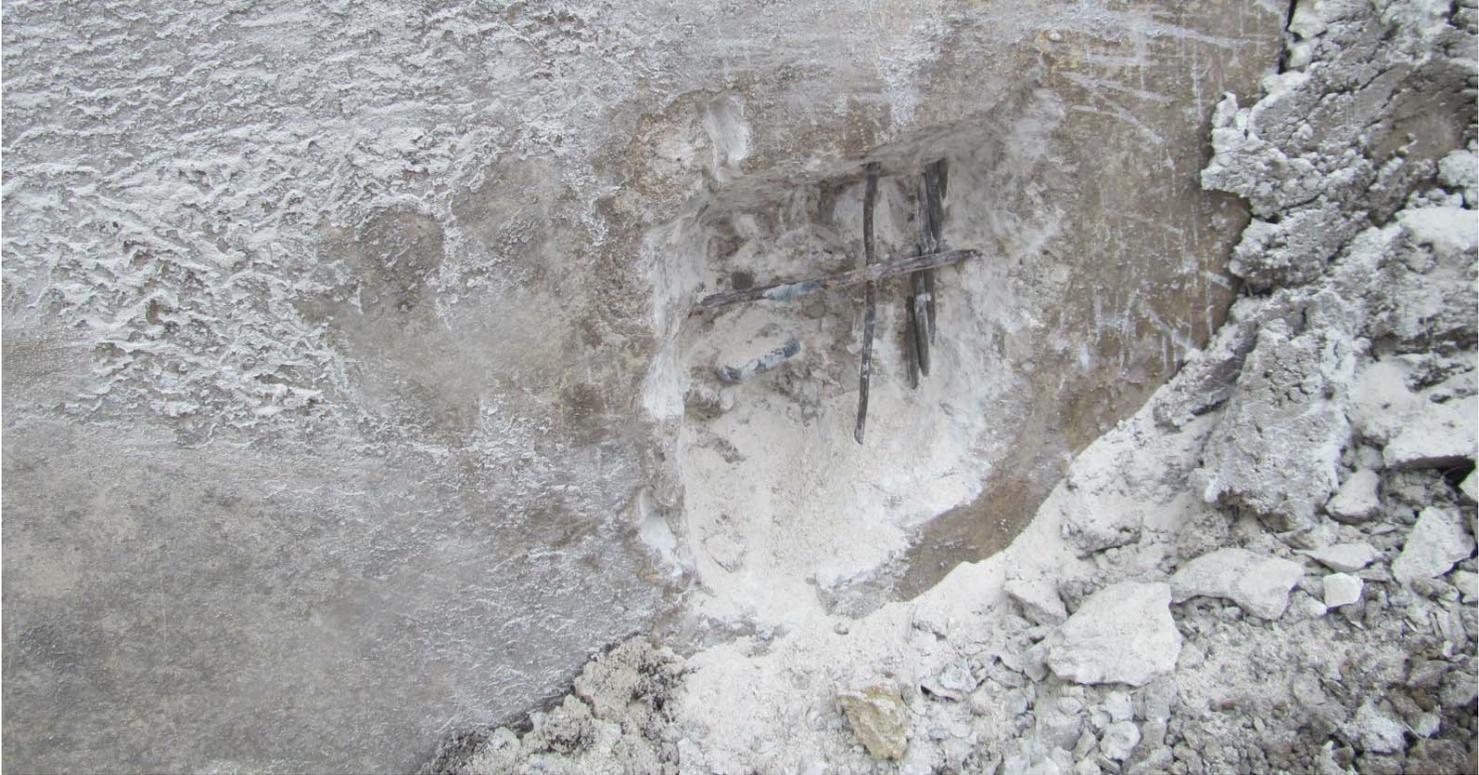
Photograph #14: The strand on the right side of the panel was corrosion free.

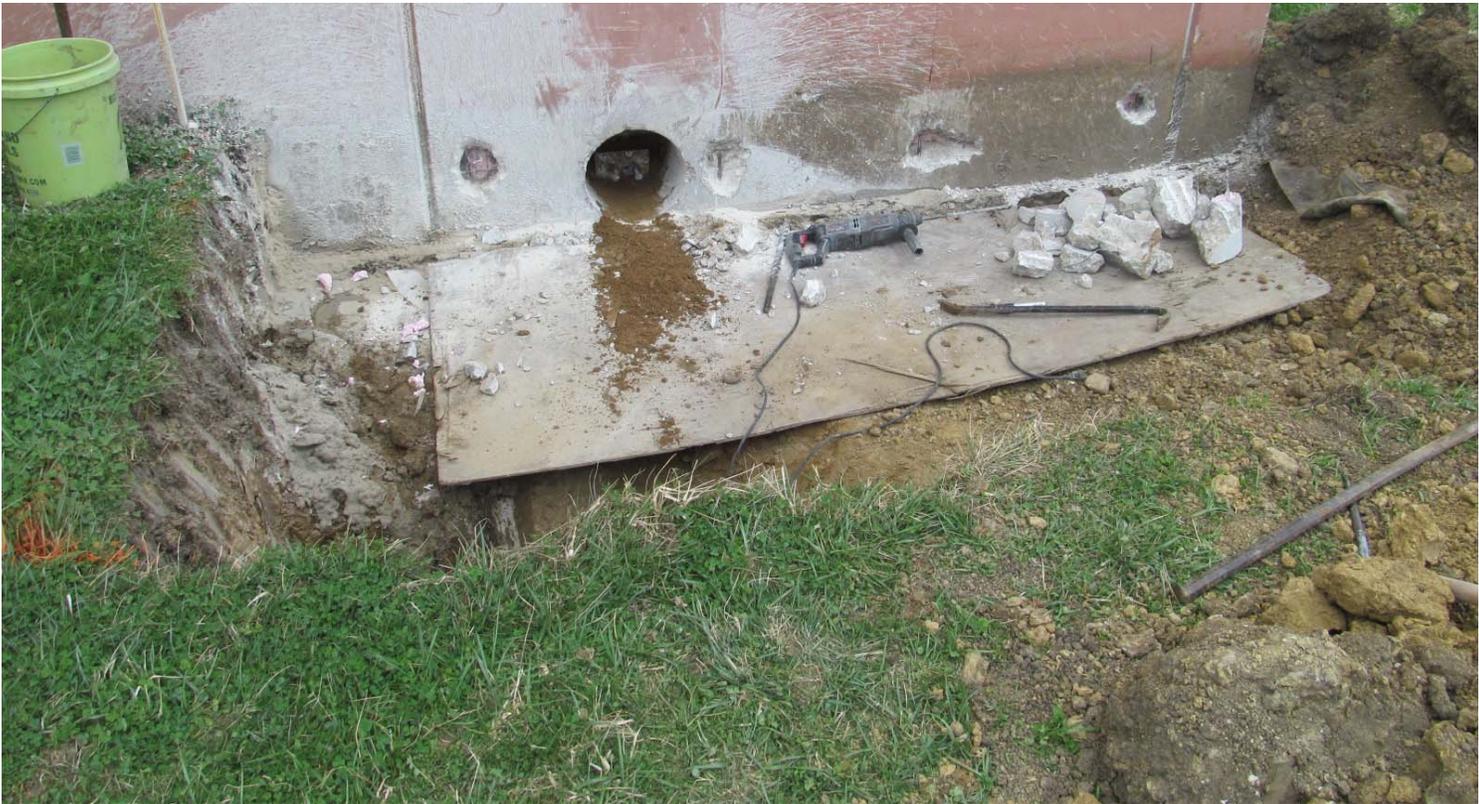
Photograph #15: Southeast Corner Location

5. The insulation layer terminates within one foot of the top and bottom of the wall panels. In Photo #15, the vertical crack at the second excavation from the right propagated horizontally in both directions at the level of insulation termination, signally water collection and freezing at that level.

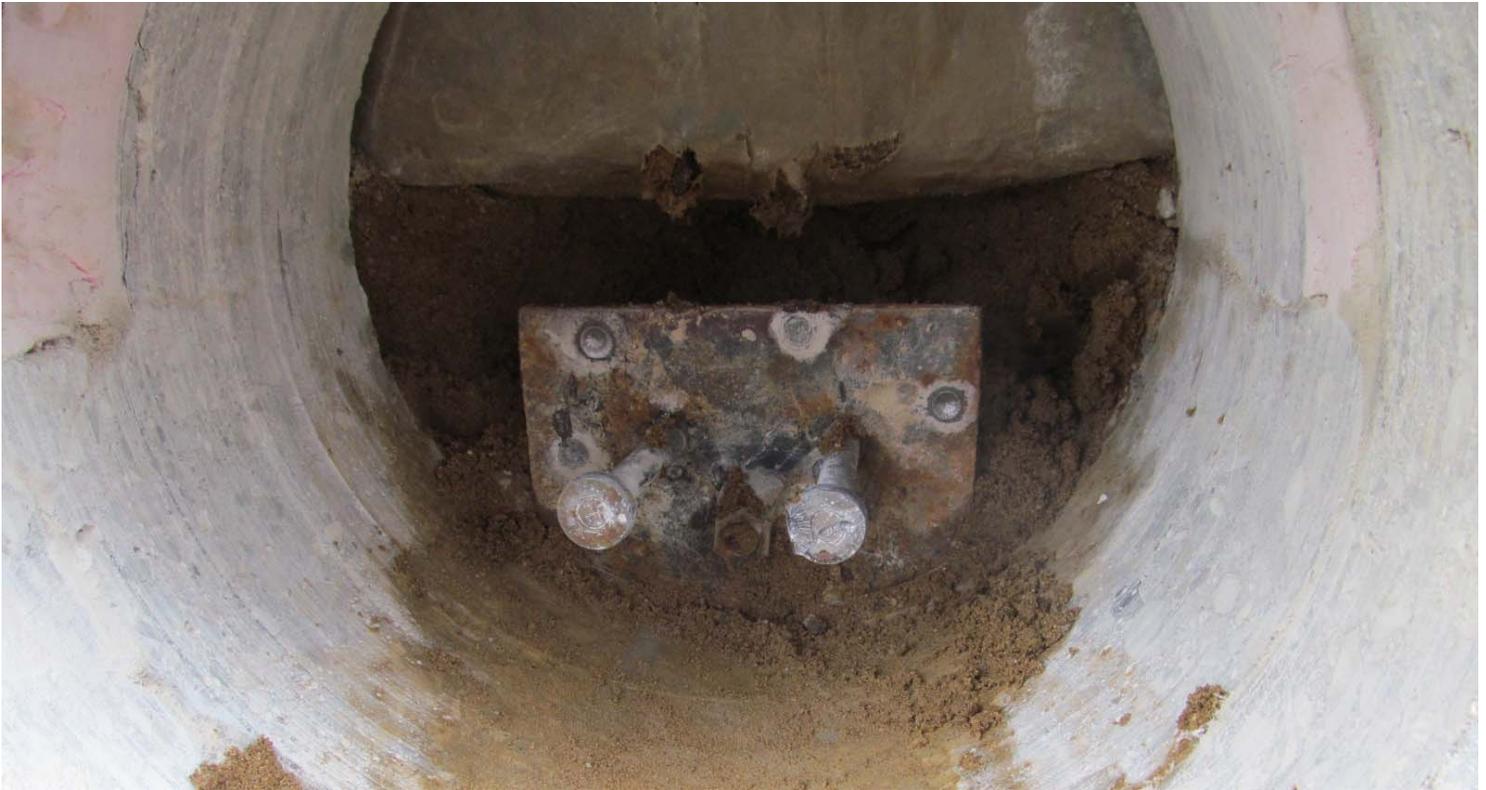
Photograph #16: The Wall Panel Base connection exhibited surface corrosion on the buried face. The steel connection is buried in moist sand below the floor.

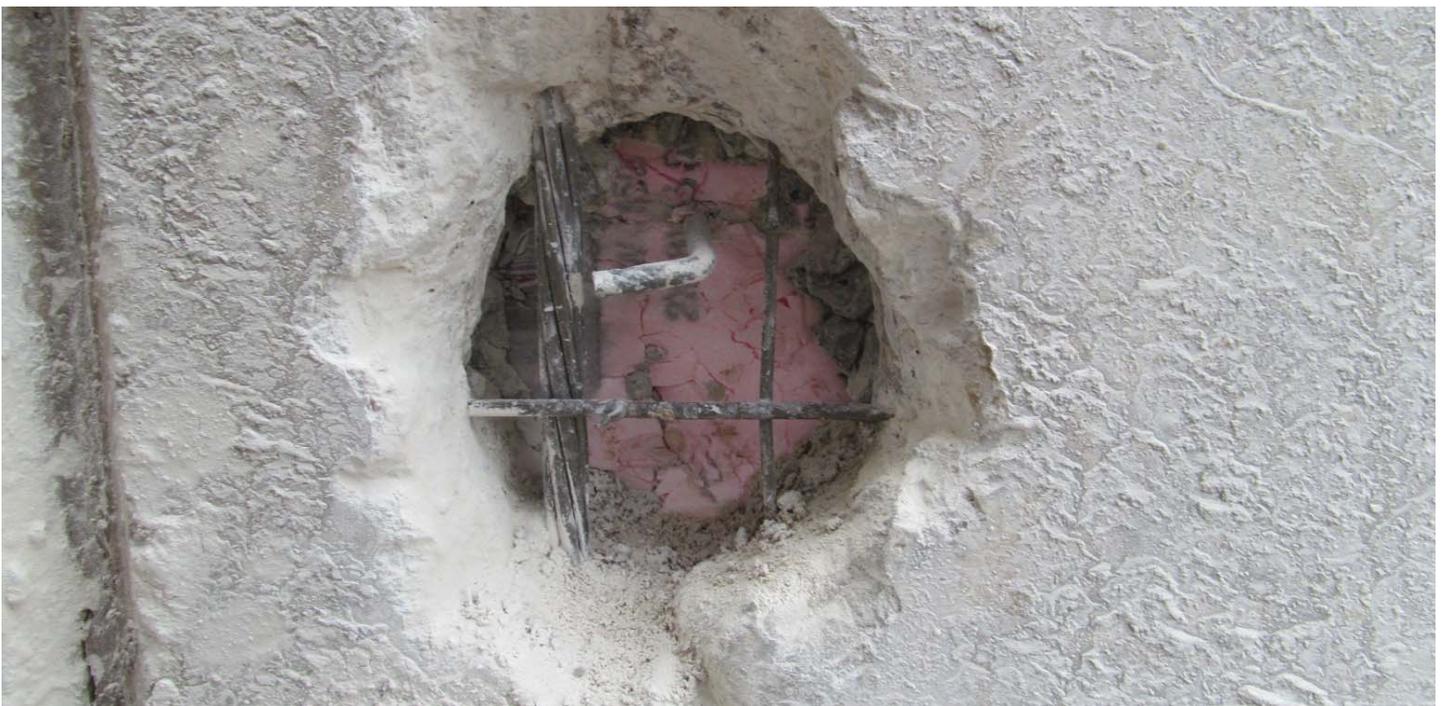
Photograph #17: The strand on the left side of the panel was corrosion free. The L-shaped tie wire is the mechanical connection between concrete layers.

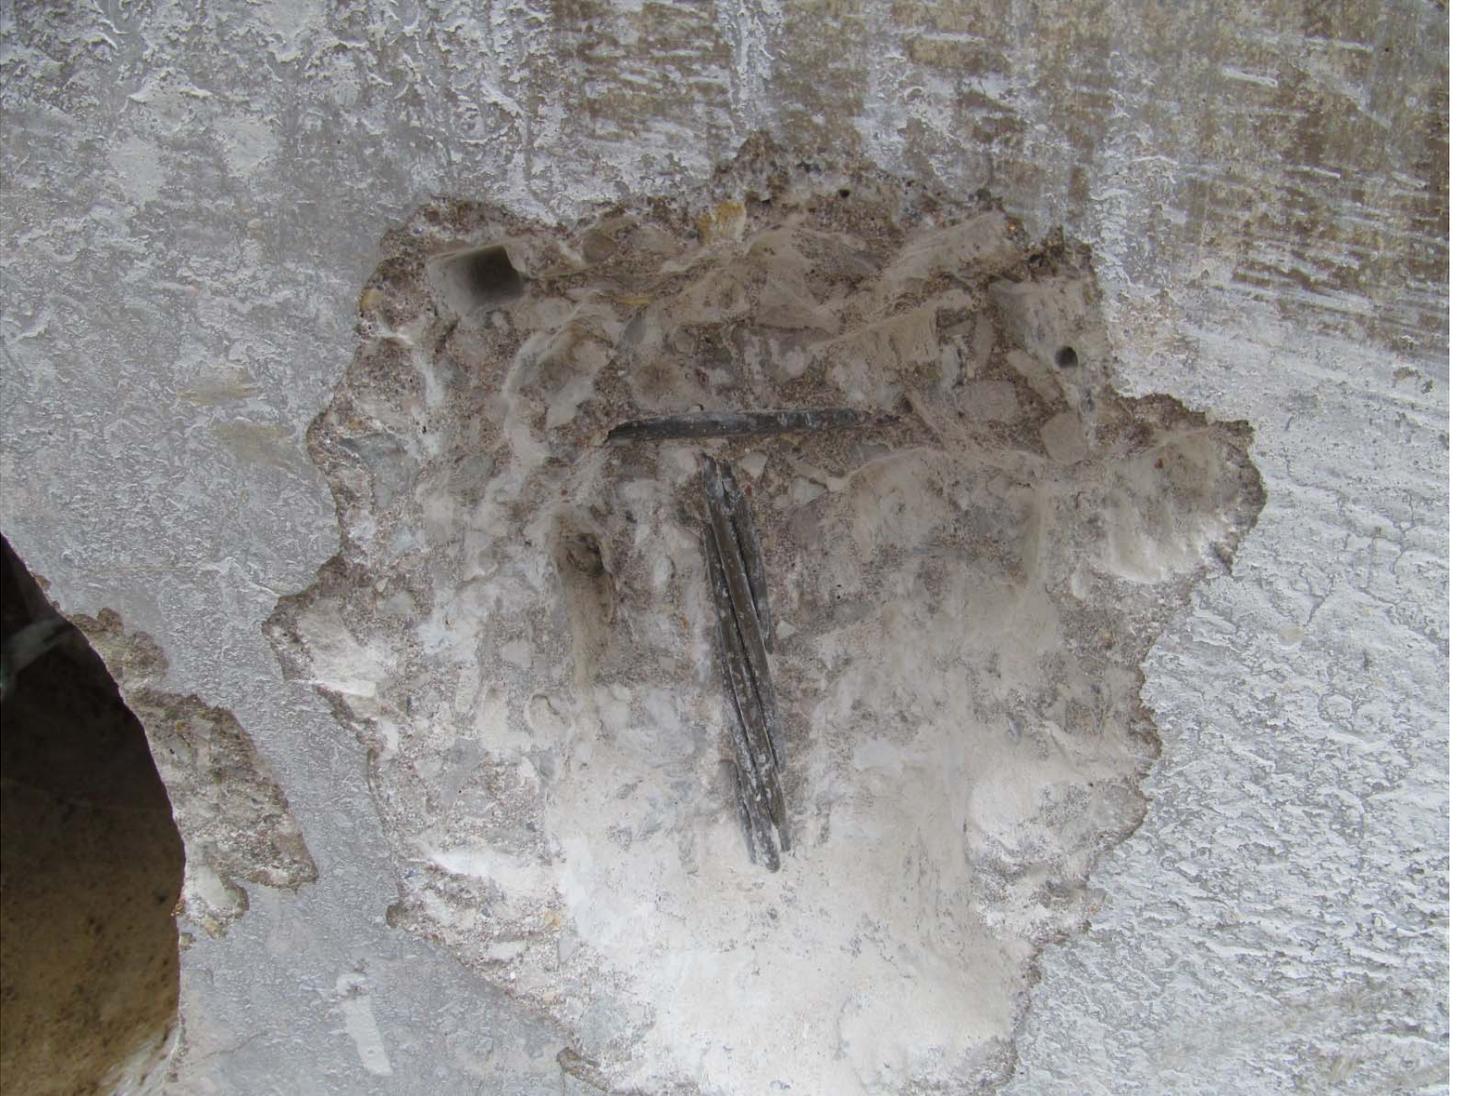
Photograph #18: The left-center prestressing strand was corrosion free.

Many of the vertical cracks dissipated below the ground surface. The crack at the right-center prestressing strand propagated downward to approximately the level of the bottom of the insulation layer and then propagated horizontally. There was a bulging of the exterior concrete layer where the vertical crack and the horizontal crack teed together. **This cracking pattern is congruent with a bursting force centered within the wall panel thickness.**
