**CHAMPAIGN COUNTY BOARD
FACILITIES COMMITTEE**
County of Champaign, Urbana, Illinois
Tuesday, June 2, 2015 6:30 pm

| IX. | Engineering Resources & Associates Report, Findings and Recommendations from the Satellite Jail Pre-Cast Concrete Study Direct County Administration to Negotiate a Contract with Engineering Resources Associates to develop the drawings, specifications and bid documents necessary to replace the pre-cast concrete panel joints for the following three Champaign County Buildings: County Highway Maintenance Facility; Juvenile Detention Facility; and, the Adult Detention Facility (Satellite Jail) and to make the necessary repairs to the Satellite Jail's pre-cast concrete panels as indicated by ERA's May 11, 2015 report. | 13 |

Concrete Wall Panel Cracking Investigation Champaign County Satellite Jail

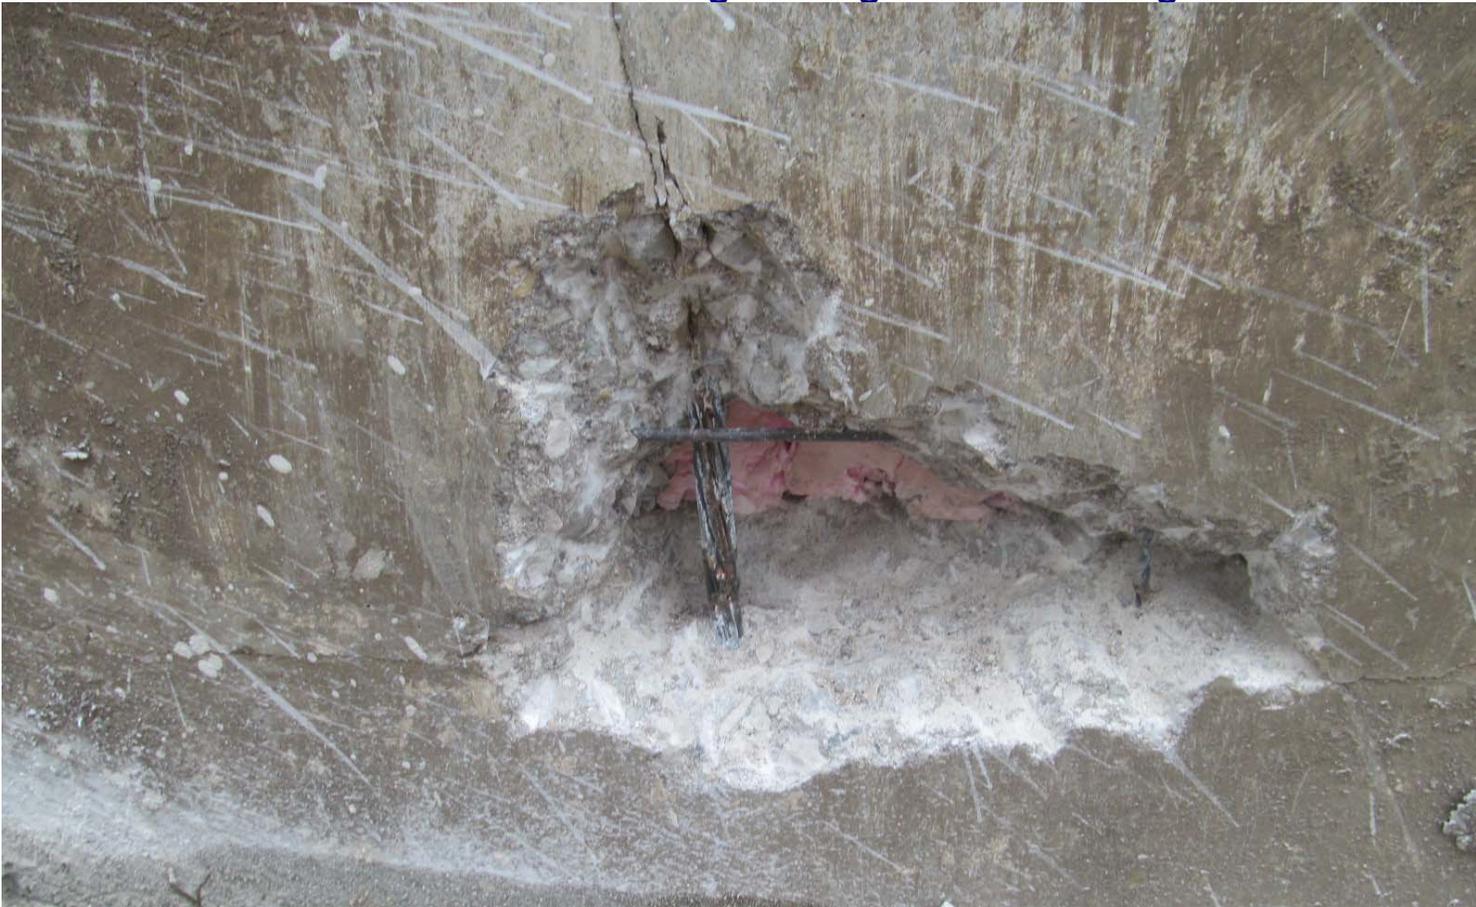
Photograph #19 shows this right-center prestressing strand location. The vertical prestressing strand exhibited surface corrosion. Near the top of the opening is a horizontal welded wire fabric wire that is corrosion free. The vertical crack in the panel propagates from the top of the opening, and the horizontal crack propagates from the sides of the opening.

At this location, pressurized air is blowing out from inside the jail through the left vertical wall panel joint. This wall panel joint sealant has failed.

Photograph #19: The right-center strand exhibited surface corrosion.

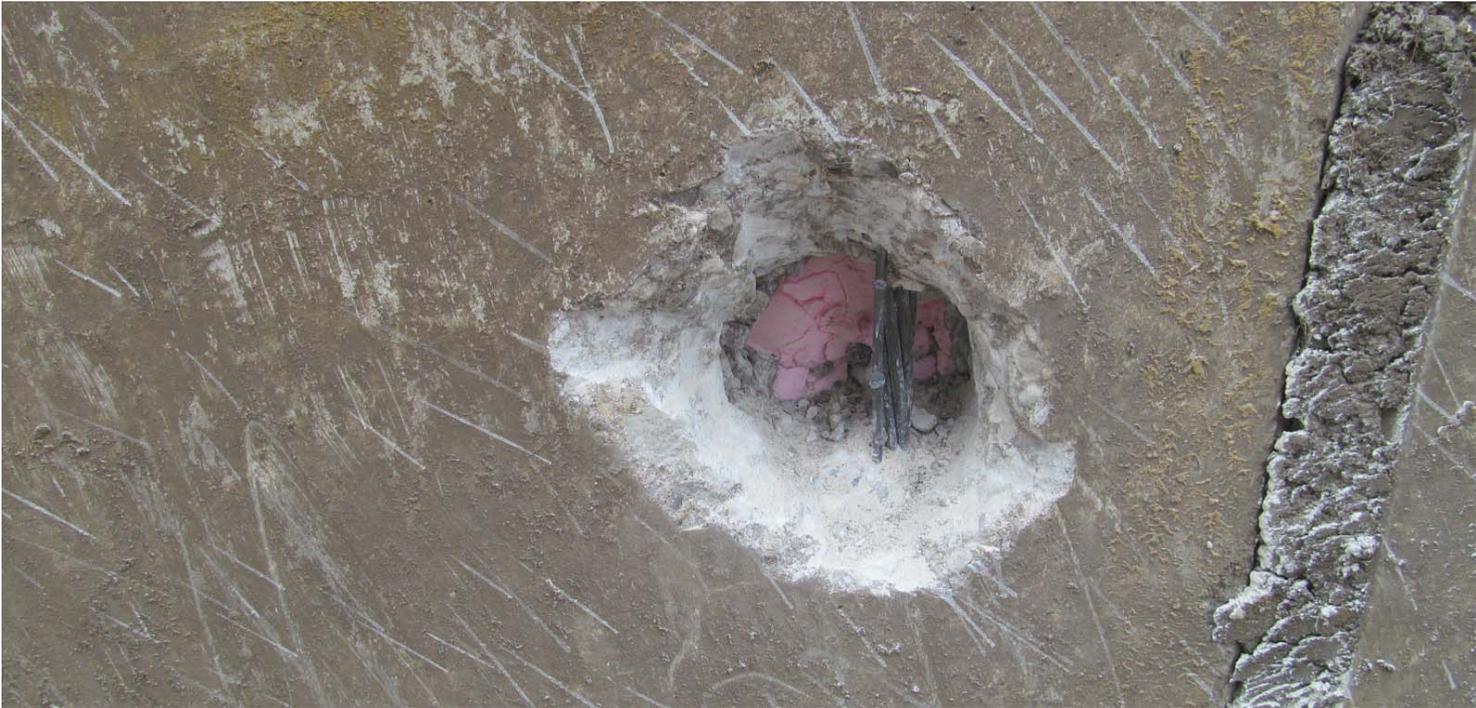
Photograph #20: The strand on the right side of the panel was corrosion free.

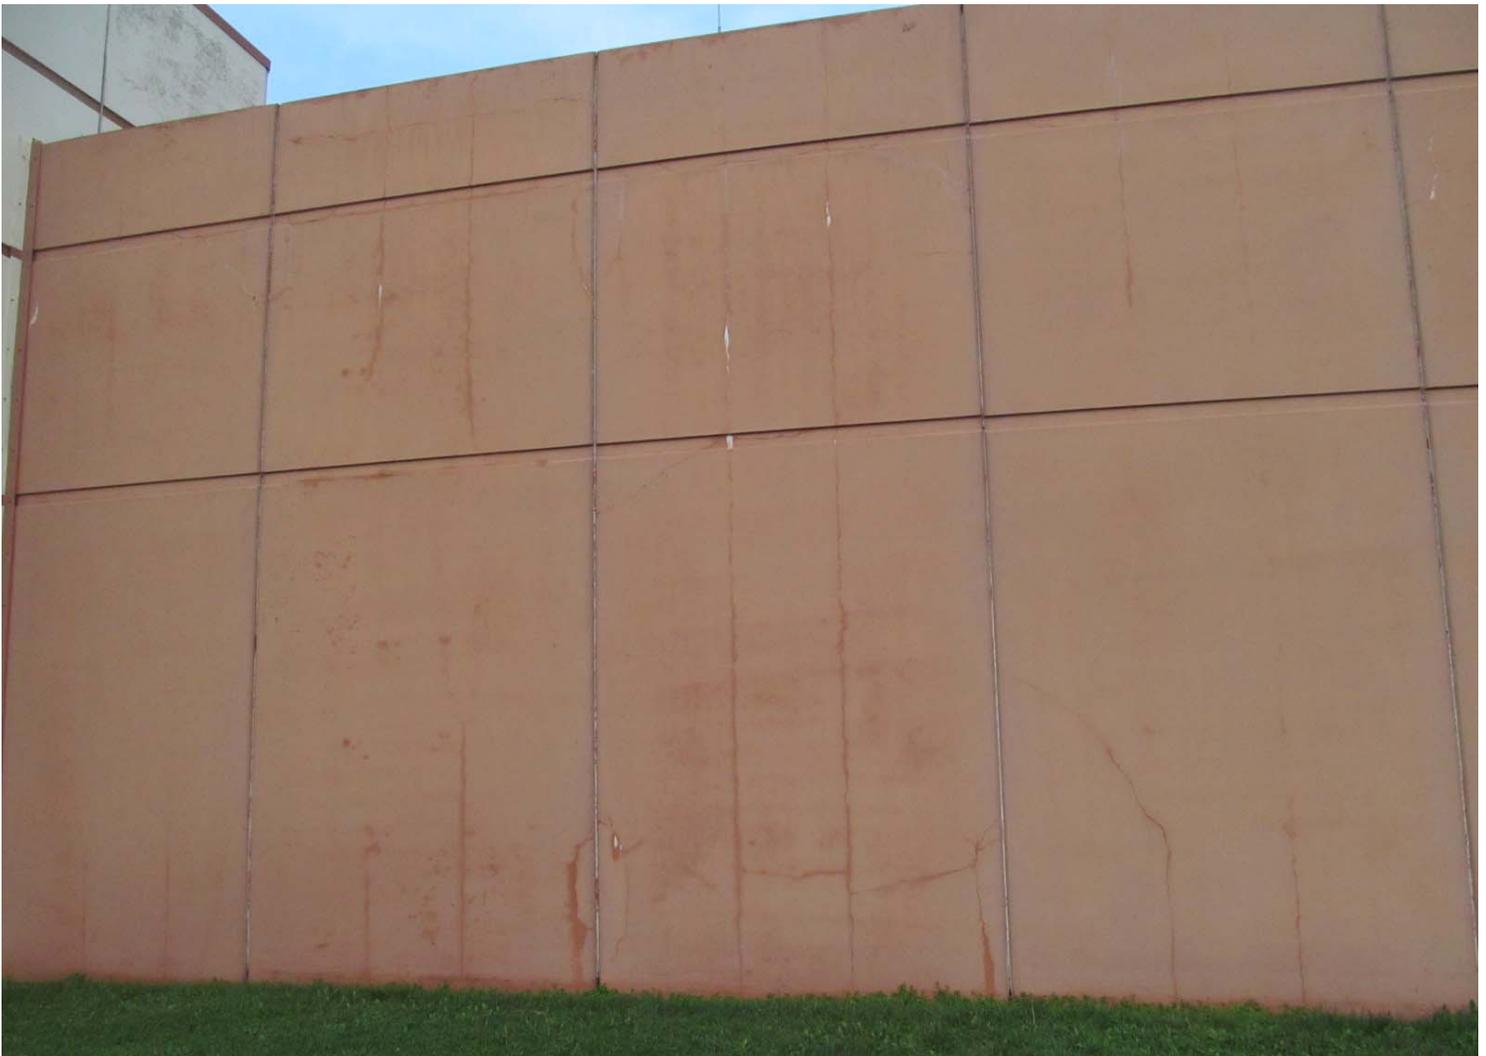
The cream colored panels generally exhibit the first three cracking types. The brown colored panels exhibit all cracking types. Photograph #21 was taken on April 8 after a rain storm the night before. After the morning sun dried the exterior face, wind driven rain then weeped from the cracks.

Photograph #21: East Wall Cracking Pattern

1A. Repair and Seal Cracks: Where feasible, inject the wall panel cracks with epoxy. Where infeasible, rout the cracks and seal. This is important to reduce wind driven rain intrusion and **critical to preserving the prestressing strands.**

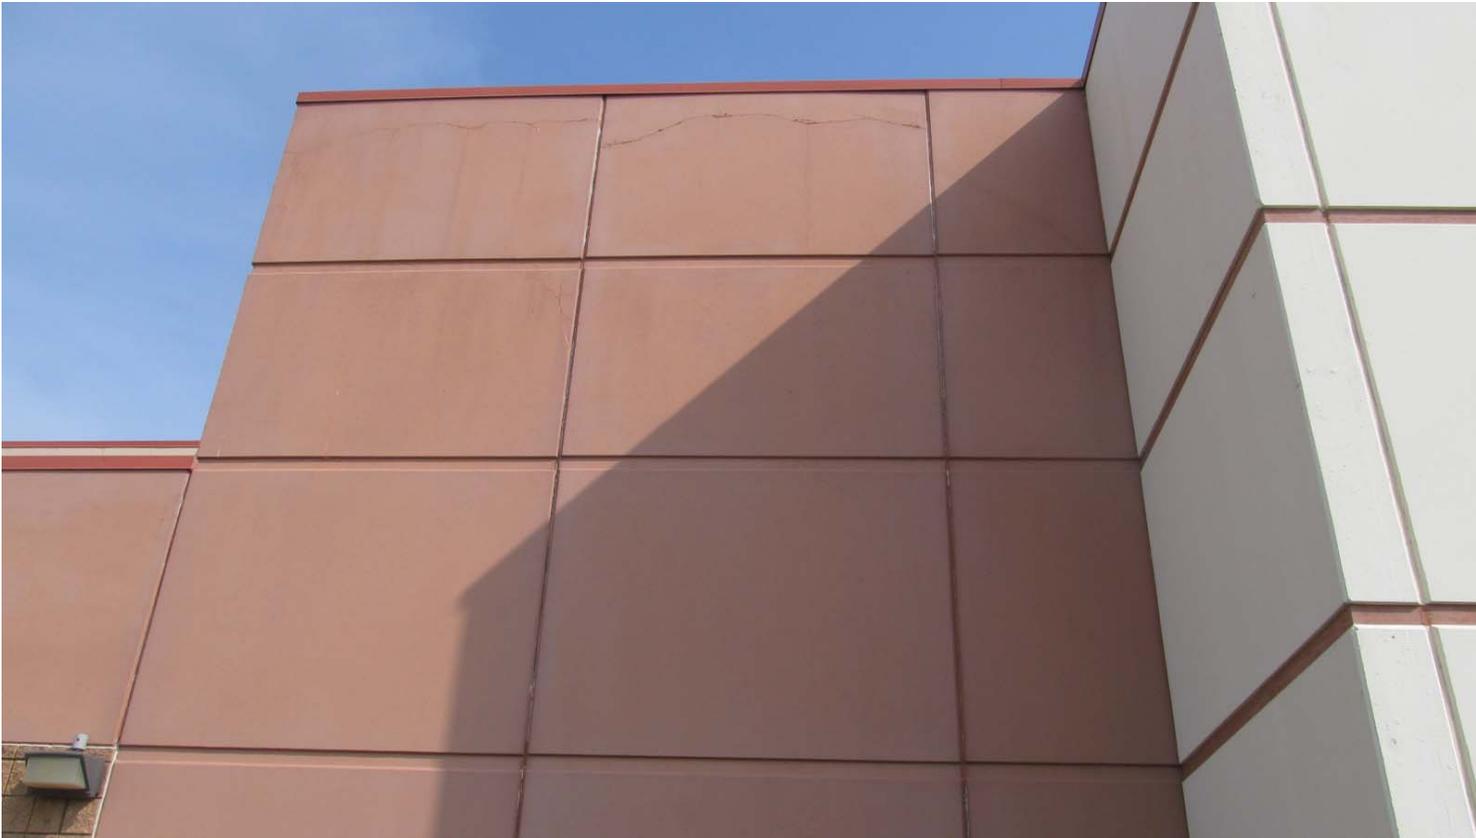
Photograph #22: Cracking at the top of a South Wall Panel

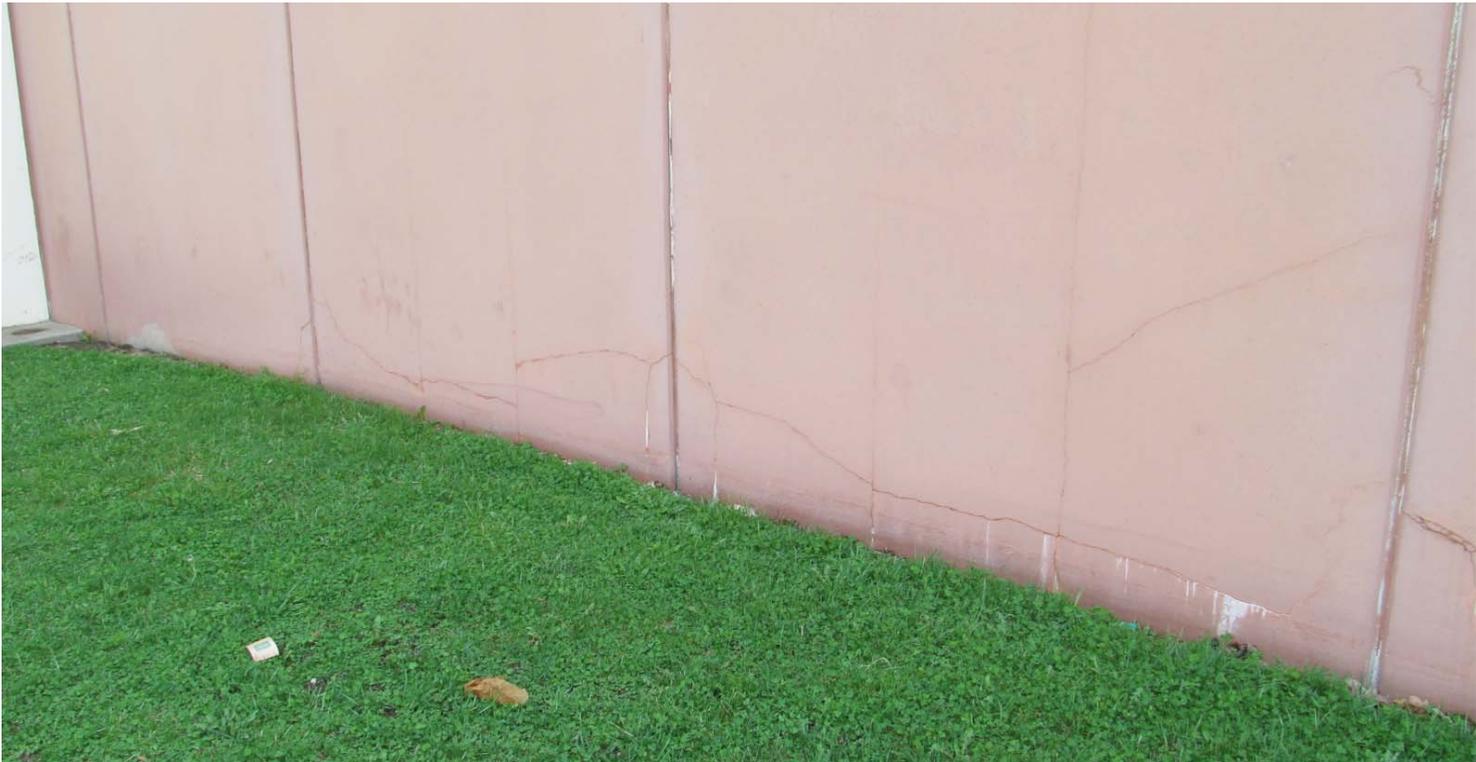
Photograph #23: Cracking at the ground line of a West Wall Panel

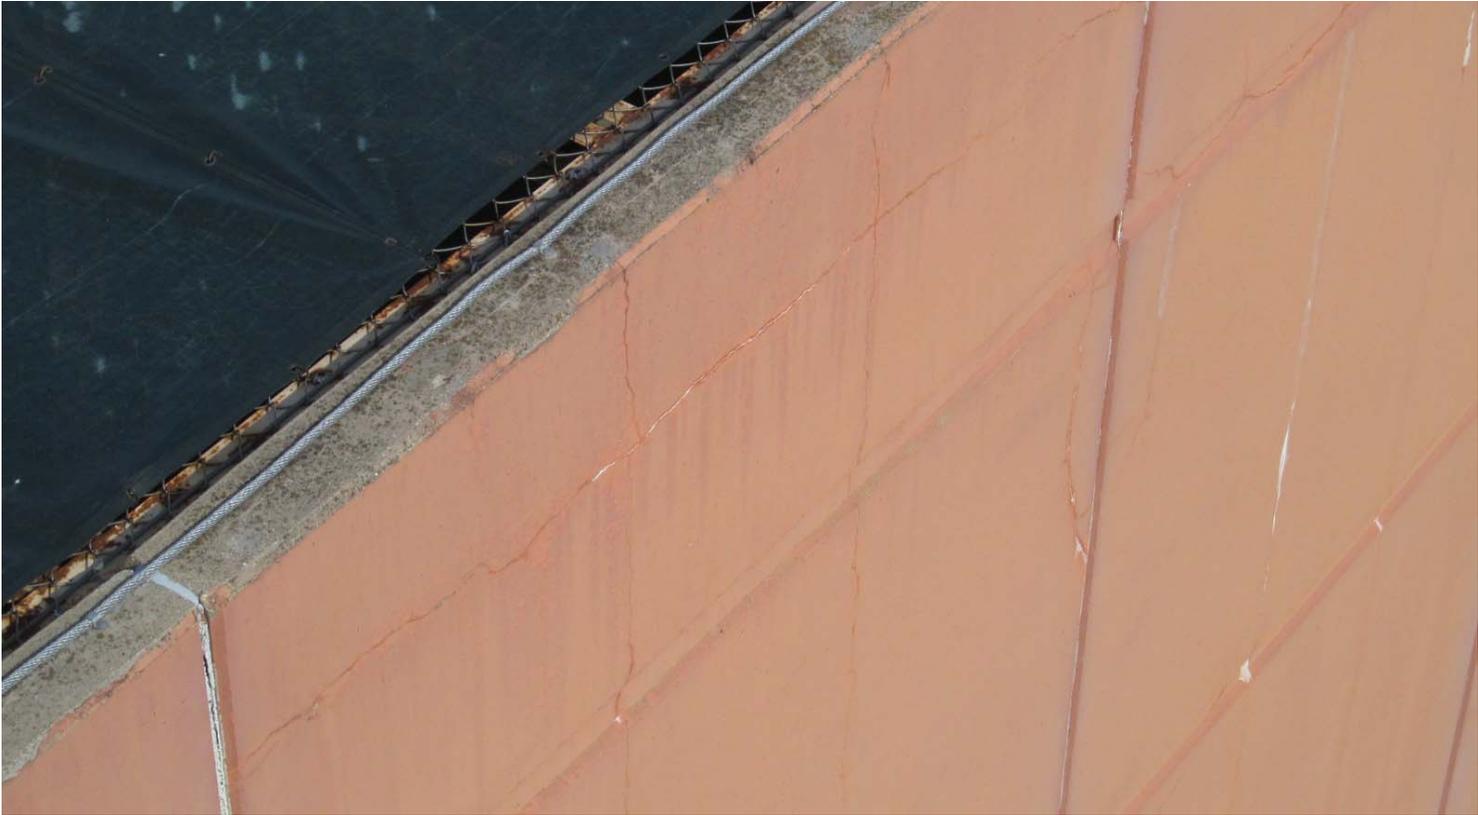
Photograph #24: East Exercise Yard Wall Cracking

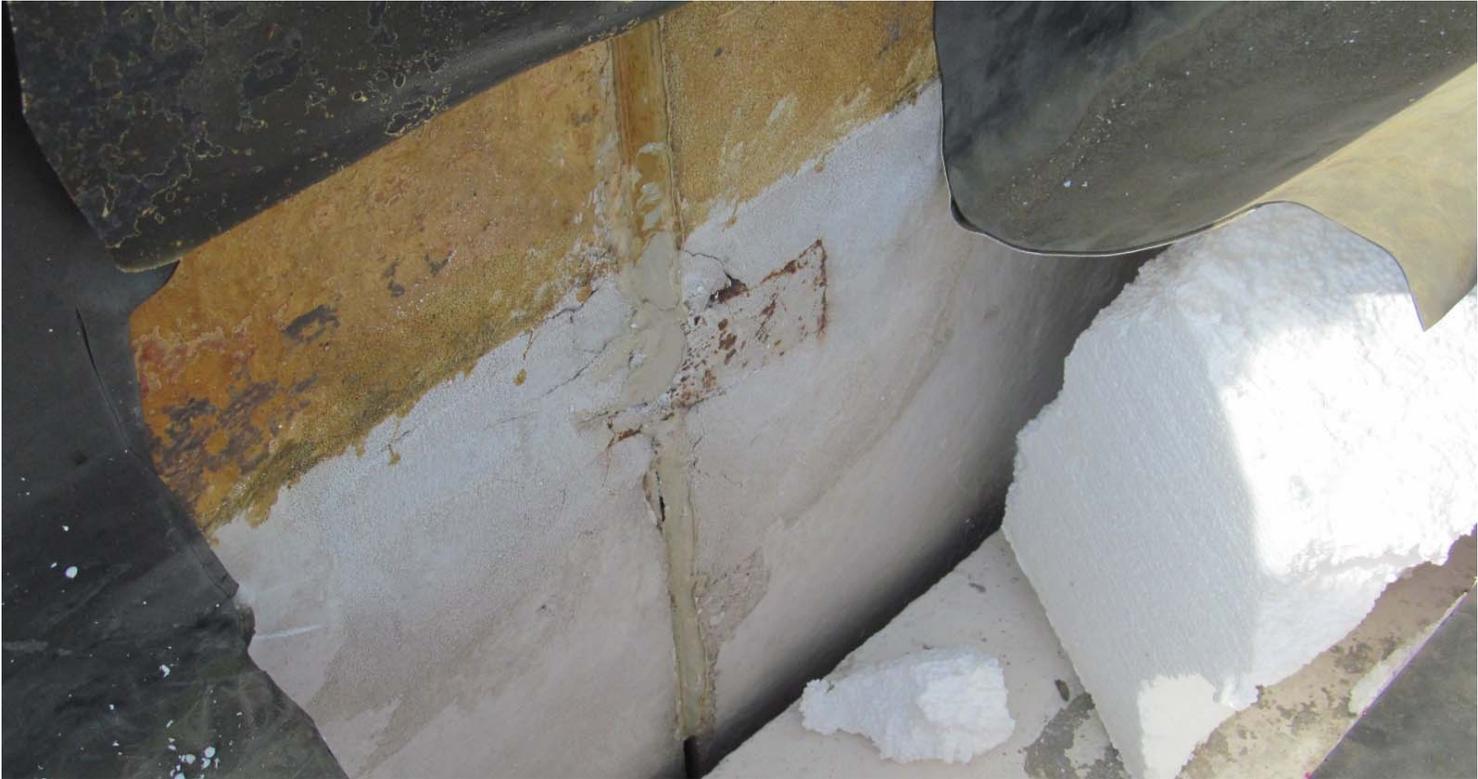
Photograph #25: Interior Wall Panel Joint Sealant

1B. Replace the Vertical Panel Joints: For all precast concrete wall panel buildings, wall panel joint repair and/or replacement is required maintenance. This recommendation has the same importance as Recommendation #1.

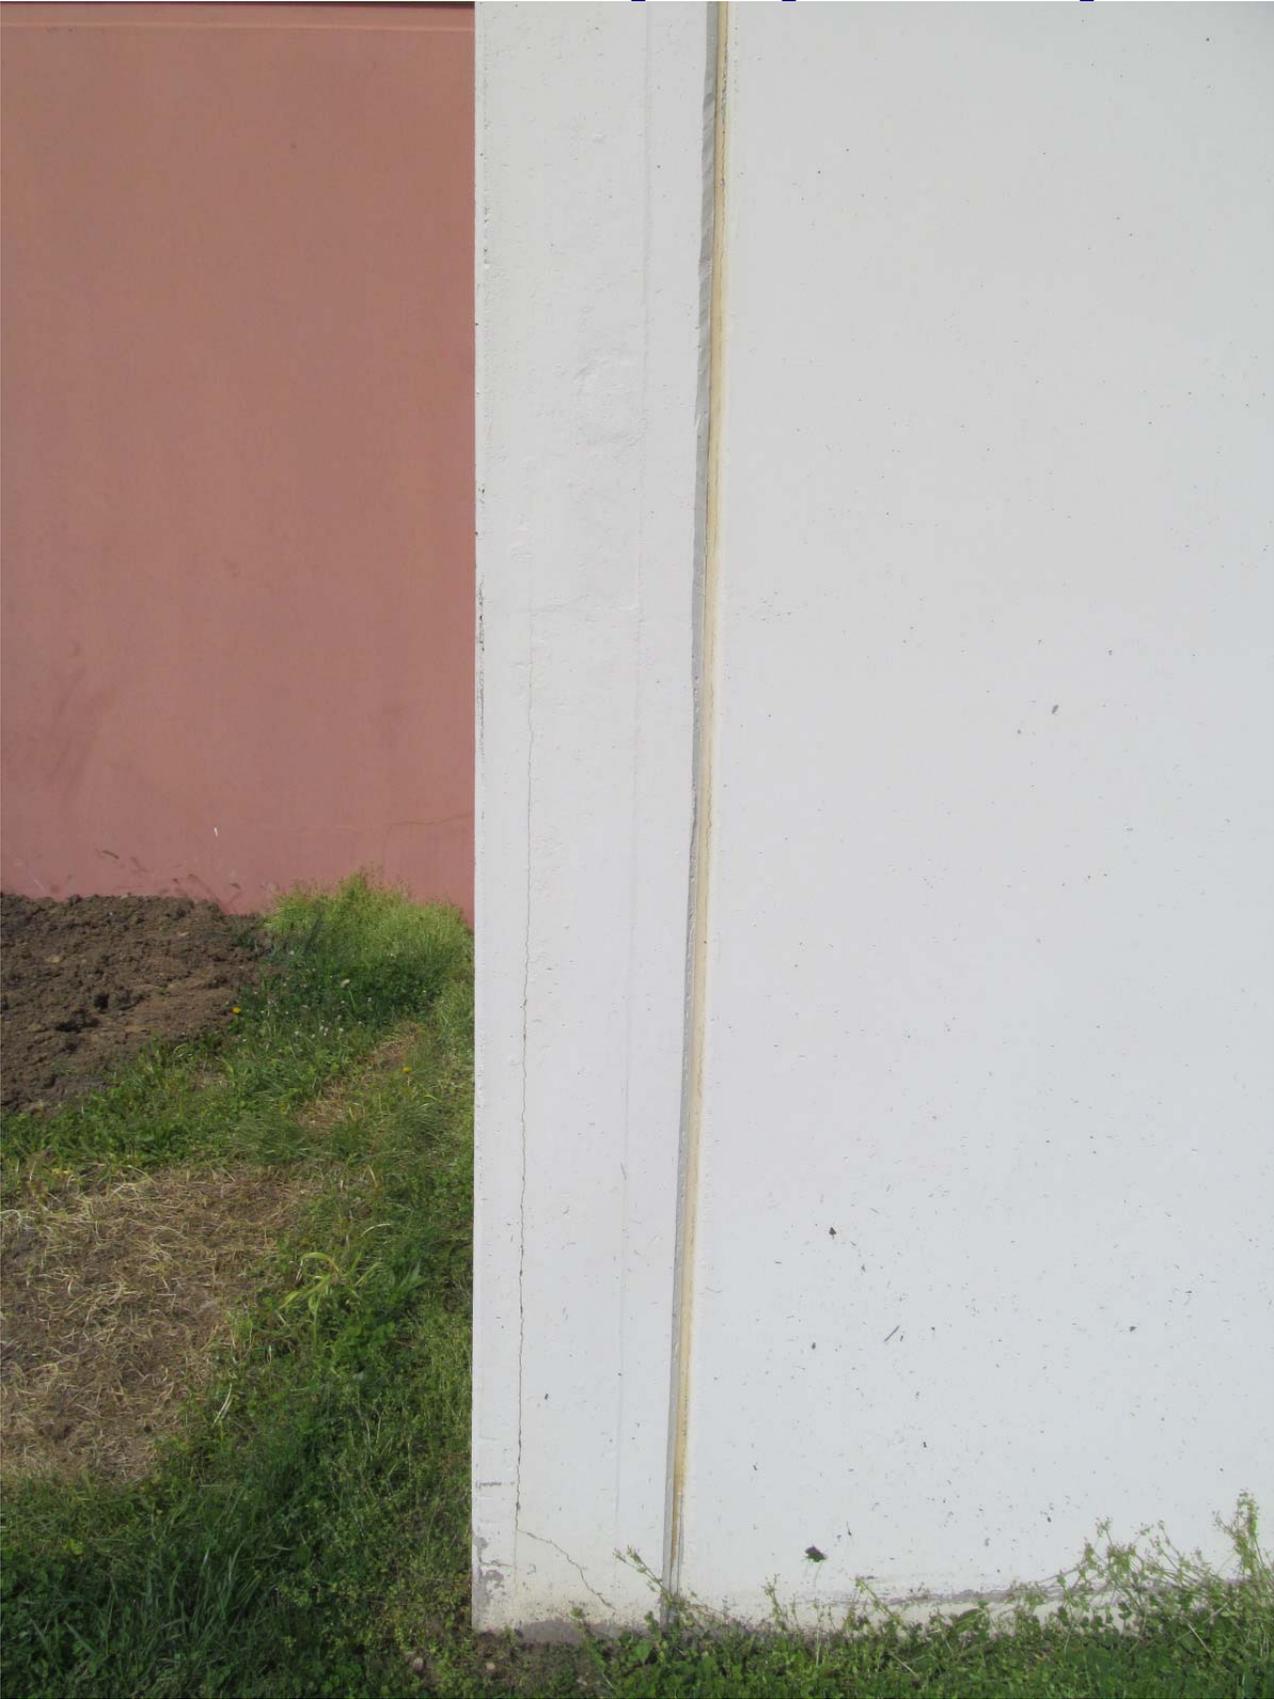
Photograph #26: East Wall Panel Edge The insulation was cut or held back from the Wall Panel Edge. The mortar over the insulation is cracked.

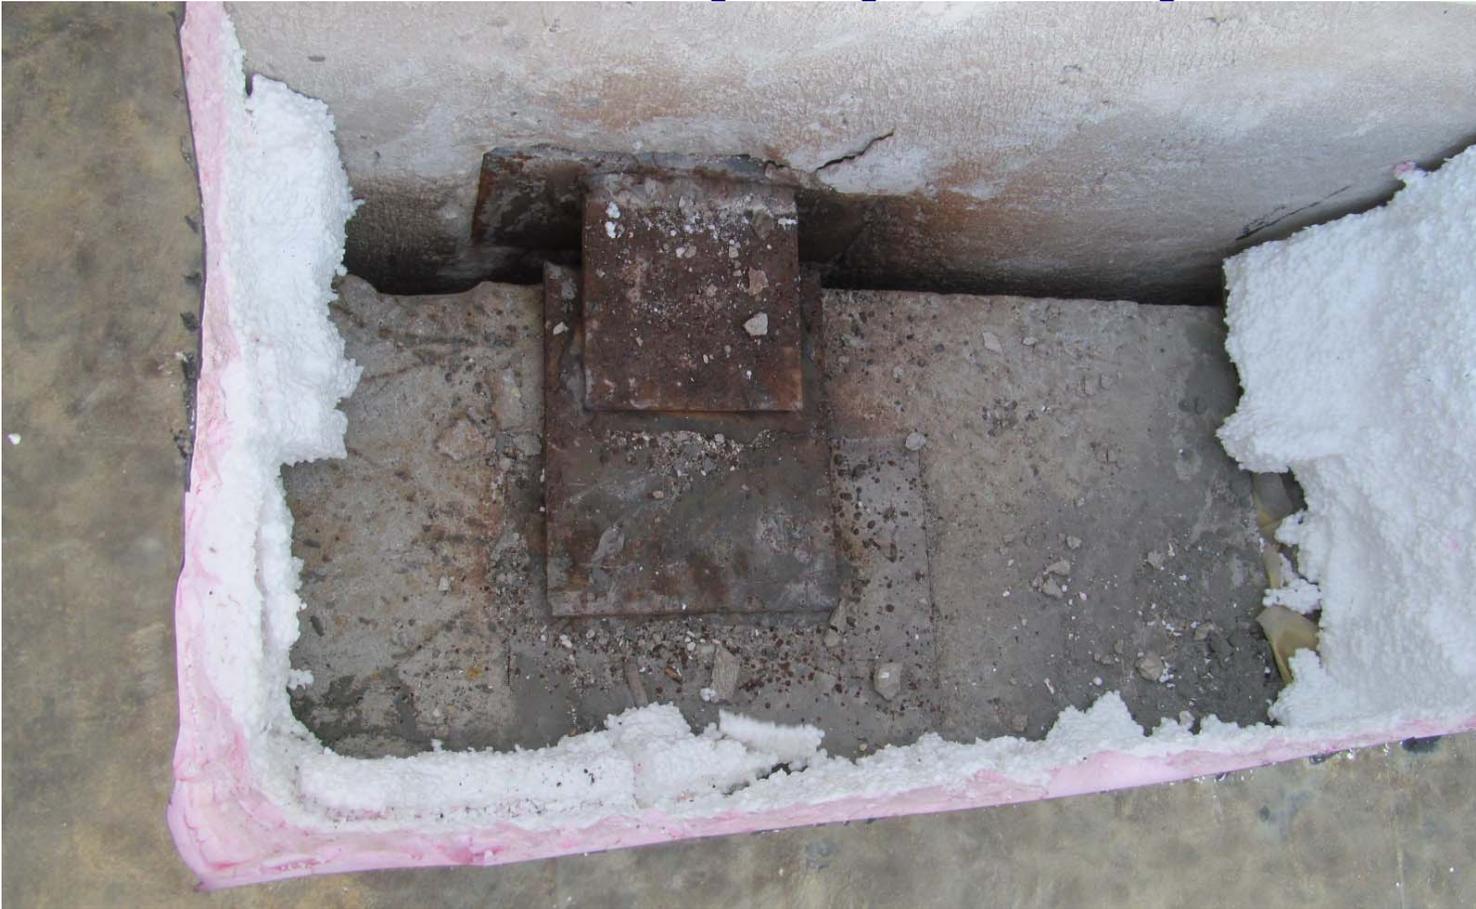
Photograph #28: Rust on roof plank / wall panel connection, East Wall

2B. Replace the Wall Cap and Roof Flashing: As the roof is replaced, remove the wall cap, the timber blocking where rotten, and the membrane base flashing. Install a wall cap with a four inch minimum vertical lap over the top of the wall panel. Secure new membrane base flashing to the inside face of the wall and protect the flashing termination with metal counterflashing. At the time of roof flashing replacement, the roof plank to wall panel connection can be cleaned of surface corrosion and painted.

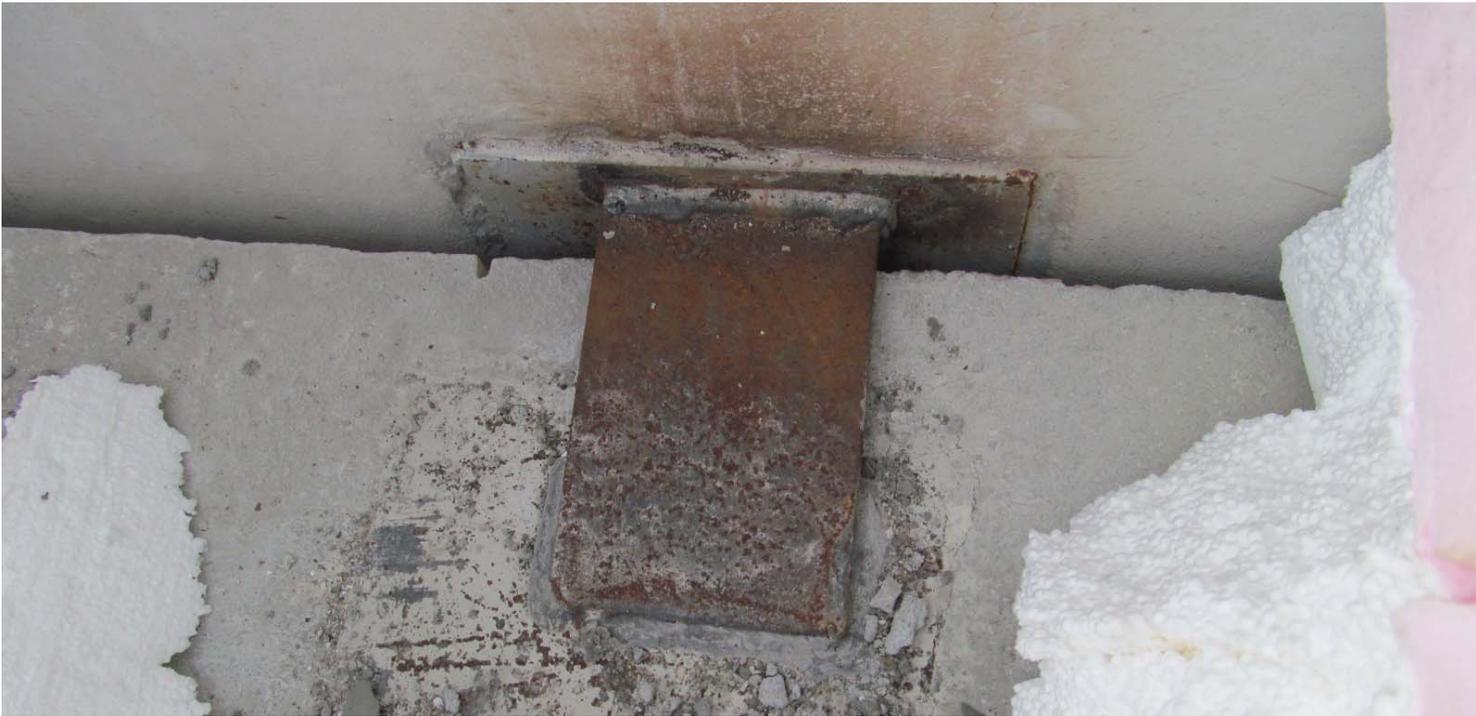
Photograph #29: Rust on roof plank / wall panel connection, SW Corner

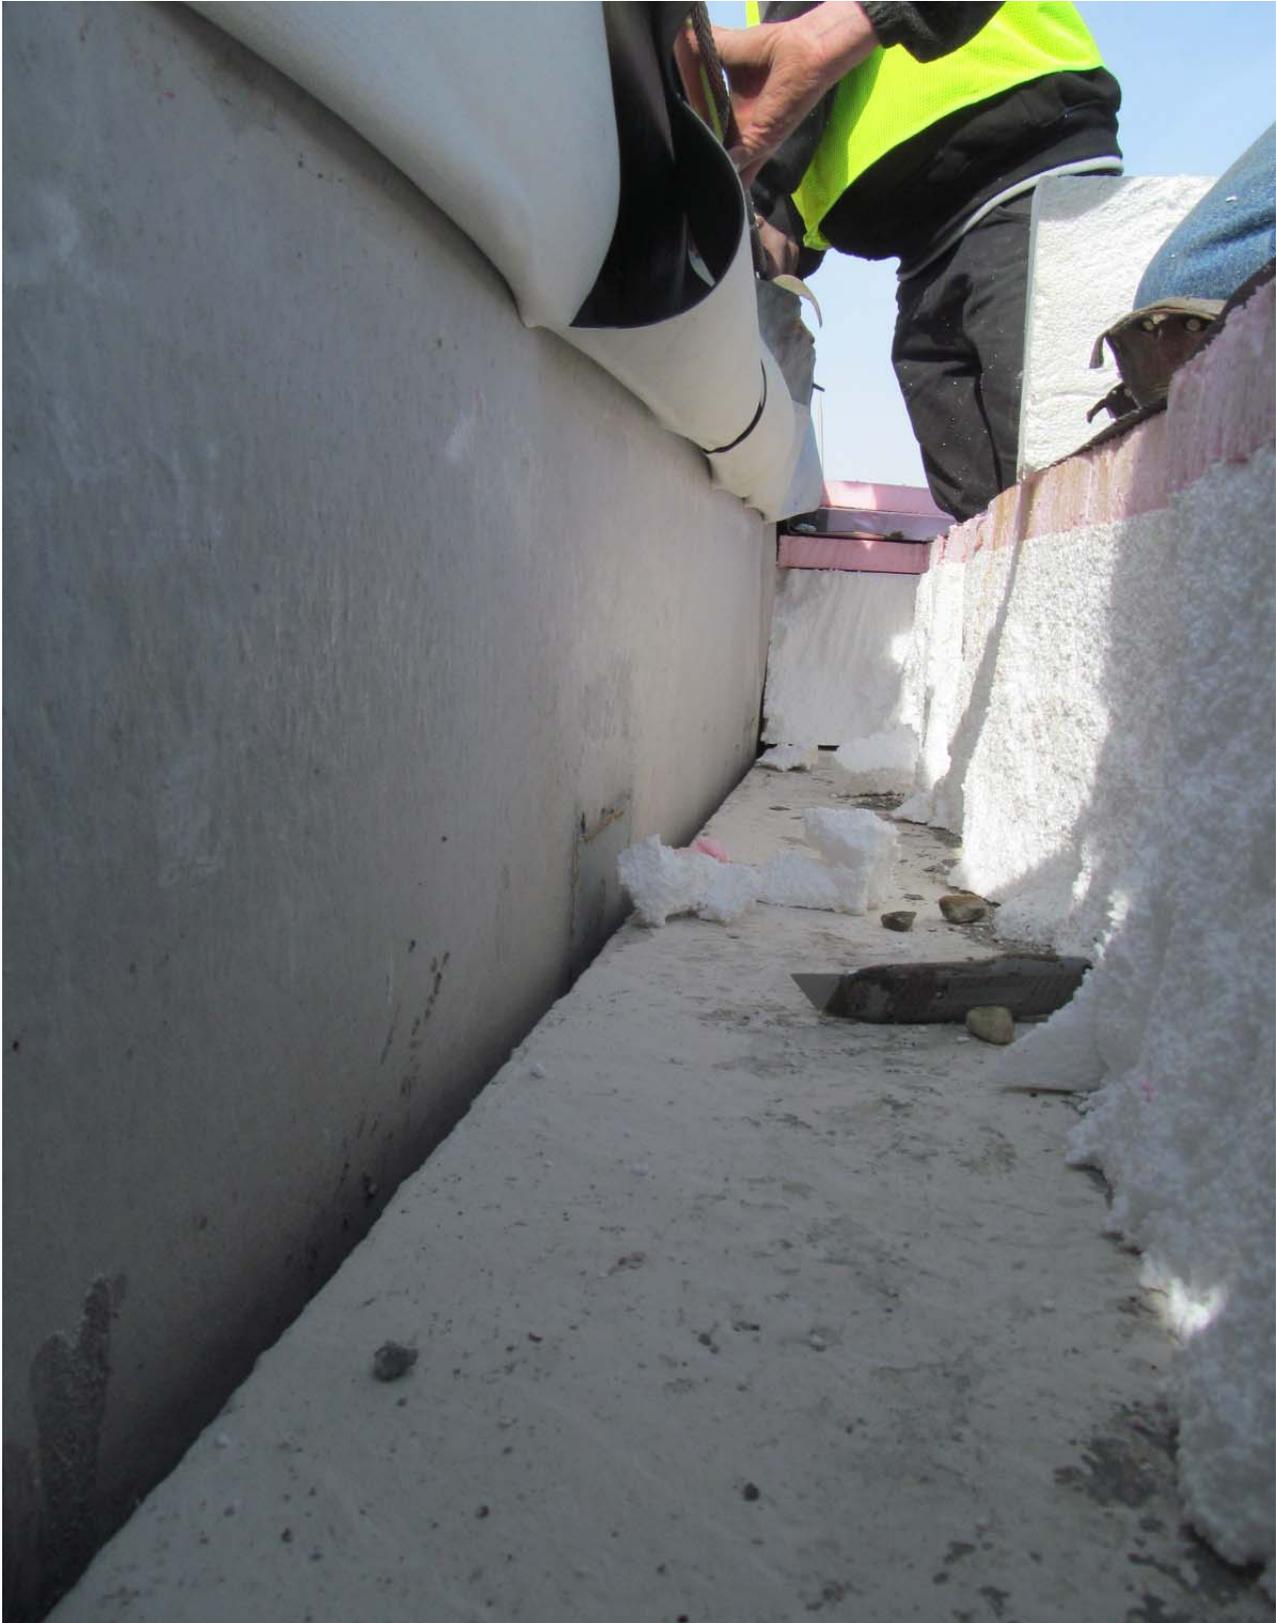
Photograph #30: Roof cut at Southwest Corner of the Cell Block
There were no connection plates in the roof plank. Wall panel connection plates are visible, and the connections were not completed.

- 1. Wall panel prestressing strands:** Should the prestressing strands corrode, the wall panels will lose structural capacity. Cracks and joints must be sealed in order to protect the strands.
- 2. Wall panel connections:** The structural stability of load bearing precast prestressed concrete wall panels is dependent upon the connections to the foundation, to the roof planks, to the floor planks, and between the panels. Omitted connections must be completed, and corroding connections must be replaced.

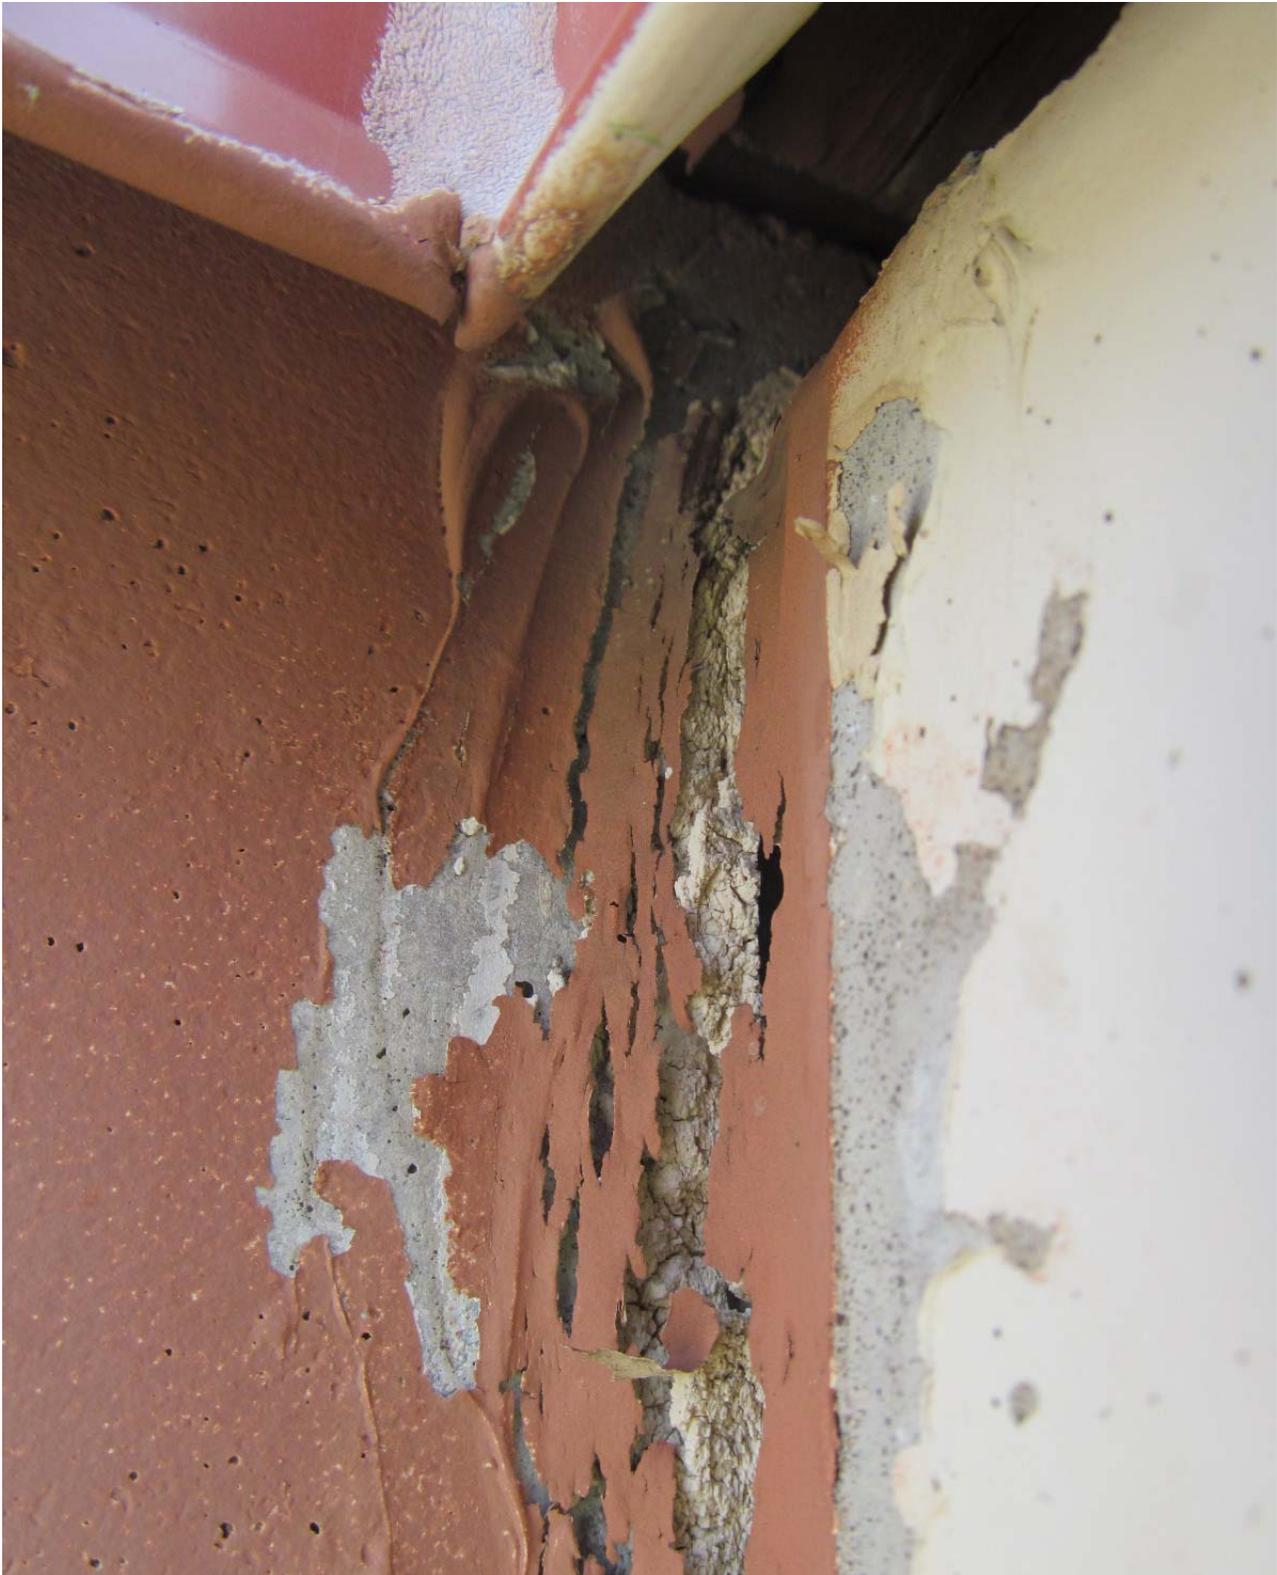
Photograph #31: Re-entrant Southwest Corner of the Cell Block
At the top of the photograph is the open roof cap that will allow wind driven rain to penetrate underneath the cap and underneath the roof membrane. The wall panel joint has fully deteriorated.
