Facilities Assessment Report

November 3, 2015

County of Champaign, Illinois

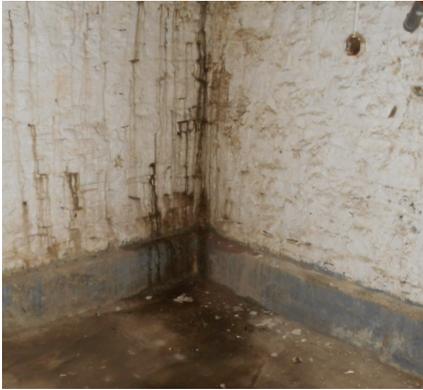
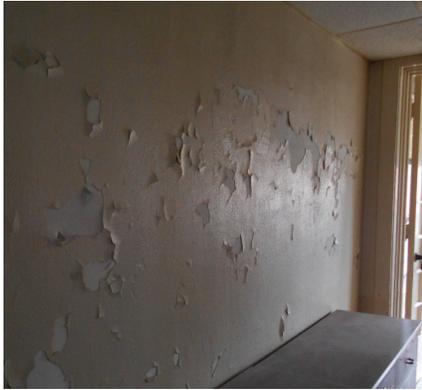
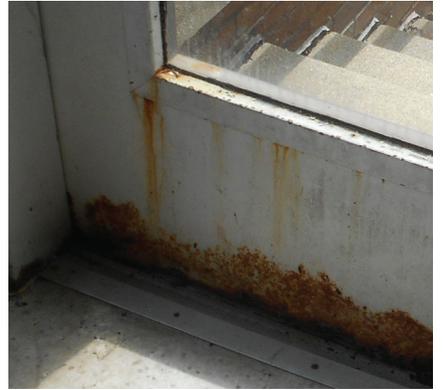
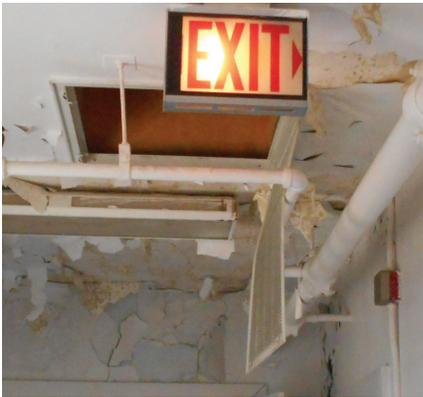
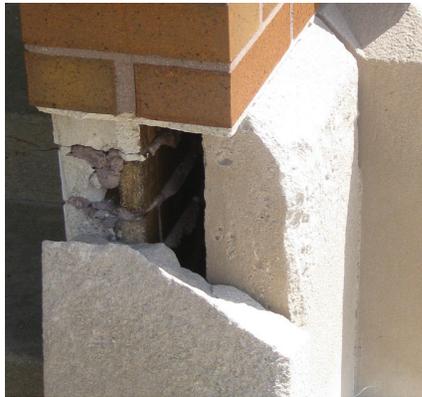
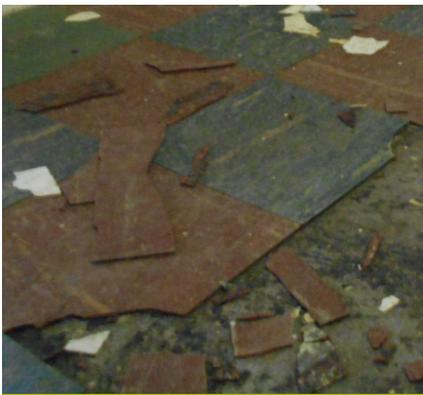
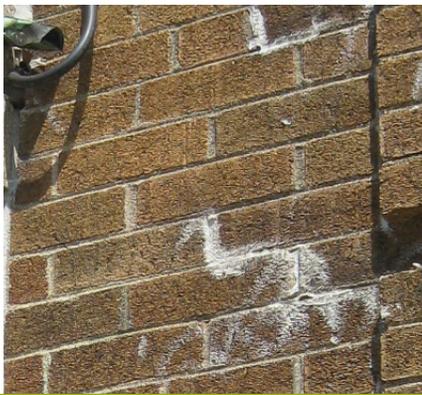
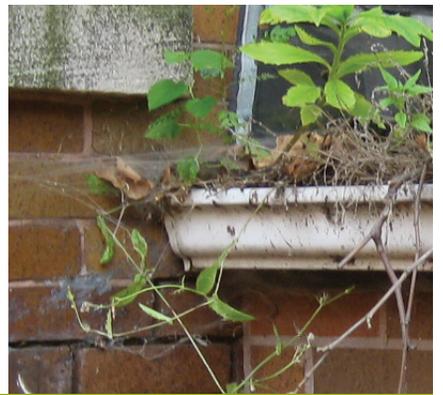
ILEAS Original Building

- This building has a back-up generator.
- Exterior brick planters are cracked.
- Some exterior walkways are cracked and pose tripping hazards.
- Two wings require interior finish upgrade.
- Grout in tile flooring is stained, some tile broken on walls.
- galvanized piping nearing the end of its useful life.
- VCT is stained and damaged at tactical areas.
- Exterior stone sealant is deteriorated, signs of water penetration.
- Exterior window storefront panels, mullion end caps missing and glass is cracked.
- Organic material found inside facility.
- Spaces served by 4 pipe fan coil units that are nearing end of useful life.

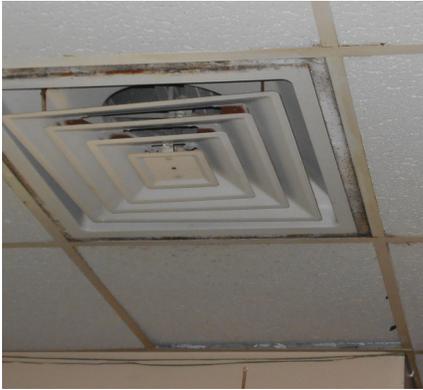
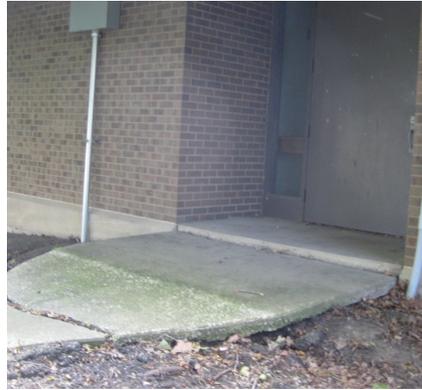
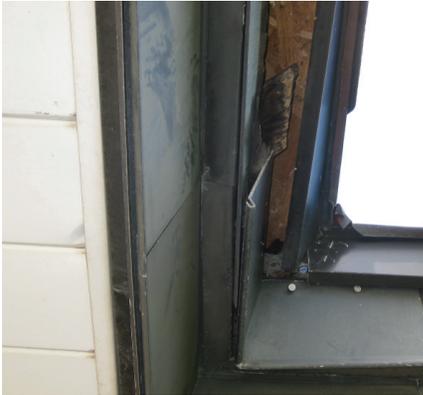
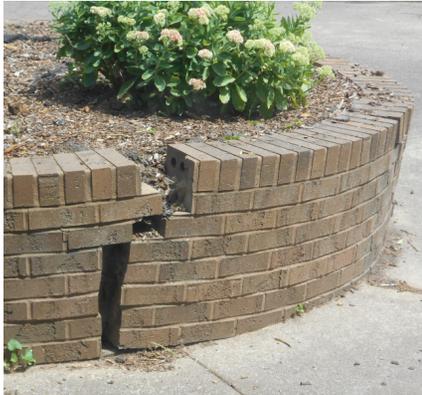
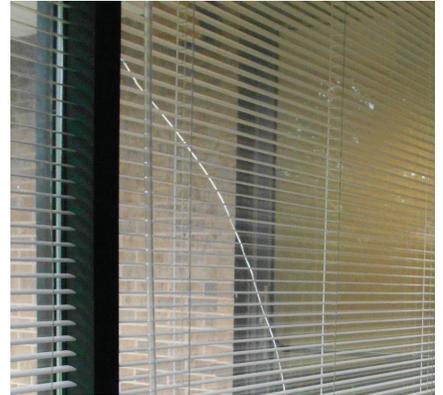
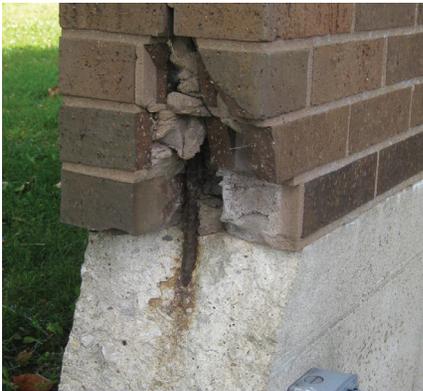
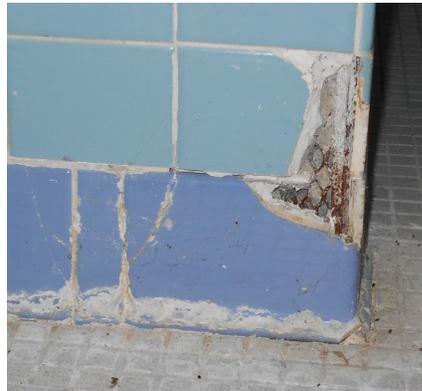
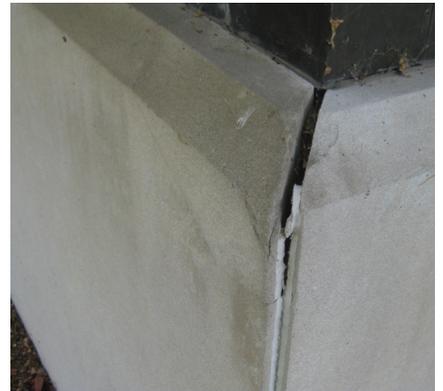
ILEAS Training Center

- This building has a back-up generator.
- Roof and soffit replacement needed at portion of facility.
- Downspouts are in need of repair, many are dented or loose.
- Parking lot recently resurfaced and is in good condition.
- Minor brick repair and sealant replacement required.
- Sidewalks cracked and damaged in places.
- Interior wall finishes in generally good condition.
- Exterior insulation is heavily damaged or missing.
- Roofing membrane in fair condition, Pod 100 and 200 need to be replaced.
- Served by small DX cool, gas heat RTUs nearing end of useful life.

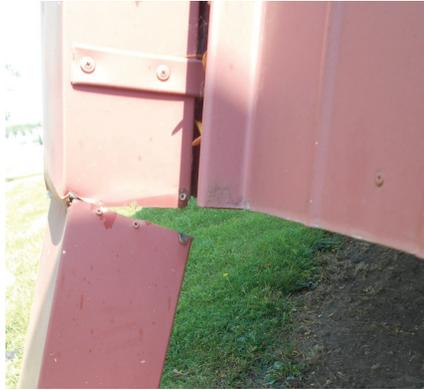
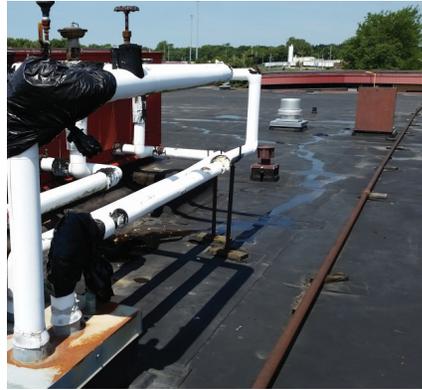
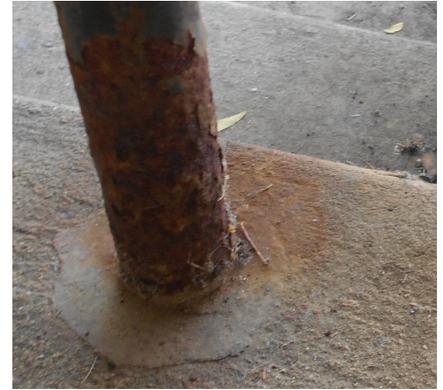
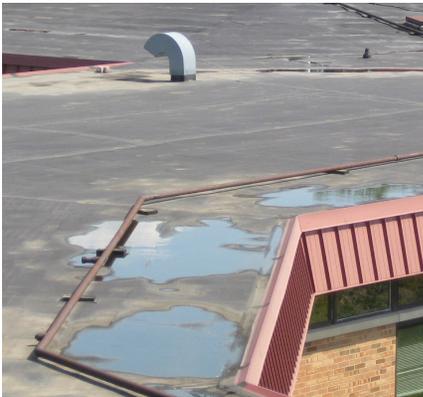
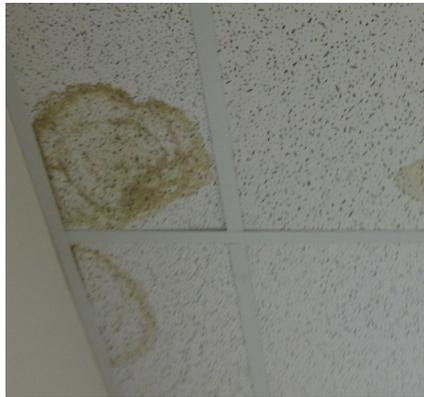
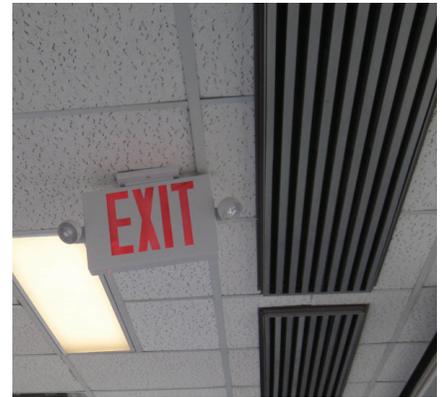
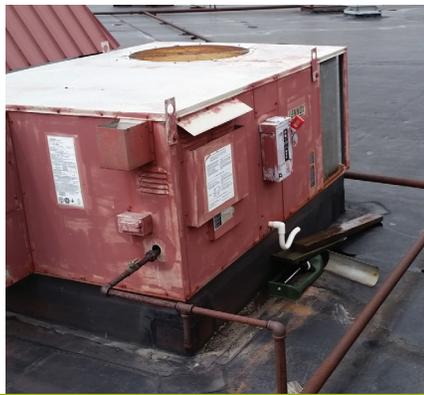
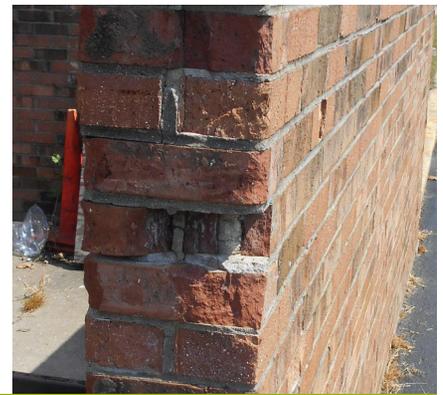
Brookens Administrative Center

- This building has a back-up generator.
- Stair treads worn and damaged.
- Carpet in generally good condition, stained and worn in select locations.
- Decorative marble chair rail stained and shows signs of deteriorated grout.
- Drywall finishes in good condition, some damage at corners and window jambs.
- Asphalt shingles in good condition.
- Wood steps and platform on roof heavily deteriorated and need to be replaced.
- Roof ballast missing and uneven in locations.
- Exterior brick and stone in generally good condition, some cracks and damaged stone.
- EPDM roof requires replacement.
- HVAC provided by air handling units, boilers, and chillers. Shared with addition.

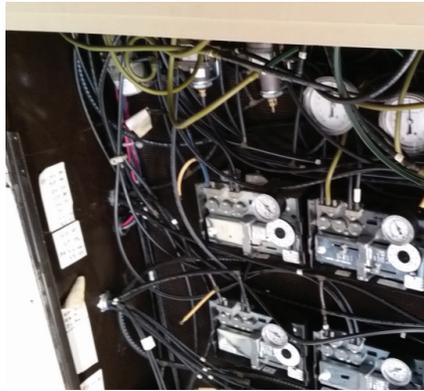
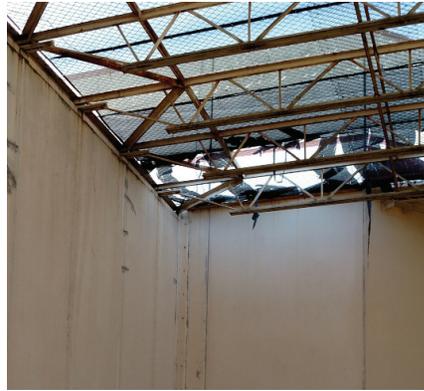
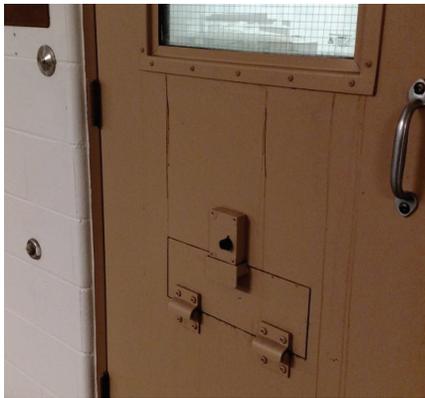
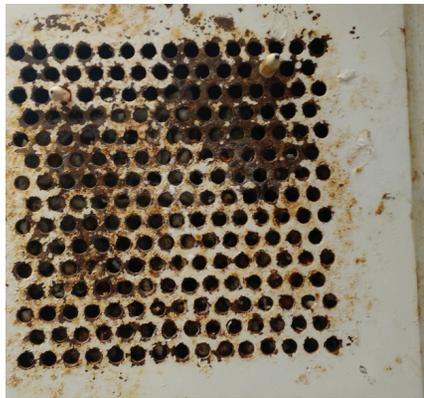
Adult Detention Facility

Observation Highlights:

- This building has a back-up generator.
- Original mechanical equipment requires replacement.
- Masonry joint deterioration, minor cracking, and plant growth.
- Major brick efflorescence on walls around building and screen walls.
- Stone parapet stained, possible moisture penetration.
- Exterior metal doors have deteriorated.
- Sun screen at ceiling enclosure in recreation area is heavily damaged.
- VCT adhesive failed and tiles are missing.
- Interior CMU cracked in multiple locations.
- Served by two boilers and a chiller original to building.
- Cooling tower leaks and is not used.

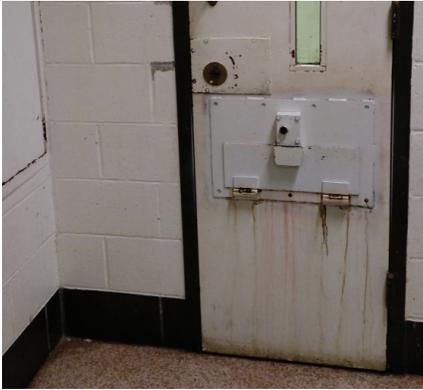
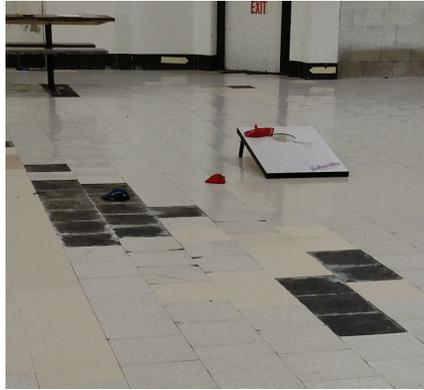
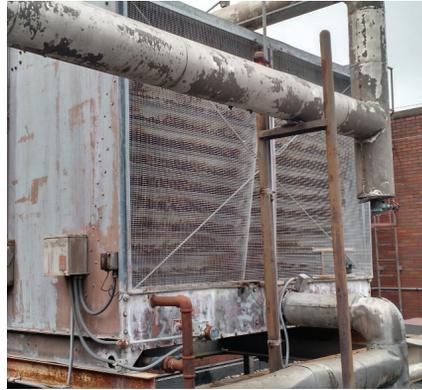
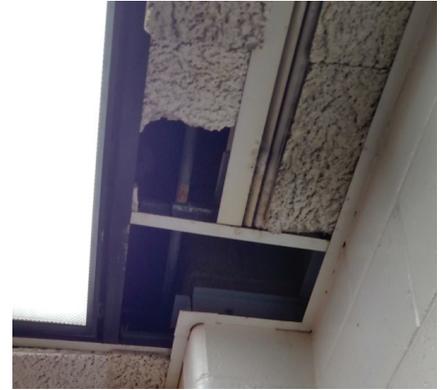
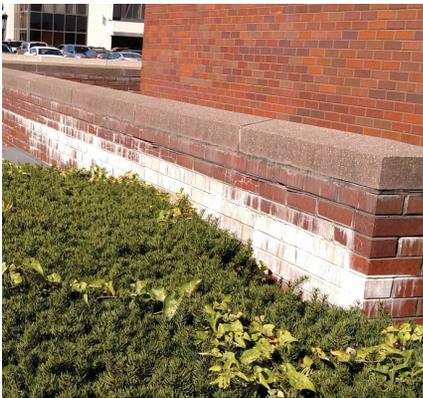
Sheriff / Correctional Center

- This building has a back-up generator.
- Overall, building is in very good condition.
- Minor cracking and efflorescence at exterior precast panels.
- Water infiltration at roof parapet walls due to exposed steel and cracked panels.
- Metal roof in good condition. Sealant replacement recommended.
- Mechanical systems in good condition with minor repairs needed.
- Power and data sufficient for current needs.
- Most interior finishes still in good condition. Minor updating and repairs recommended.
- Parking lot recently resealed. Concrete pathways in good condition.
- No deficiencies noted in structural system.
- Offices served by small blower coil units, maintenance exhausted by gas fired MAU's

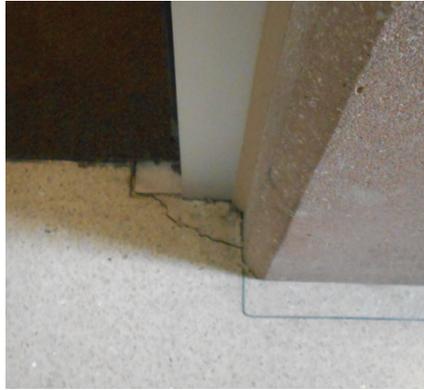
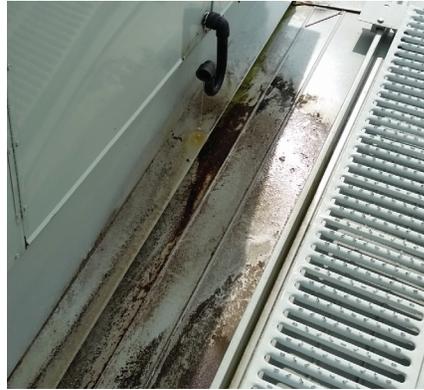
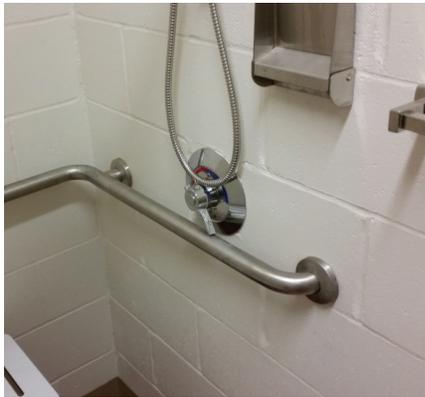
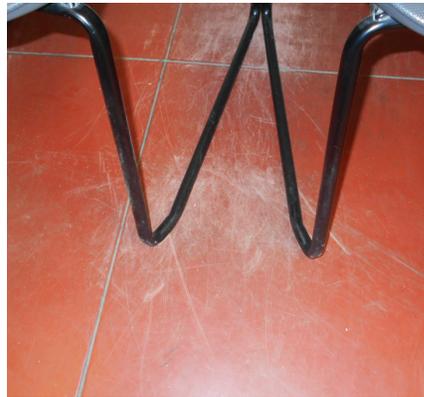
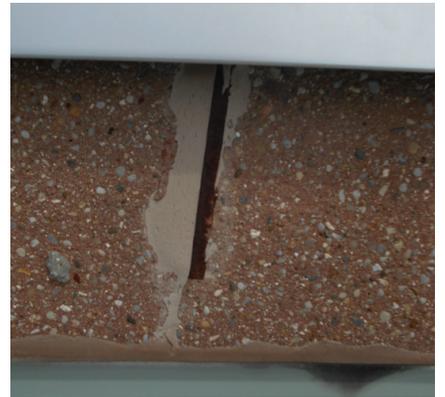
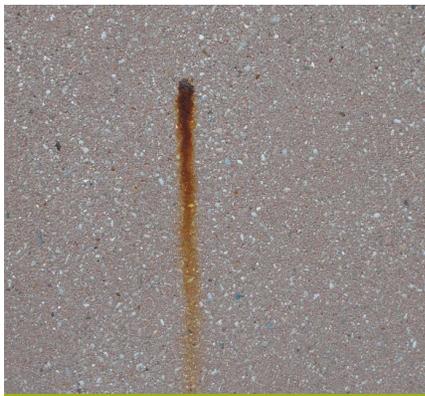
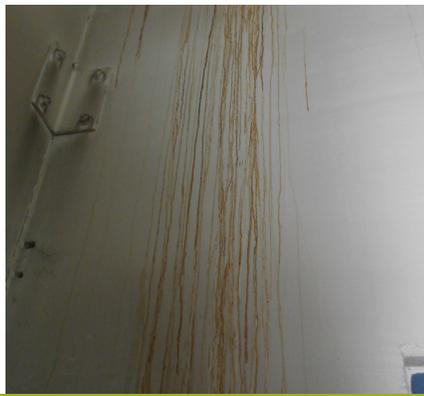
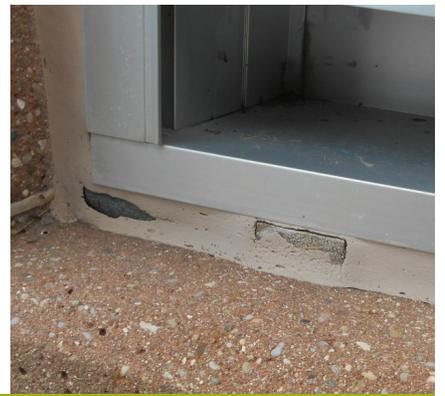
Highway Fleet Maintenance

- This building has a back-up generator.
- Interior carpet in generally good condition, minor wear and stains from normal use.
- Paint peeling and flaking off interior window sills and jambs.
- Ceiling tiles stained around HVAC vents.
- Heavy wear and staining to VCT in bathrooms.
- Interior metal doors show signs of wear and rust. Trim and frame paint peeling in areas.
- Sealed concrete flooring stained in some places, mostly along walls.
- Vinyl wall base heavily damaged and worn.
- Main entrance threshold worn, VCT chipped.
- Exterior is in generally good condition, some water stains and minor cracks.
- Served by several small rooftop units and are in good condition.

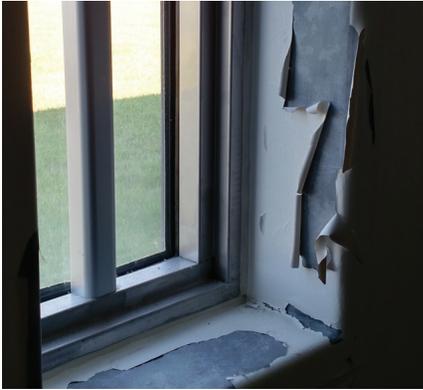
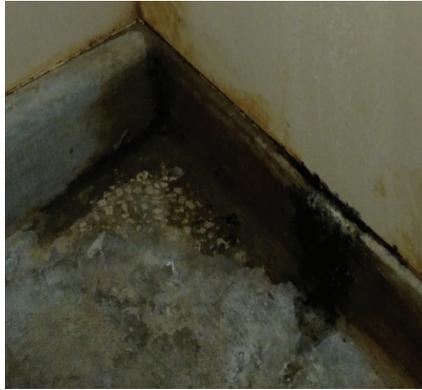
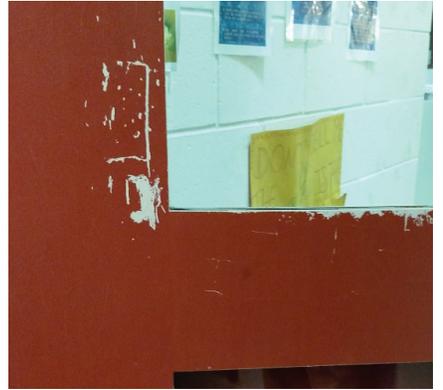
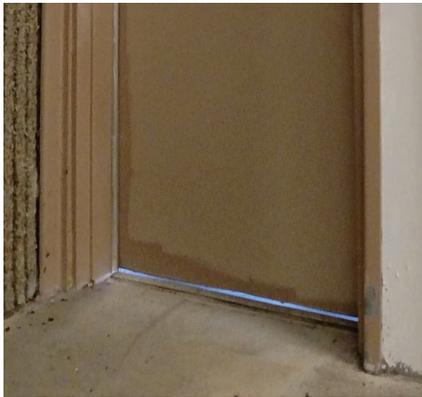
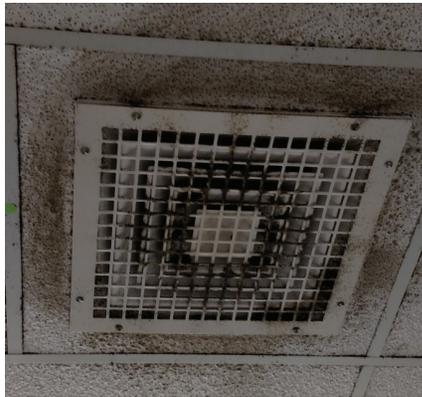
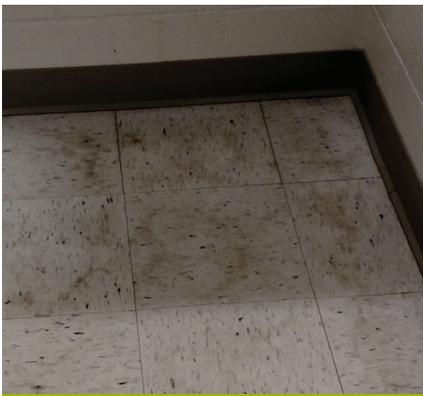
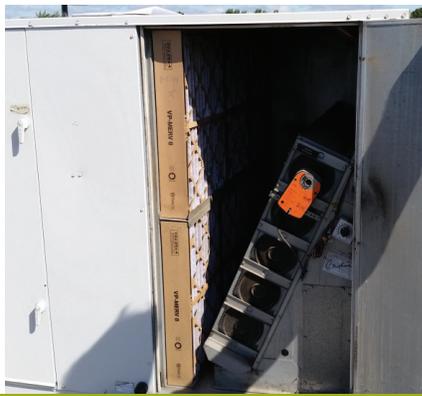
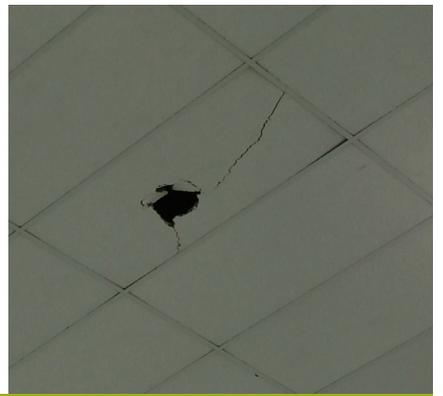
Juvenile Detention Facility

- This building has a back-up generator.
- AHU near the end of its useful life.
- Overall, the building is in good condition.
- The interior wall finishes are in generally good condition, normal use wear.
- Carpet and VCT surfaces are in good condition.
- Exterior brick is worn, some sealant damage at windows.
- Railings along accessible ramp are deteriorating.
- Minor cracks on ramp and walk.
- Gutters in good condition, some paint peeling.
- Roof will need replacement.
- Served by AHU's and condensing units, AHU's nearing end of useful life.

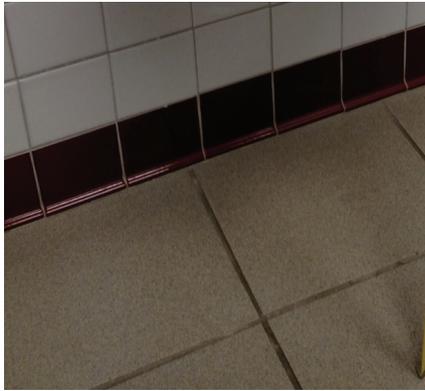
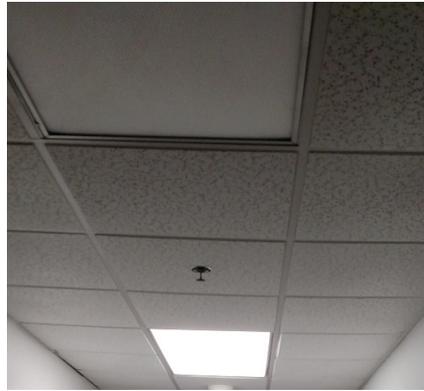
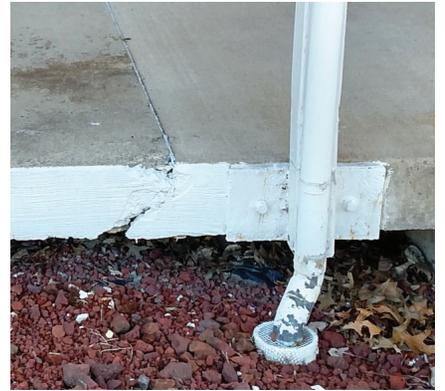
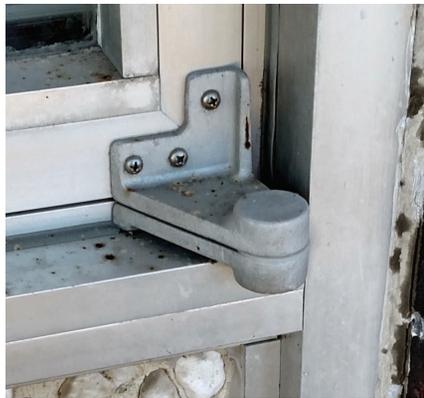
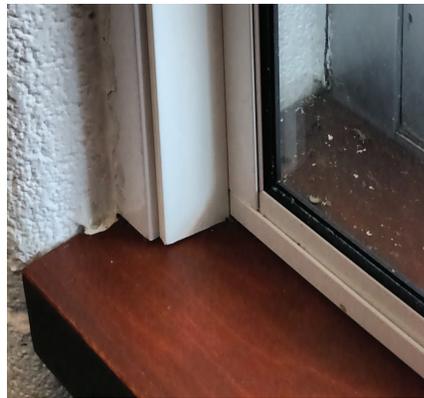
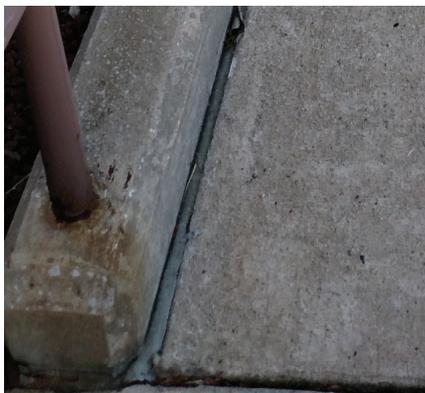
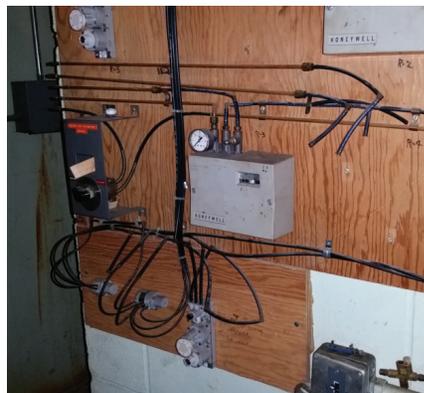
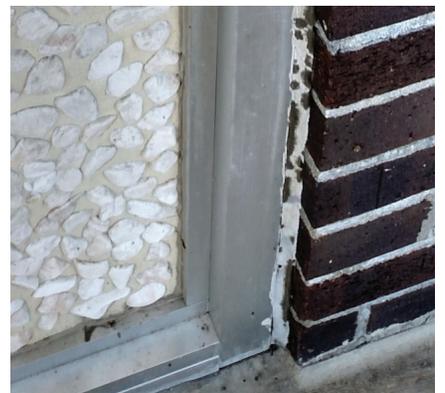
Emergency Operation Center (METCAD)

- This building has no back-up generator.
- The building is in generally good condition.
- Ceiling tiles show signs of minor water damage.
- VCT flooring is worn and scratched in places of heavy use. Some joints are separated.
- Drywall is in good condition, minor scratches and cosmetic damage.
- Interior doors show signs of wear and some damage to finishes.
- Exterior wall panels have minor surface damage.
- Insulation along foundation is damaged, missing in places.
- Windows are in good condition.
- Served by packaged AHU at grade. AHU is in good condition.

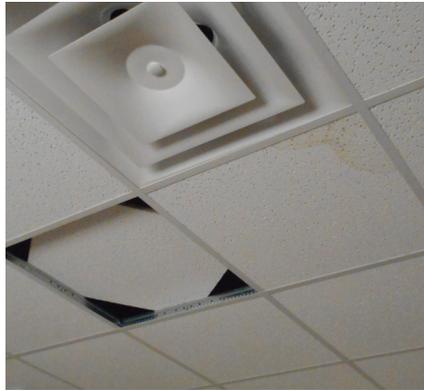
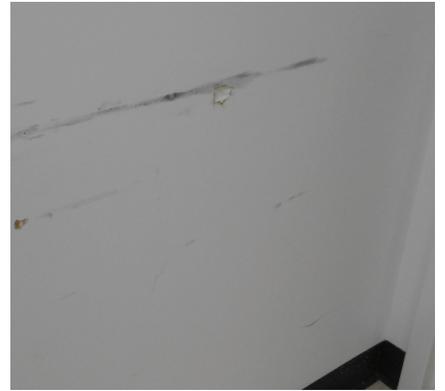
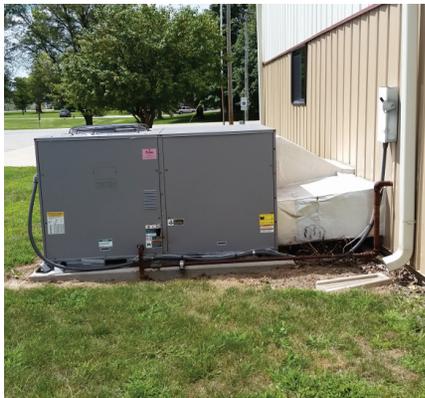
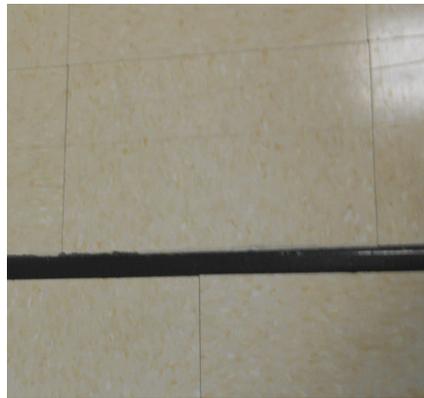
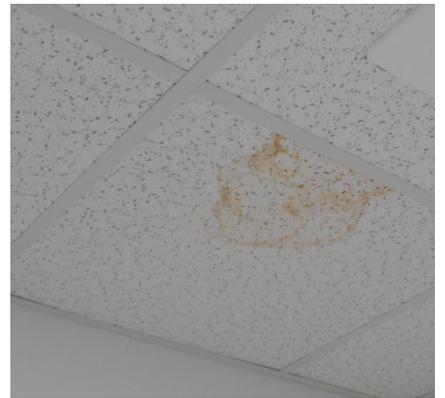
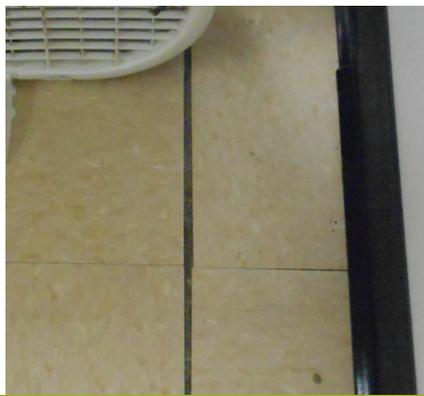
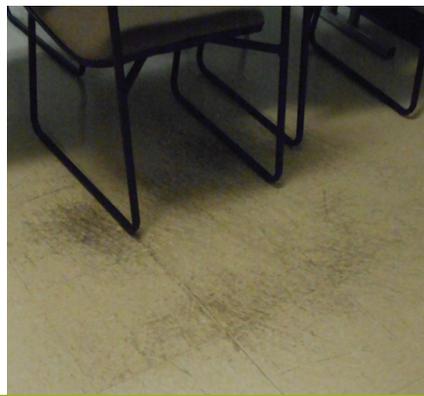
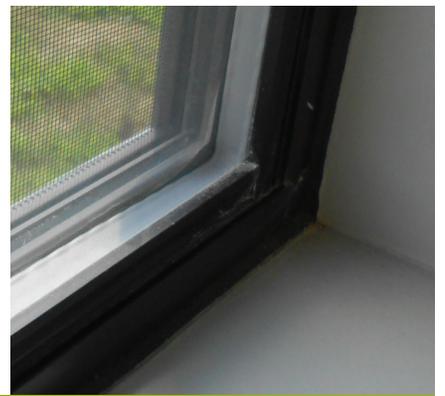
Coroner's Office

- Building is overall in good condition.
- Metal wall panels on exterior in generally good condition, minor damage.
- Interior sealed concrete flooring stained and worn.
- VCT flooring heavily scratched and worn, stained in some areas.
- Minor drywall damage, some impact damage and scratches.
- Insulation behind exposed structure stained in places on ceiling and walls.
- Insulation along foundation damaged and missing in places.
- Heavy water damage to landscaping at downspouts.
- Sealant failure along edge between metal panels and concrete.
- Ventilation provided by roof mounted exhaust fan in good condition.
- Heating provided by three gas fired unit heaters in good condition.

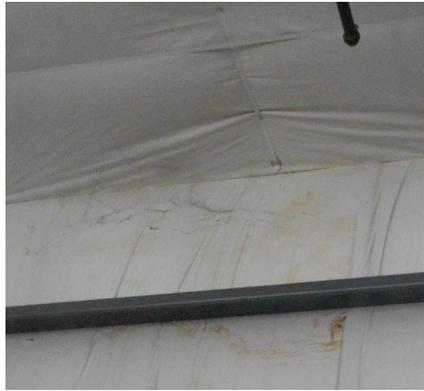
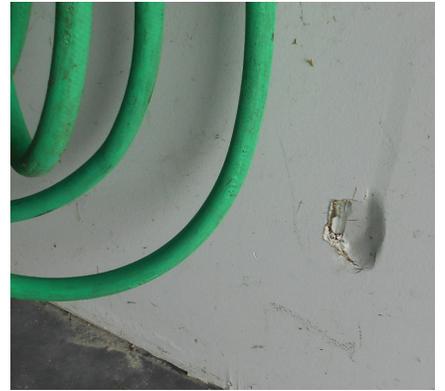
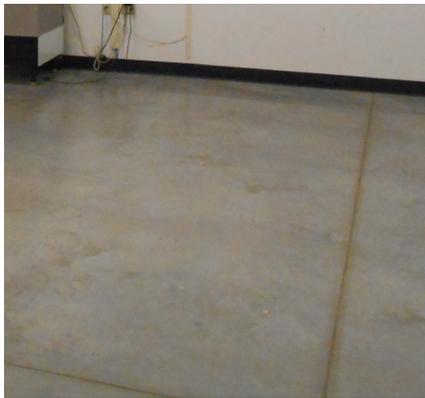
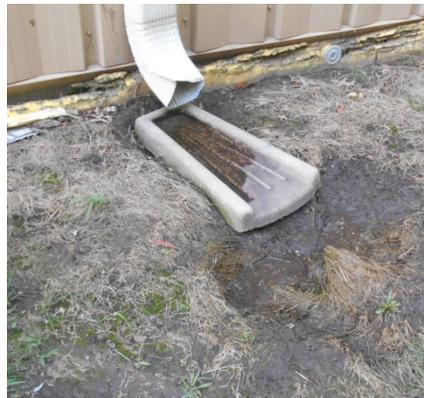
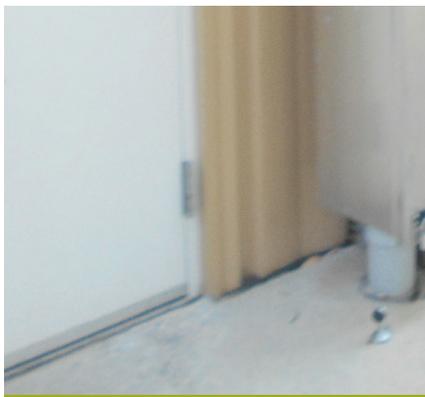
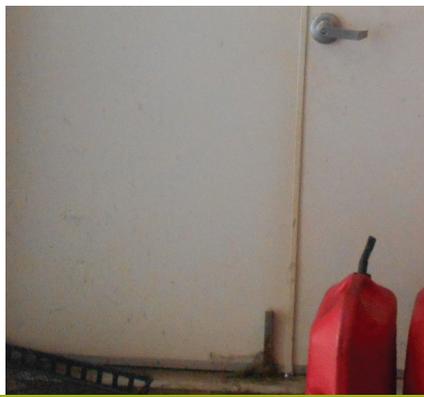
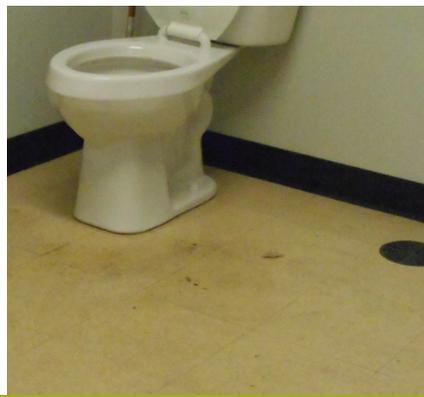
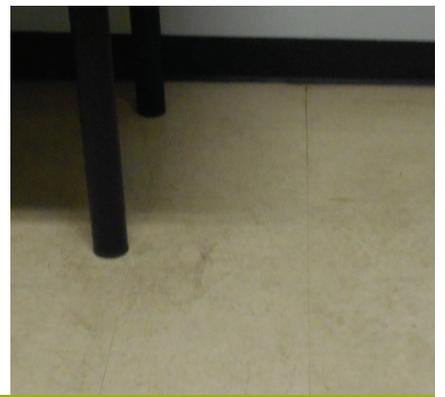
Physical Plant Shop

- This building is in good condition.
- Minor dents and cosmetic damage to exterior metal panels.
- Windows are in good condition.
- Foundation insulation is damaged and missing in places.
- Interior sealed concrete flooring is stained and worn.
- Ceiling tiles are in good condition, few missing or stained.
- Rubber wall base missing in places.
- VCT in bathroom worn and stained.
- Carpet tiles in good condition.
- Interior drywall and finishes in good condition.
- HVAC provided by unit mounted on grade

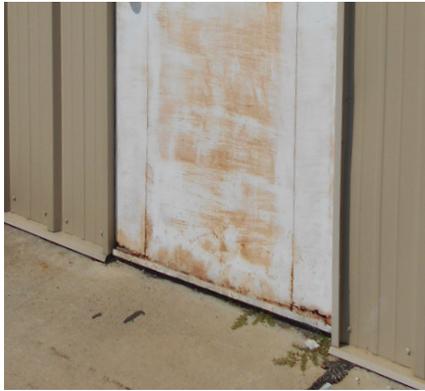
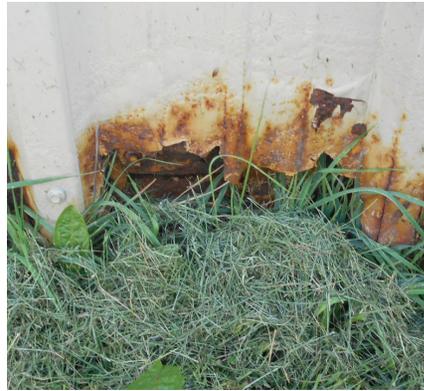
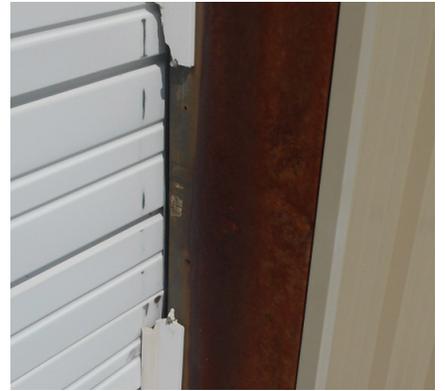
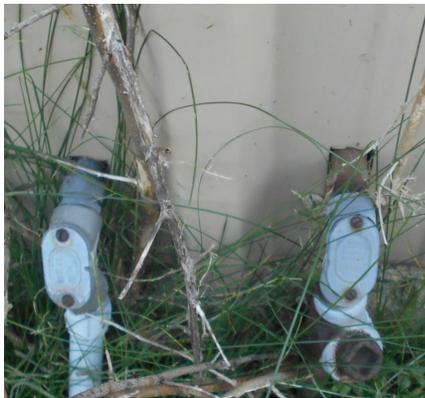
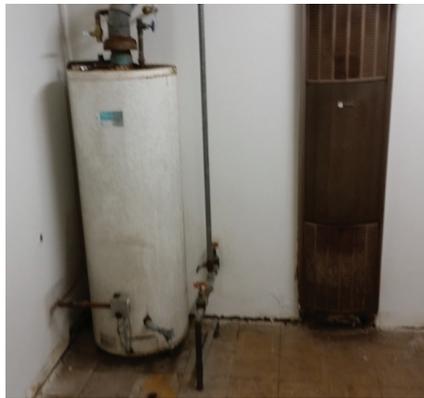
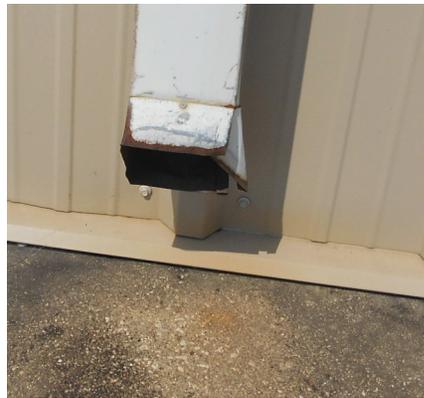
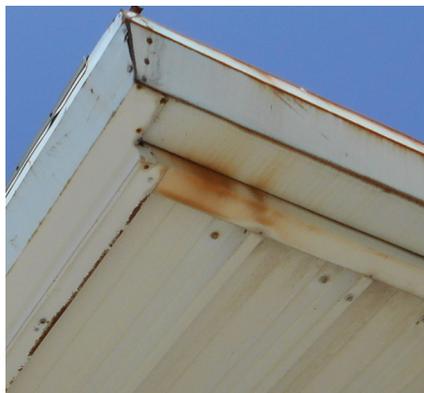
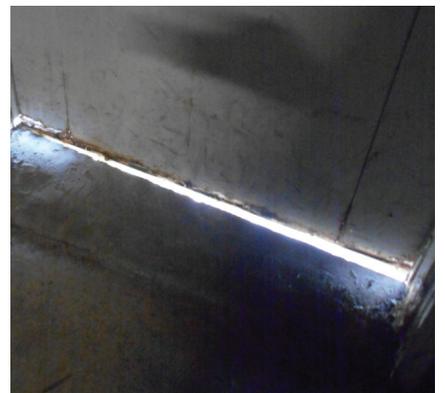
Sheriff Garage

- The garage overall is in fair condition.
- Concrete flooring stained and worn, minor cracks.
- Exterior door finishes and frames are deteriorated and rusted at base.
- Fiberglass overhead doors are damaged, panels cracked and kicked-in at base of frame.
- Overhead door jambs are dented and warped.
- Moisture damage and rust at base of metal wall panels.
- Metal wall panel seams dented and peeling apart.
- Several large tears in metal wall panels.
- Sealant at base of metal wall panels along concrete deteriorated.
- Bollards damaged from impact.
- No ventilation or heating present. No oil interceptor at trench drains.

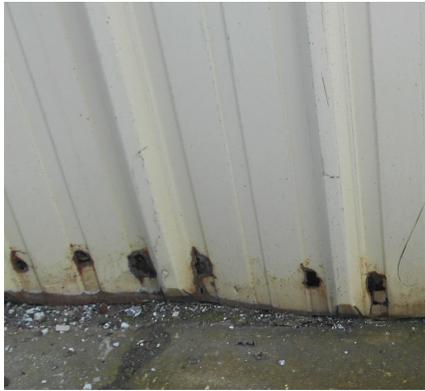
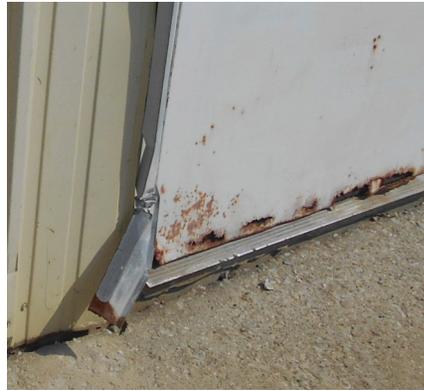
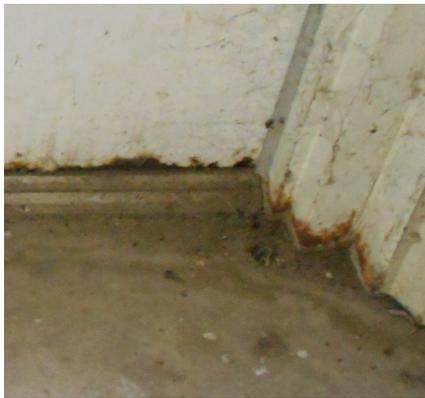
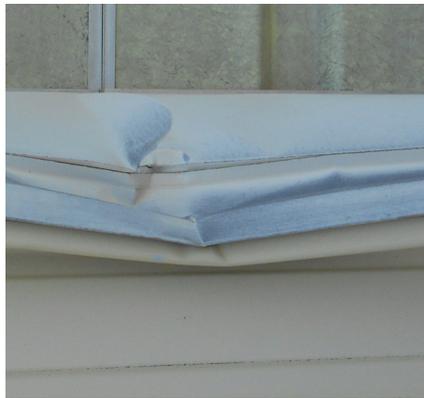
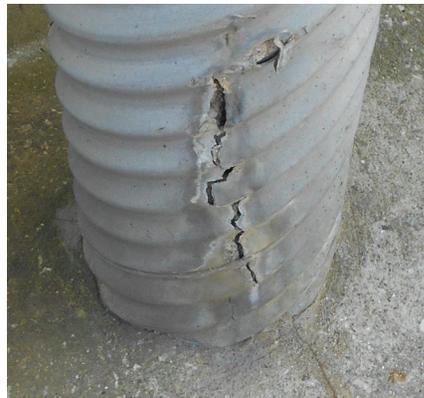
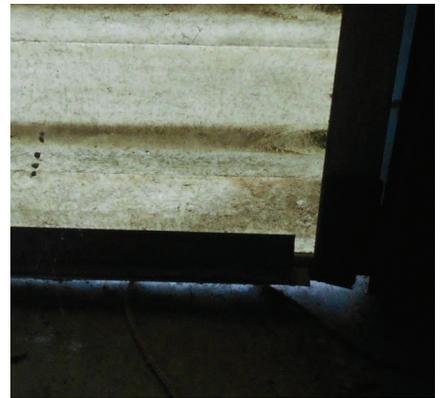
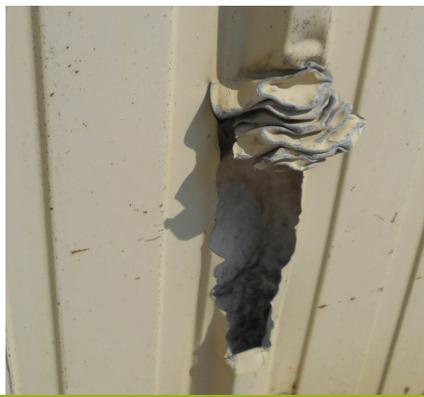
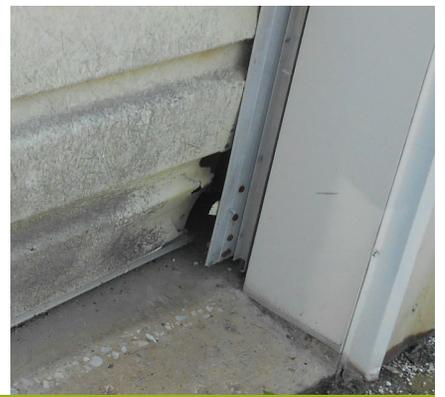
County Highway Garage

- Building is in overall good condition.
- Sealant failure at base of metal wall panels along concrete.
- Insulation along foundation broken, damaged and missing in places.
- Metal panels dented at corner.
- Interior drywall in fair condition, minor scratches; one puncture found.
- Sealed concrete flooring in good condition, minor wear.
- Interior cage in good condition.
- No rubber base at bottom of drywall.
- Exterior door in good condition.
- Exposed structure and insulation in good condition.
- No ventilation. Heat provided by ceiling mounted gas fired unit heater.

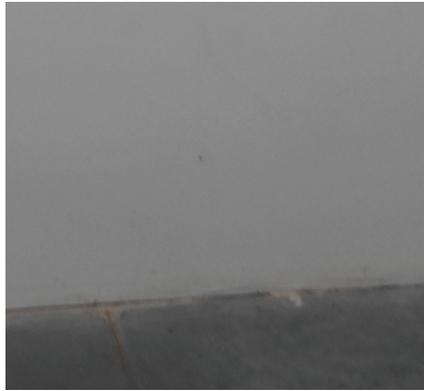
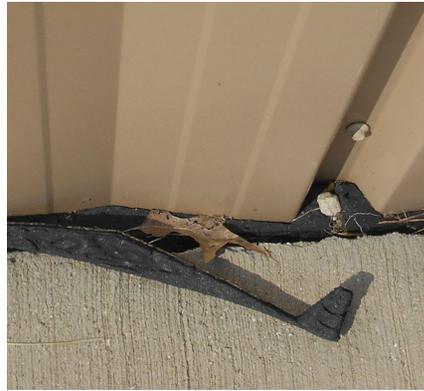
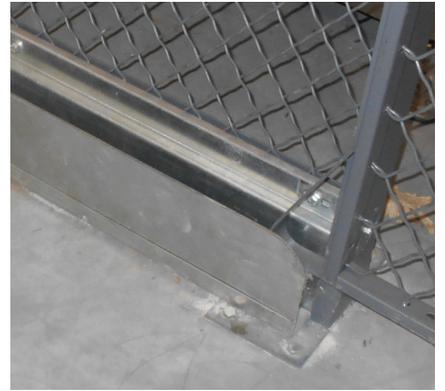
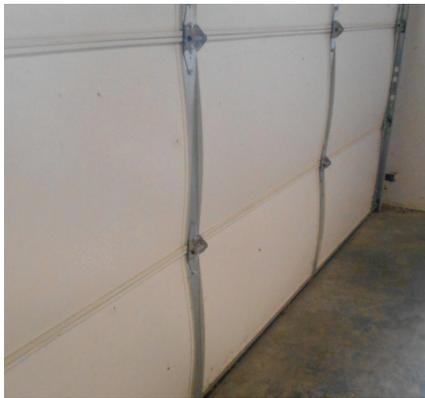
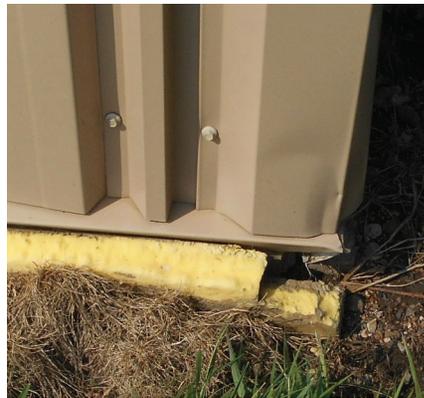
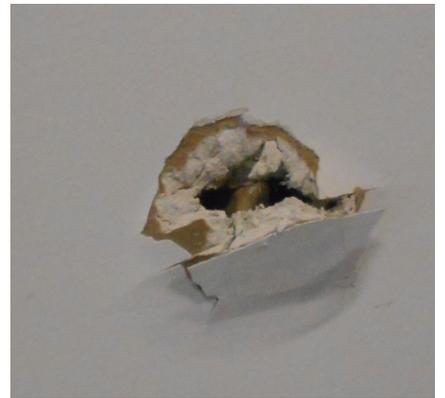
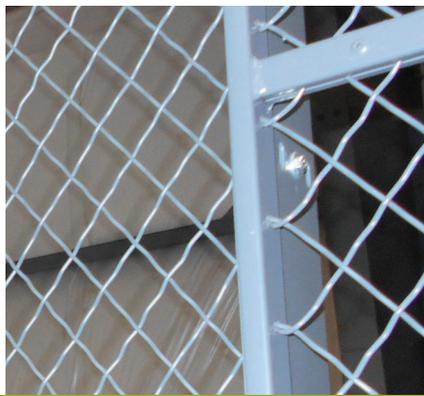
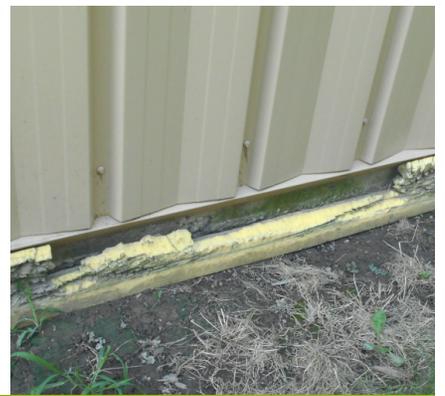
Nursing Home Storage

- Concrete flooring is in fair condition, some stains and wear from use.
- A few large cracks in concrete flooring.
- Interior and exterior deterioration on metal panel.
- Metal downspouts deteriorated, leaks found at joints.
- Exterior trim bent and damaged at door openings.
- Exterior doors deteriorated and damaged at base.
- Interior steel structure worn and deteriorated.
- Punctures, bent and damaged metal panels along base of exterior.
- Oil interceptor at trench drains and exhaust fan installed.
- No ventilation. Ceiling mounted gas fired unit heater nearing end of useful life

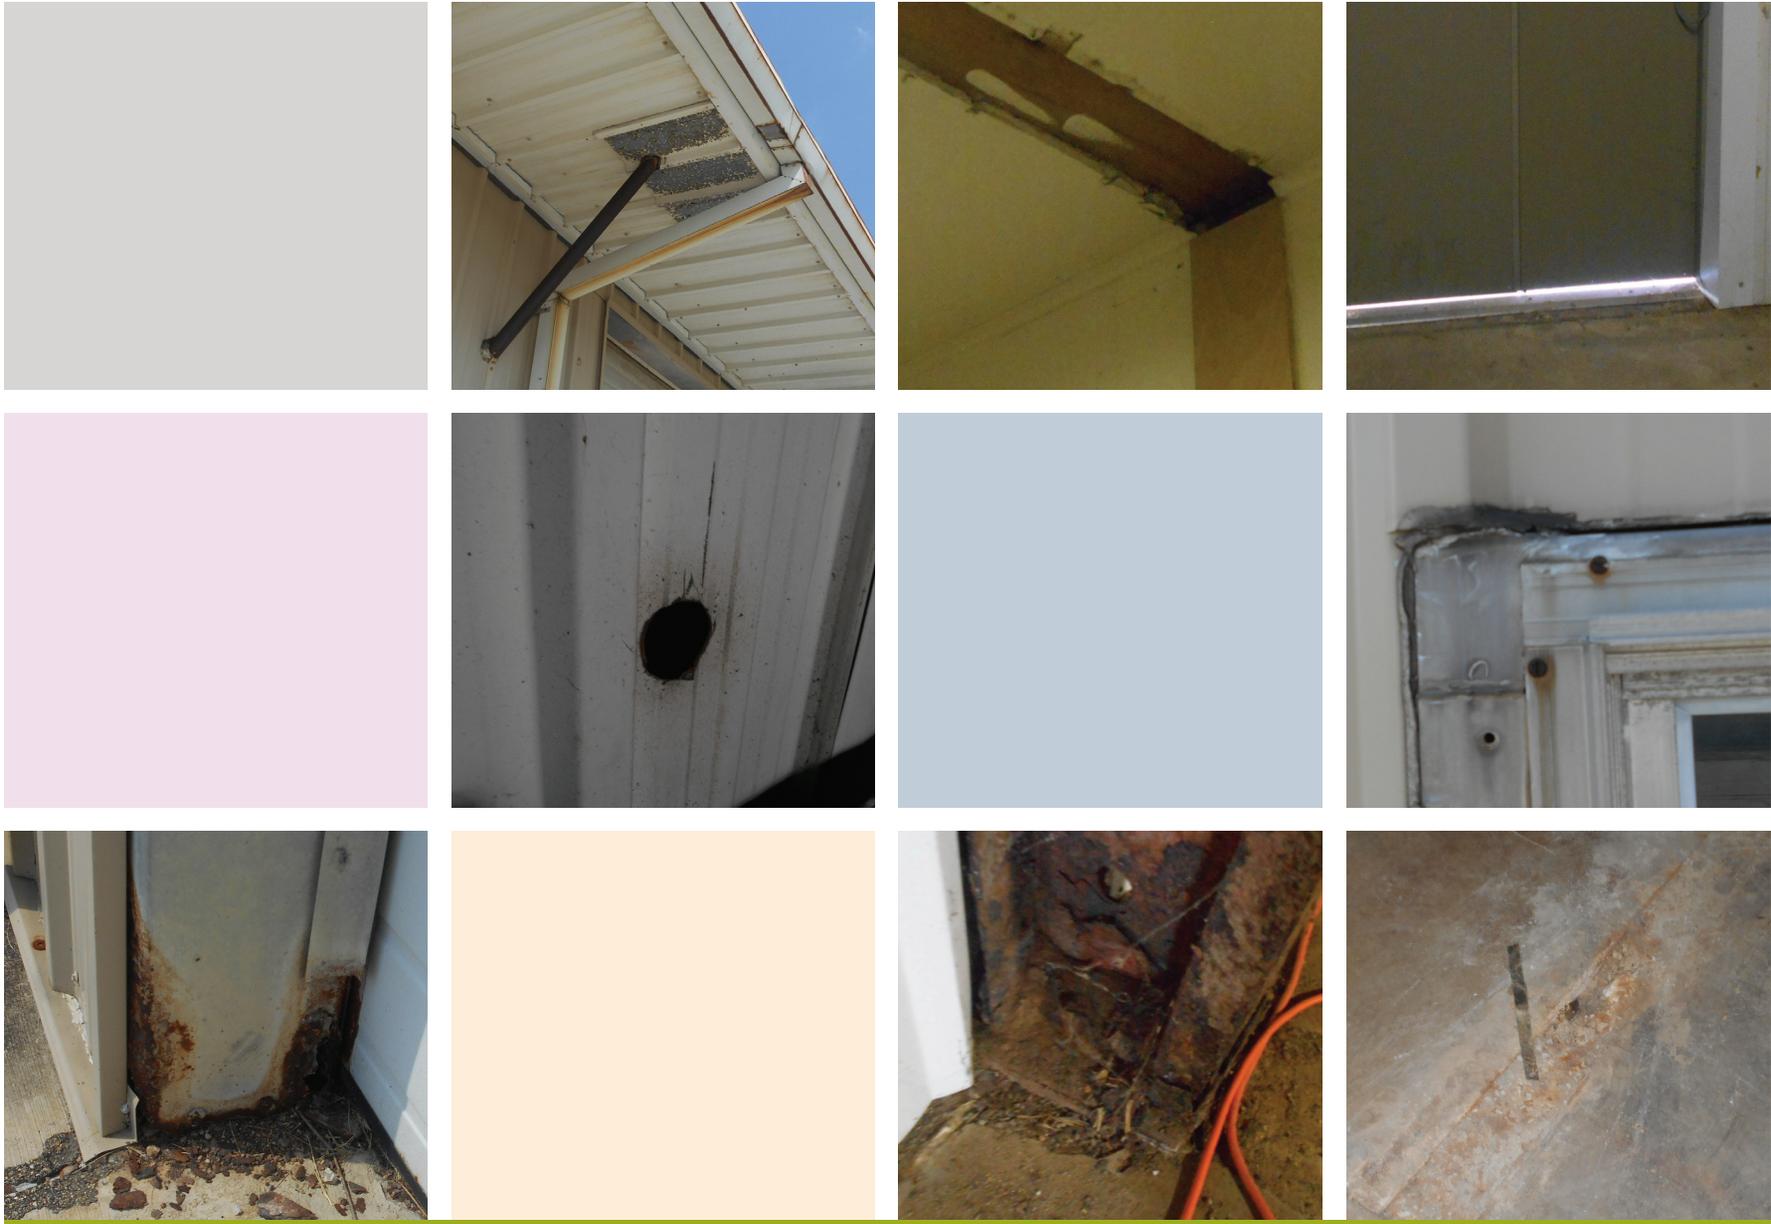
- ILEAS Garage 2 is connected to Sheriff's Garage.
- The building is in overall fair condition.
- Sealed concrete flooring is scratched and worn in places.
- Doors are worn with some deterioration.
- Finish on interior exposed structure is worn and deteriorated.
- Metal wall panels are in fair condition.
- Gutters and downspouts are deteriorated.
- Roof overhang is deteriorated and has impact damage.
- Organic plant growth in cracks along exterior concrete and base of building.
- Sealant deterioration in places along concrete.
- No ventilation. Heat provided by ceiling mounted gas fired unit heater.

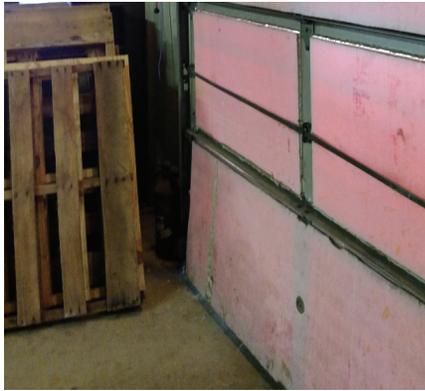
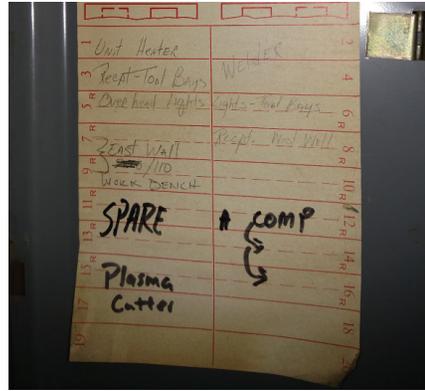
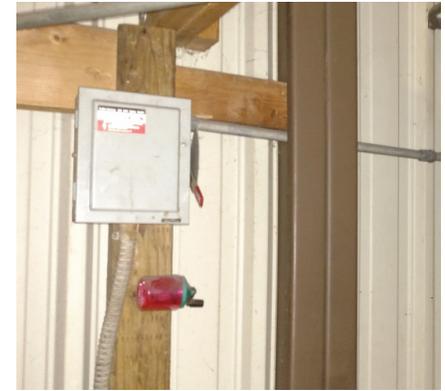
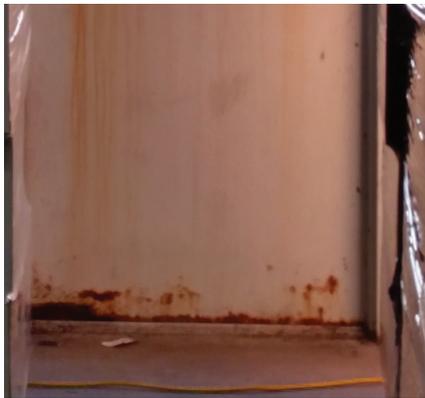
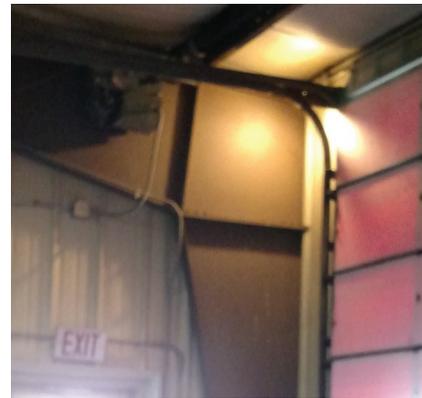
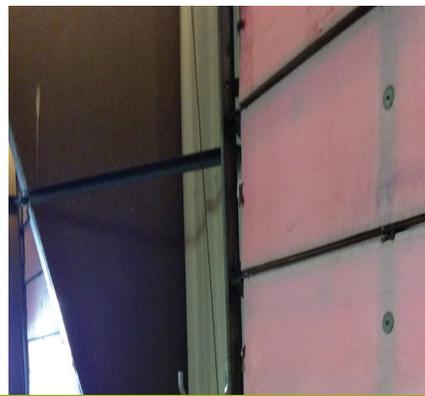
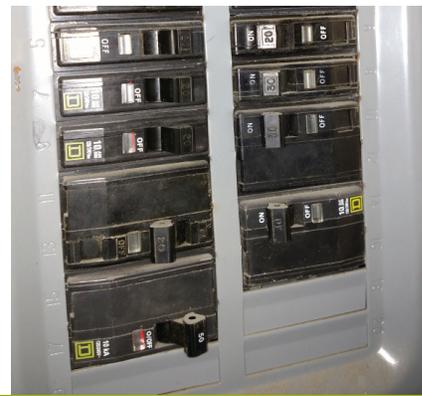
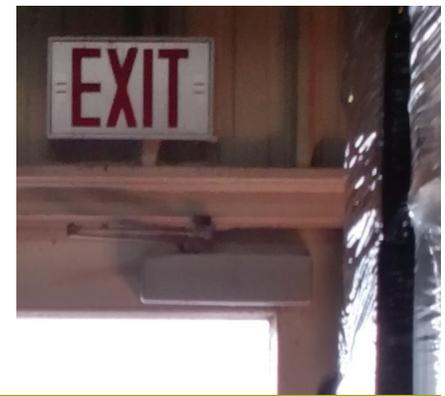
- ILEAS Garage 3 is connected to County Highway Garage.
- The building is in overall fair condition.
- Sealed concrete flooring is scratched and worn in places.
- Finish on interior exposed structure is worn and deteriorated.
- Metal wall panels are in fair condition.
- Doors have some deterioration and are in fair condition.
- Interior structure is in good condition, some deterioration.
- Overhead door is in fair condition, minor impact damage.
- Organic plant growth in cracks along exterior concrete.
- Sealant deterioration in places along concrete.
- No ventilation. Heat provided by ceiling mounted gas fired unit heater.
