Facilities Assessment Report

November 3, 2015

County of Champaign, Illinois

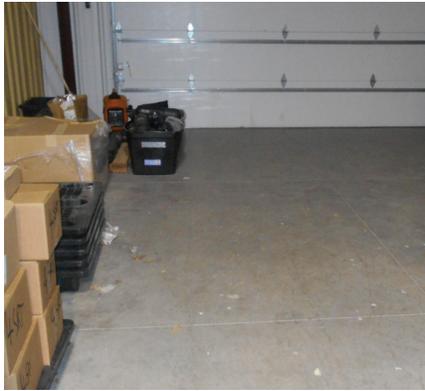
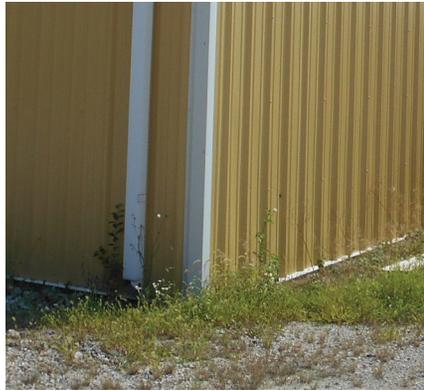
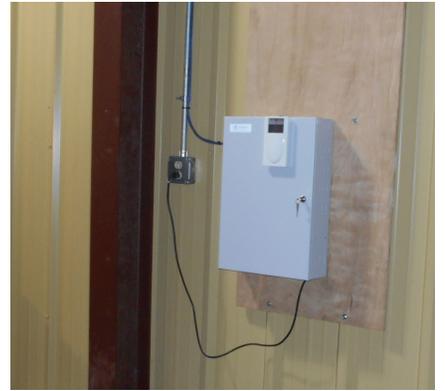
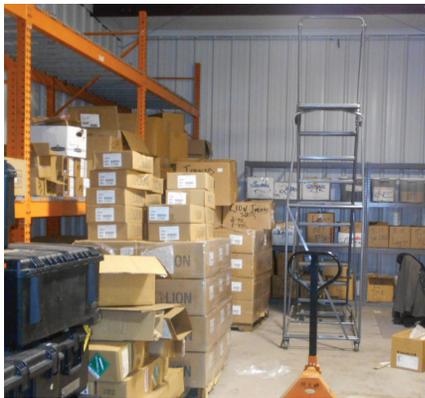
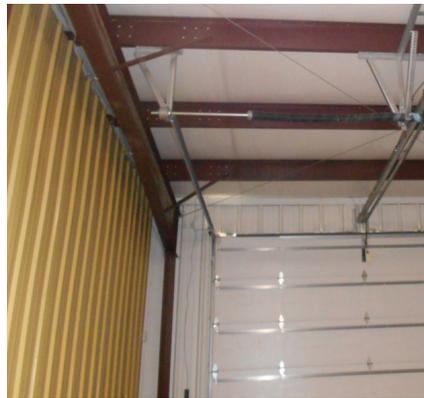
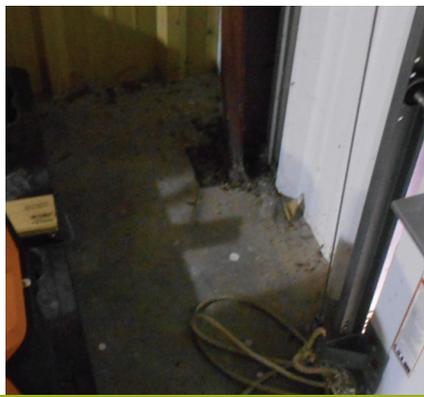
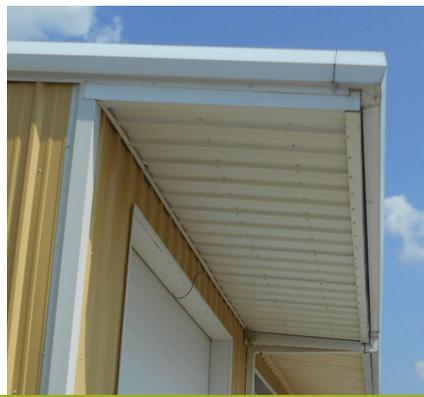
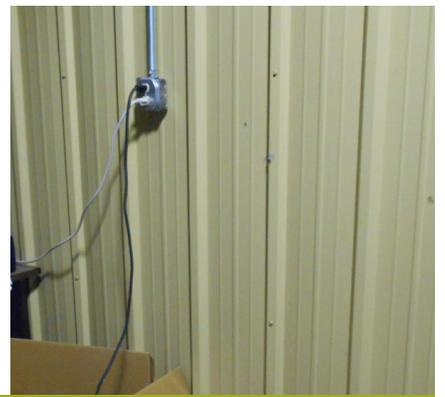
- ILEAS Garage 1 is connected to EMA Garage.
- The building is in overall good condition.
- Sealed concrete flooring is scratched and worn in places.
- Finish on interior exposed structure is worn and deteriorated.
- Overhead door and frame is in fair condition.
- Metal wall panels are in good condition.
- Roof system is in good condition.
- Gutters and downspouts are in good condition.
- Some plant growth in cracks along exterior concrete and pavement.
- Sealant deterioration in places along concrete.
- No ventilation. Heat provided by ceiling mounted gas fired unit heater.
