Facility Condition Assessment Summary of Results November 19, 2015

Champaign County

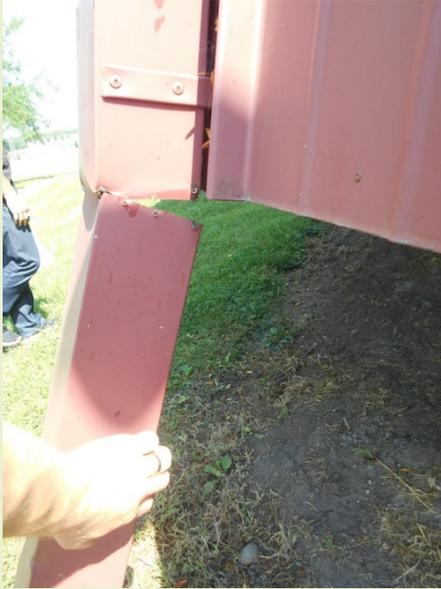
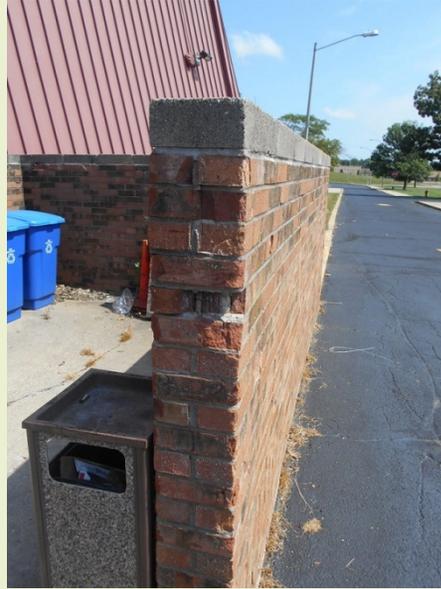
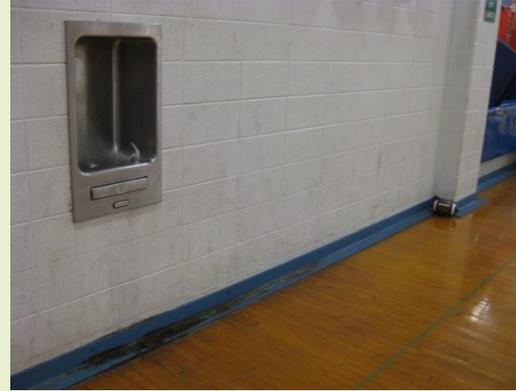
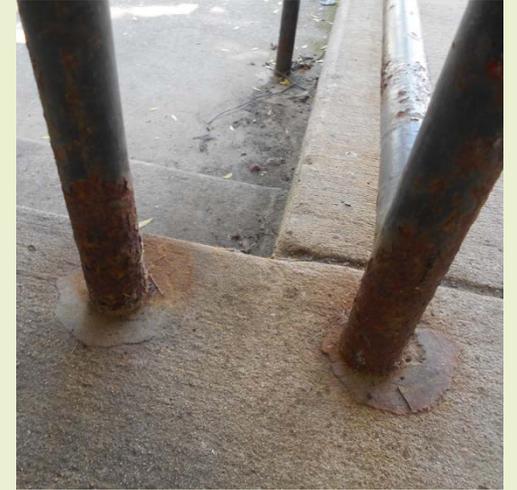
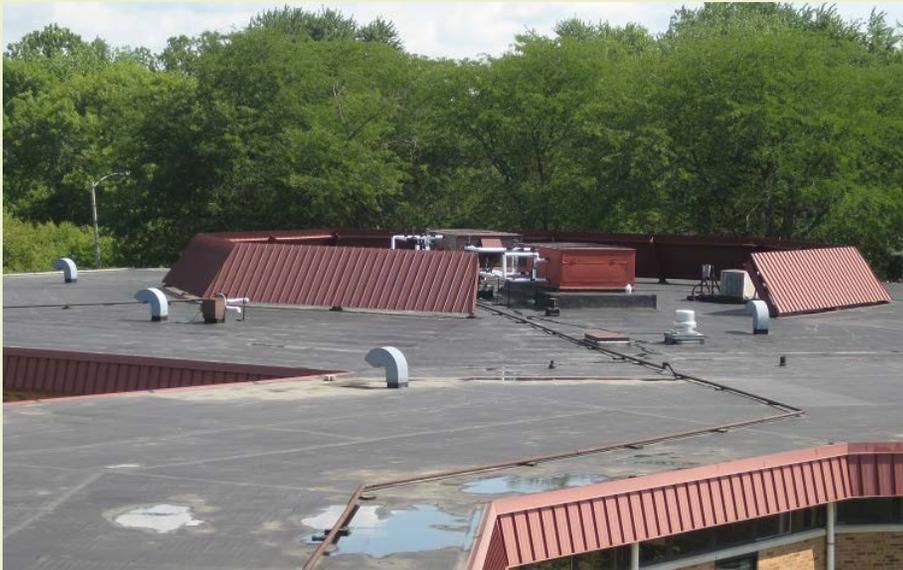
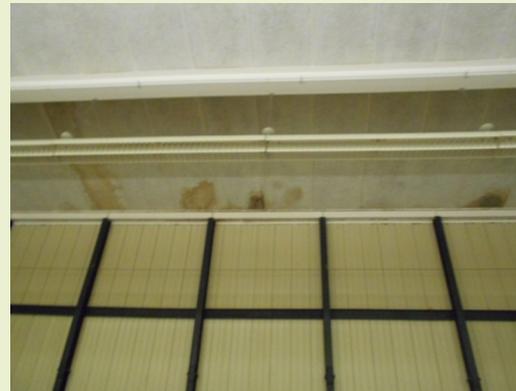
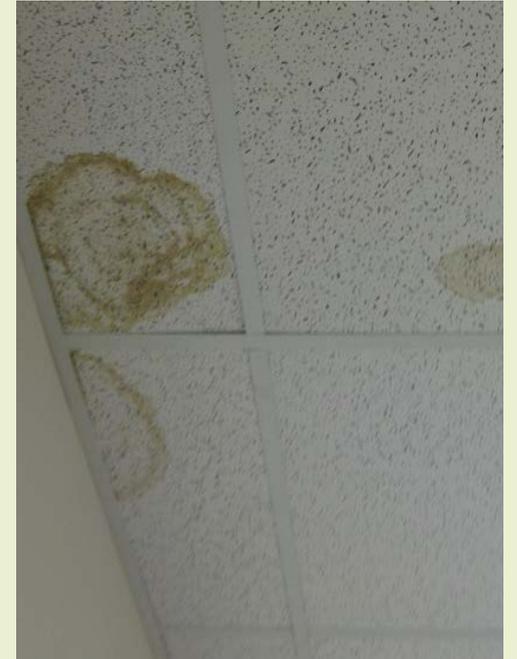
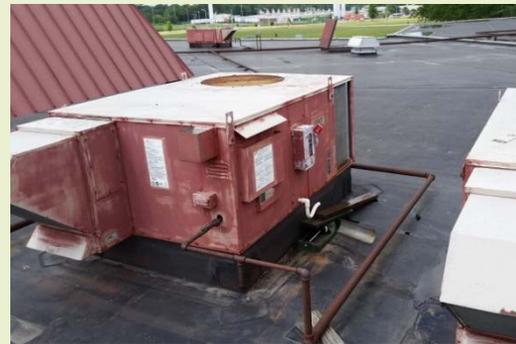
- This building has a back-up generator
- Roof and soffit replacement needed at portion of facility
- Downspouts are in need of repair, many are dented or loose
- Parking lot recently resurfaced and is in good condition
- Minor brick repair and sealant replacement required
- Sidewalks cracked and damaged in places
- Exterior insulation is heavily damaged or missing
- Exterior Lighting and controls require replacement

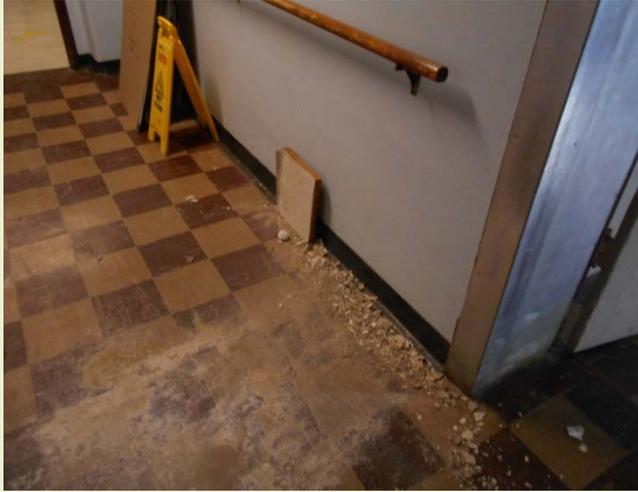
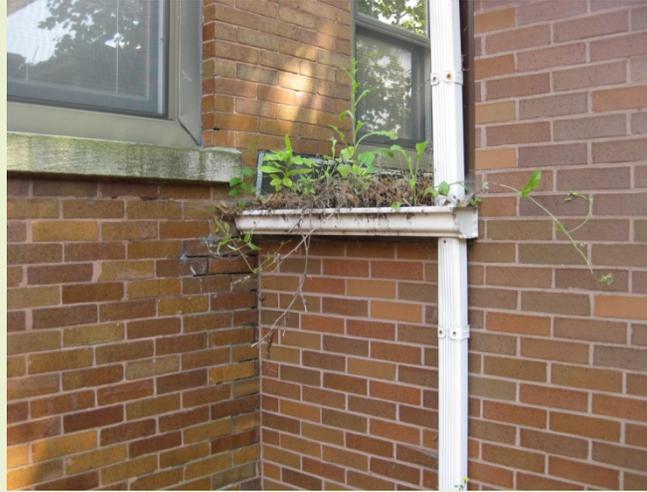
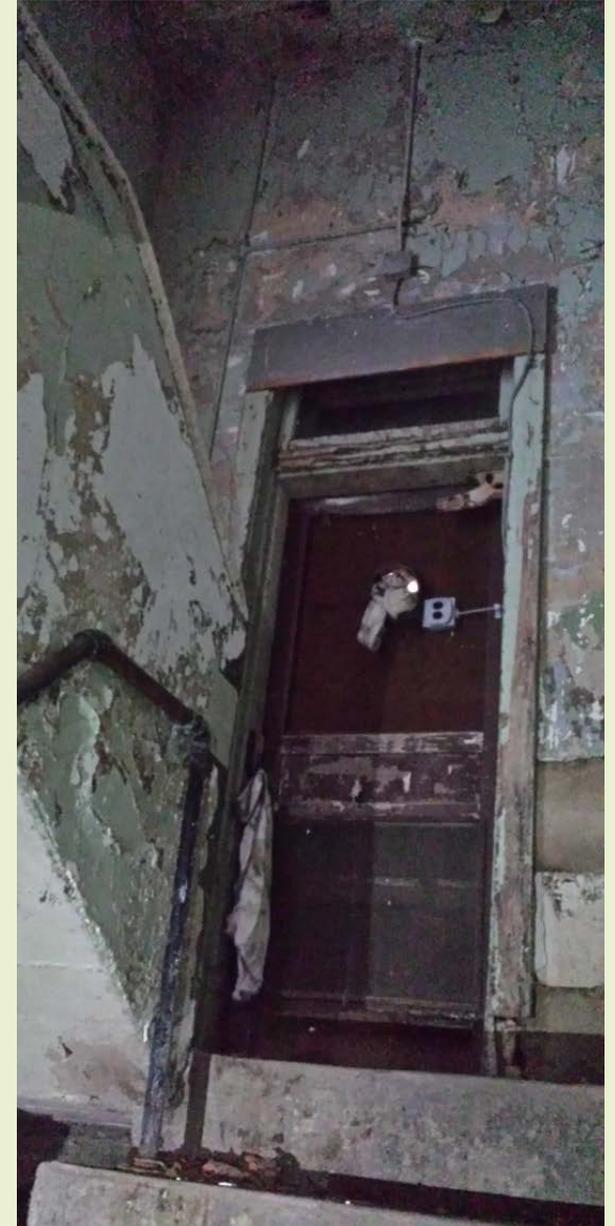
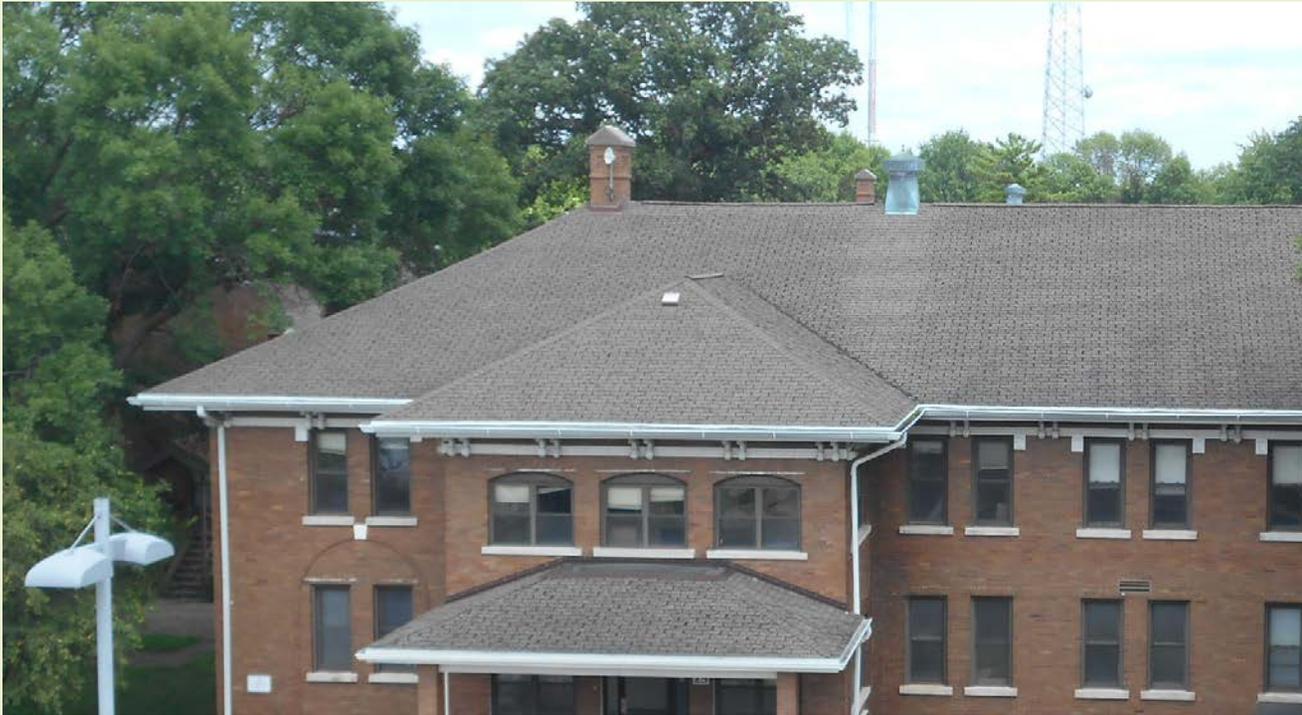
- The building envelope is severely deteriorated..
- There is water penetration and efflorescence on exterior brick.
- Gutters are overgrown with organic material.
- Mechanical systems require replacement.
- Adjacent concrete and paving is cracked.
- Brick joints are deteriorated or missing; bricks are loose in places.
- Wood trim is heavily damaged and deteriorated.
- Asphalt shingles are damaged and missing; roofing requires replacement

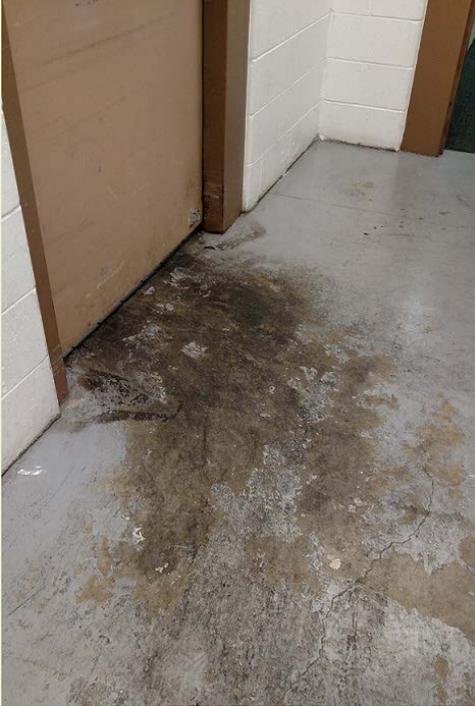
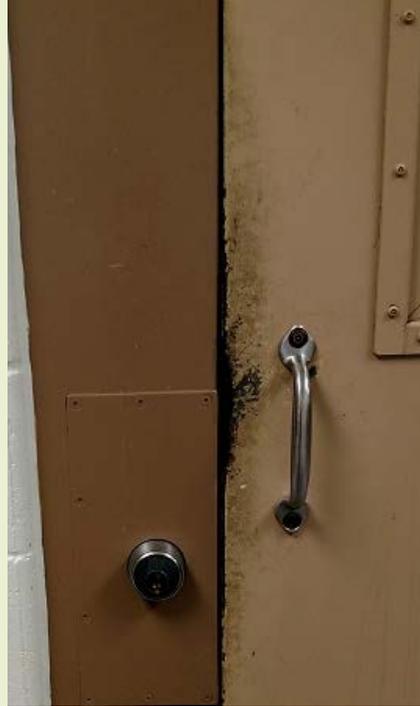
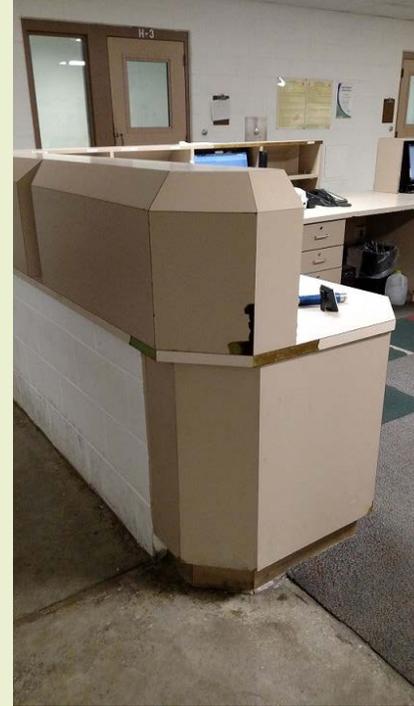
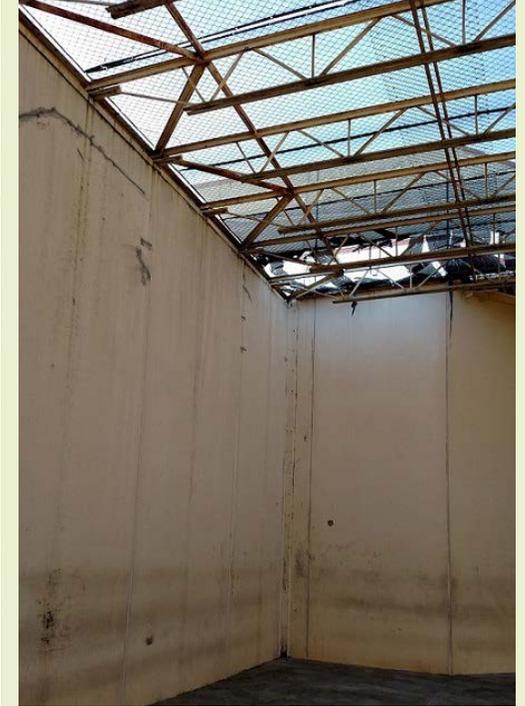
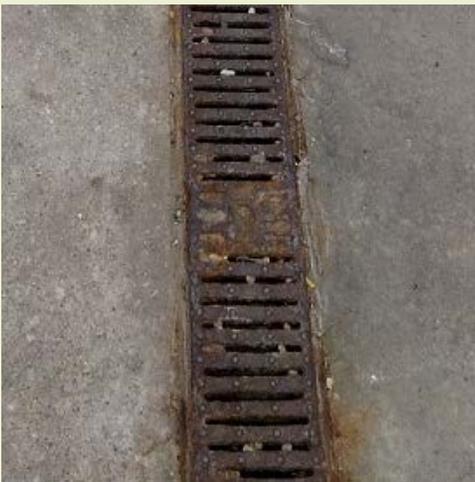
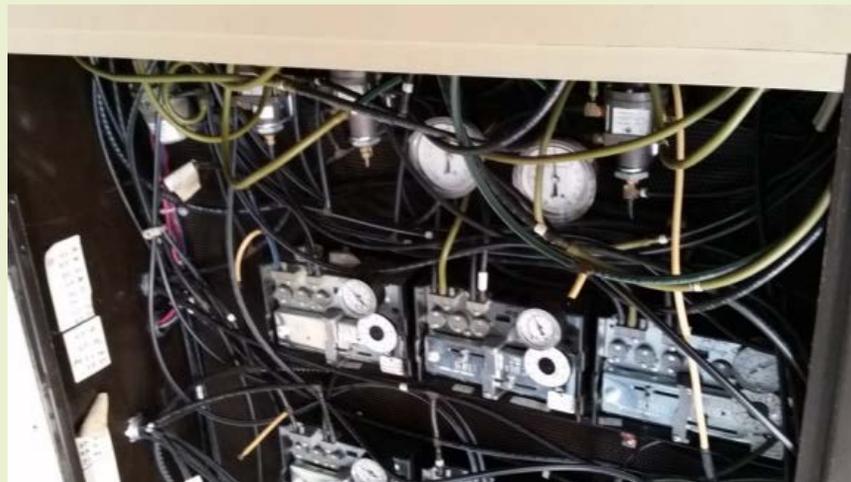
- Roof in poor condition and needs replacement
- Paint peeling from interior windows and sills
- Ceiling tiles stained at HVAC vents
- Deteriorated floor finishes require replacement
- Incandescent lighting needs replaced
- Combustion fan motors periodically fail

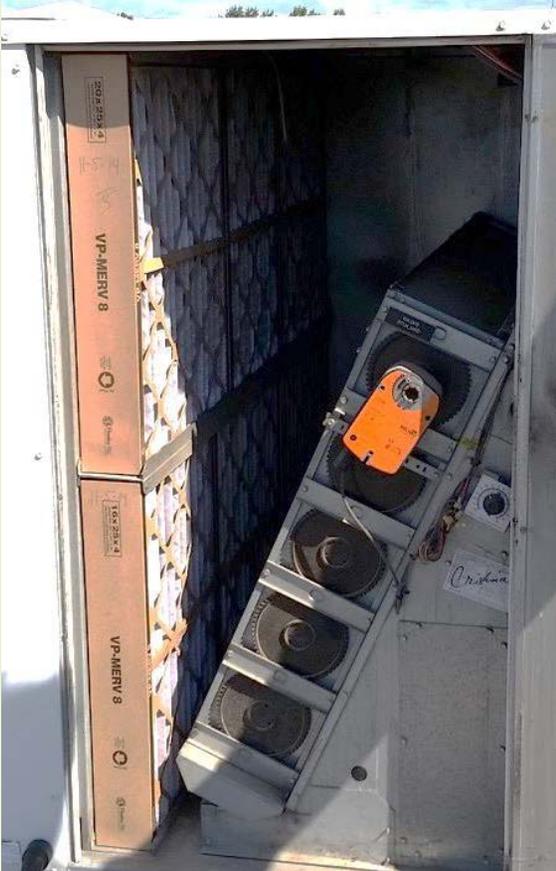
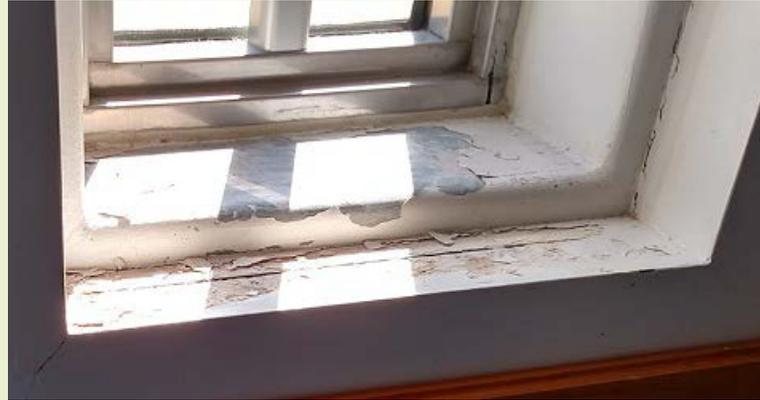
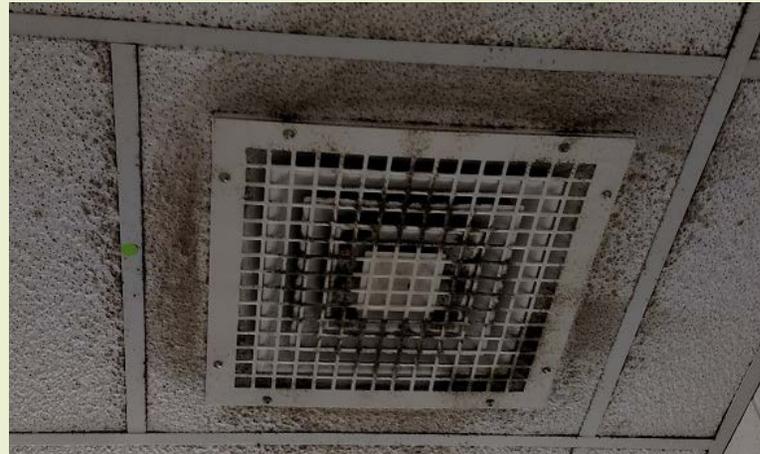
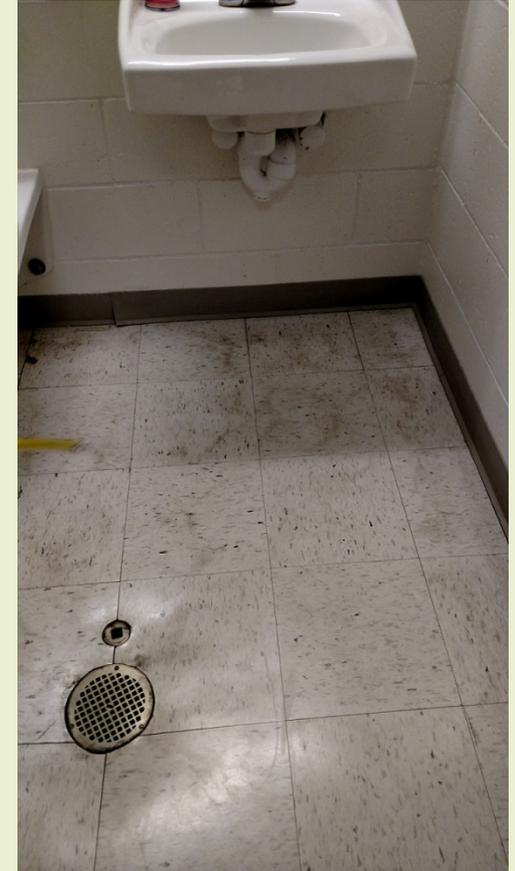
- Return side of HVAC system is inadequate.
- Exterior soffit panels missing,
- Interior flooring in good condition, some repair required
- Wall/ finishes in generally good condition, some repair required
- Wall base missing at several locations
- Nurses call system should be replaced
- Outside air intake location for the boilers causes boiler failure

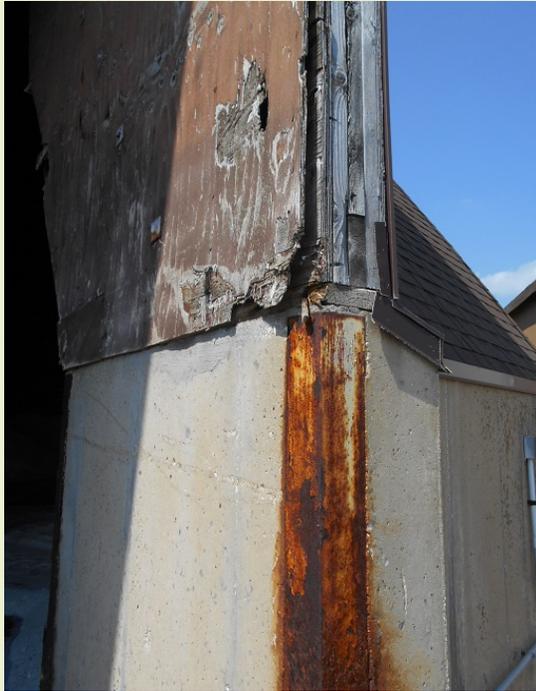
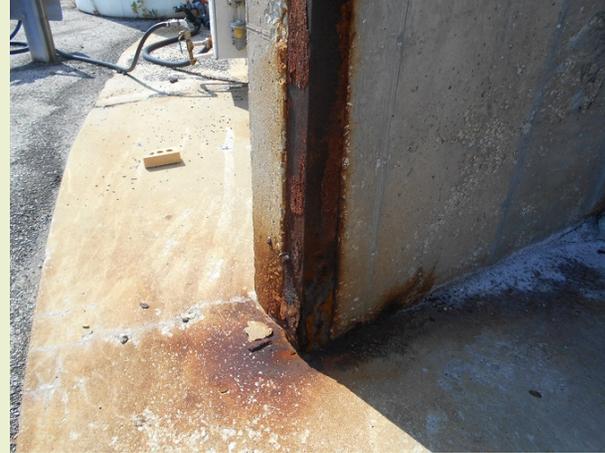
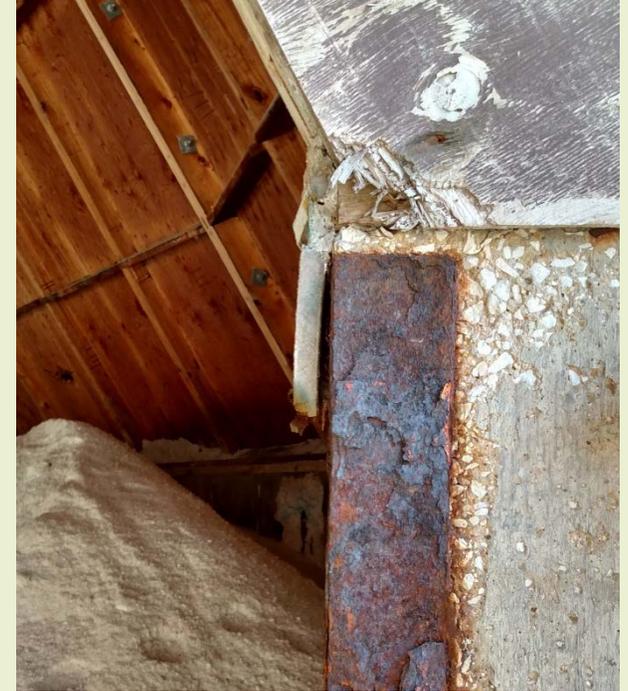
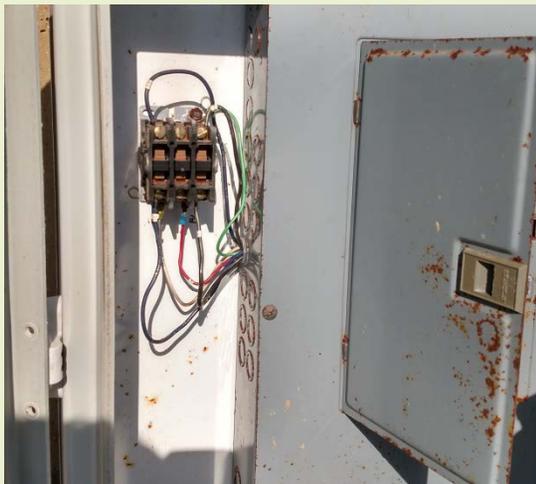
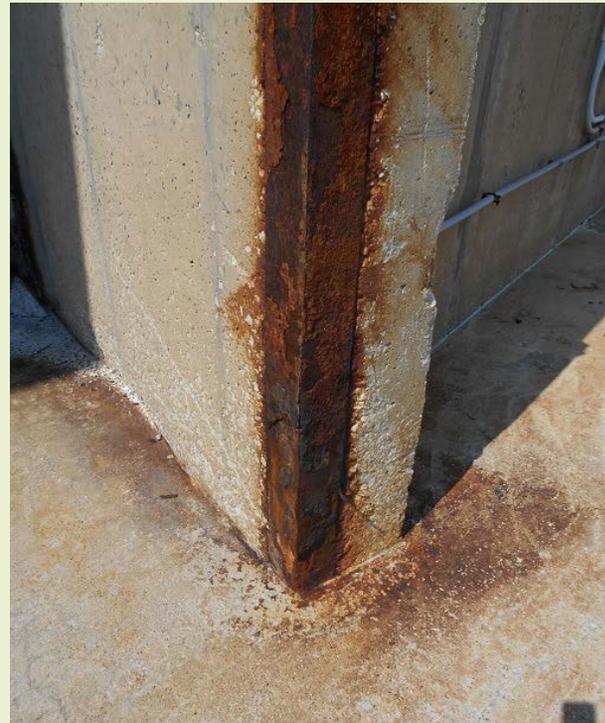
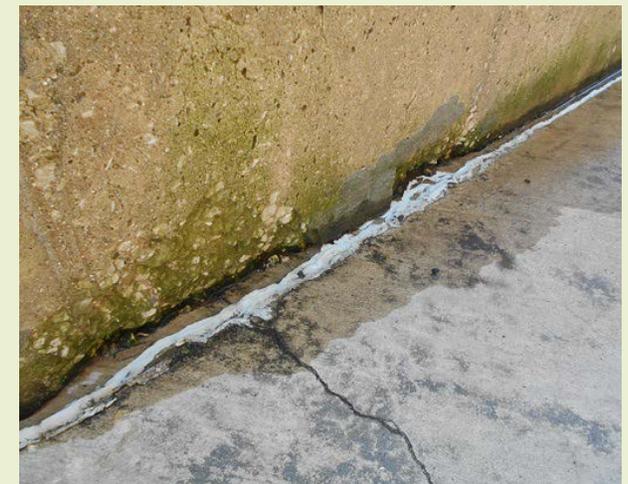
- The building overall is in poor condition.
- Interior wood is deteriorated from age.
- Minor exterior trim damage, missing or broken pieces.
- Soffits are not protected, raw wood exposed to elements.
- Asphalt shingles are in good condition.
- Worn and deteriorated paint at roof edge trim.
- Paint overall is in fair condition.
- Overhead door is in good condition, minor impact damage.

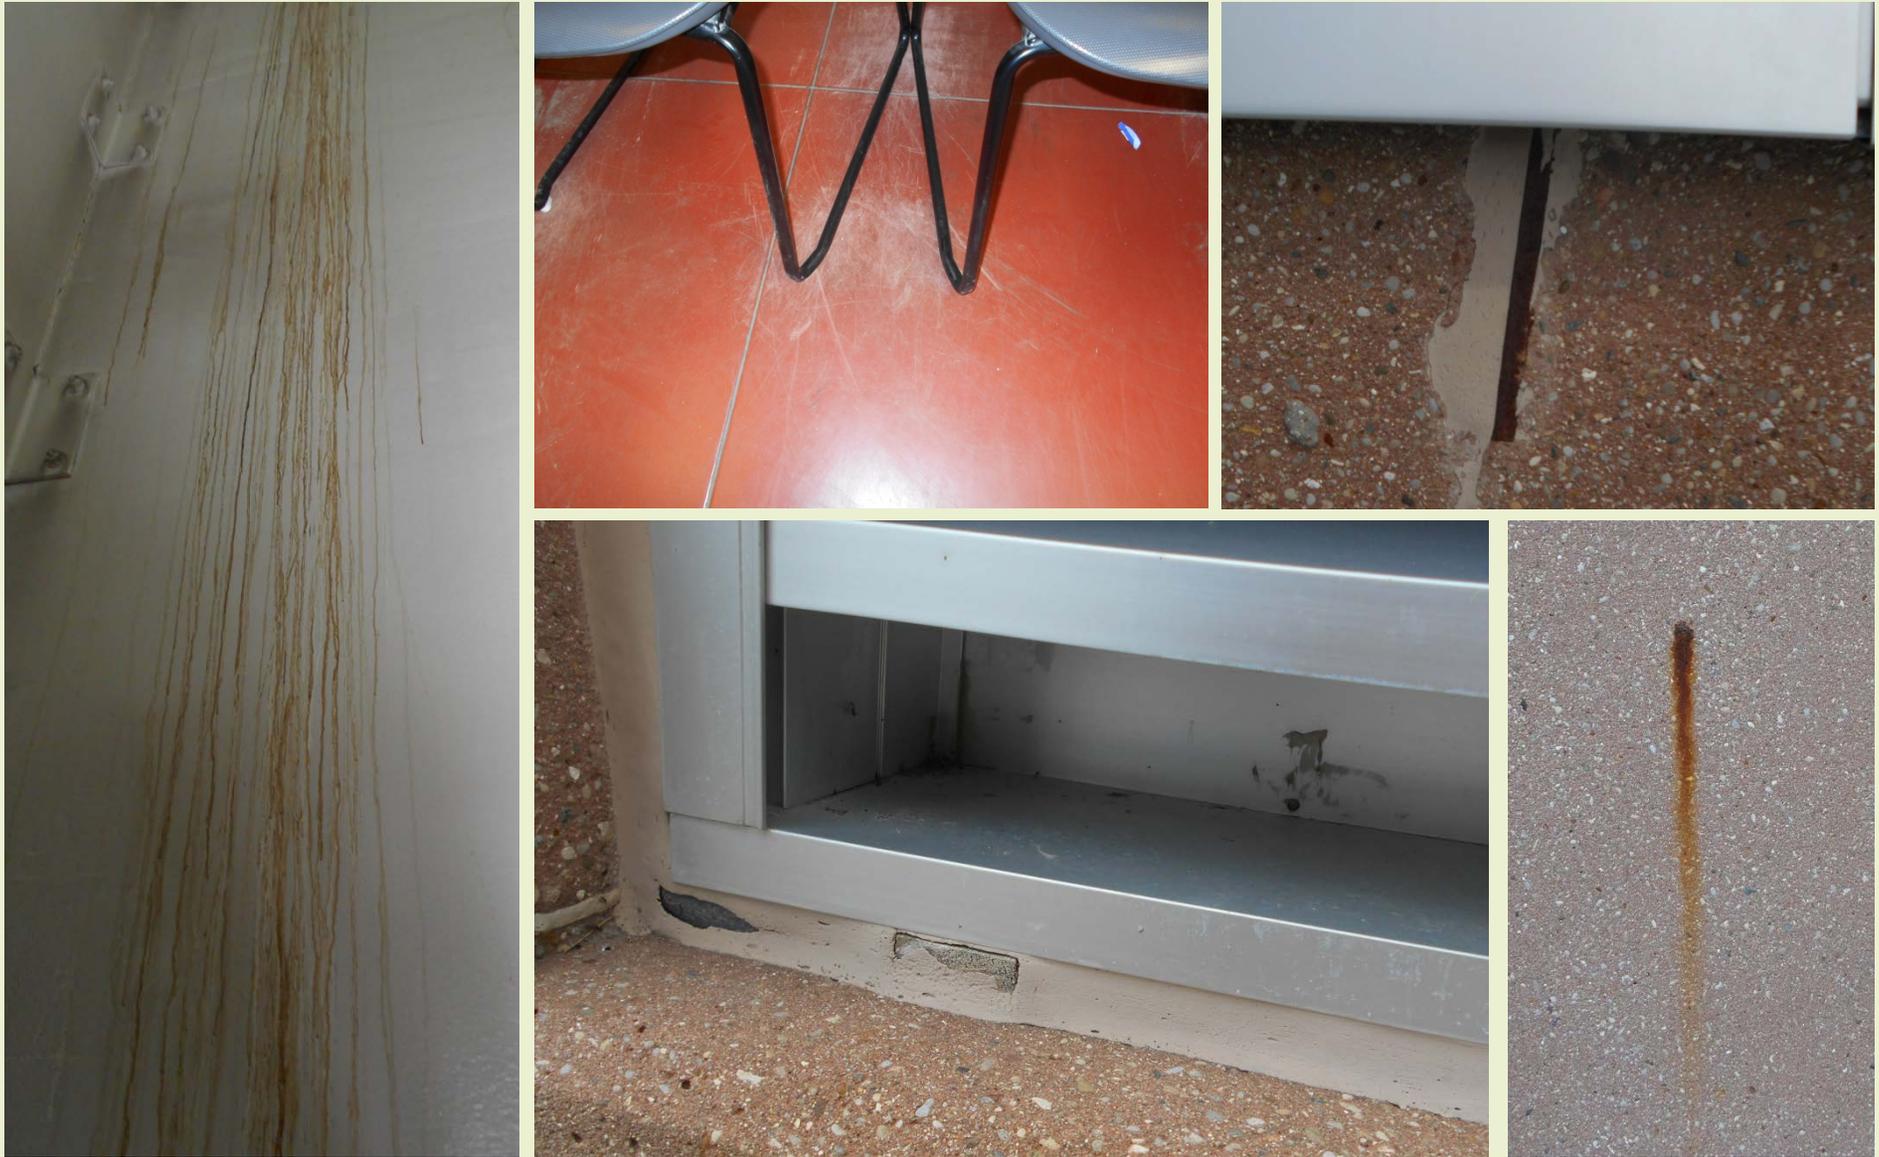
- This building has a back-up generator.
- Overall, the building is in good condition.
- Exterior brick is worn, some sealant damage at windows.
- Railings along accessible ramp are deteriorating.
- Minor cracks on ramp and walk.
- Gutters in good condition, some paint peeling.
- Roof will need replacement.
- Served by AHU's and condensing units, AHU's nearing end of useful life.

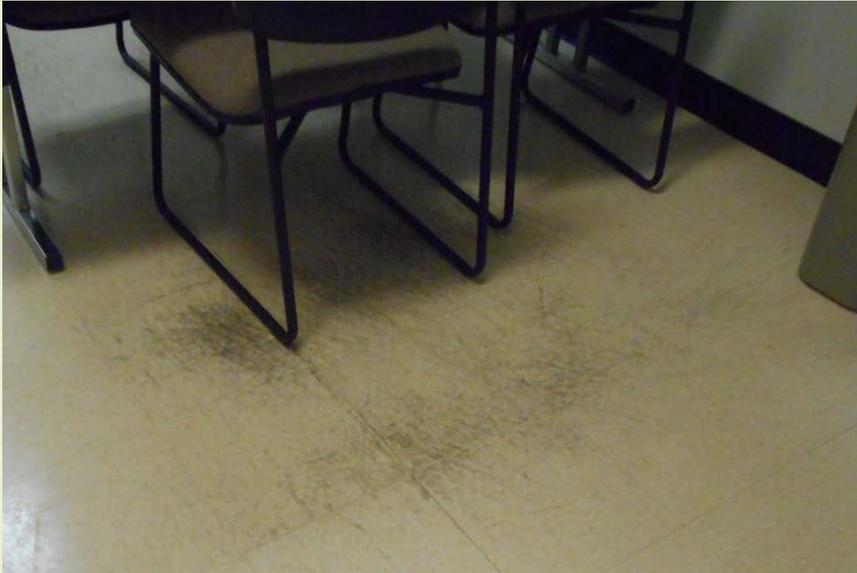
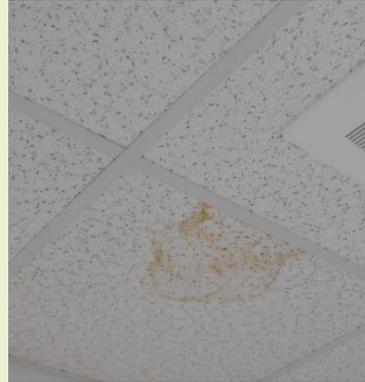
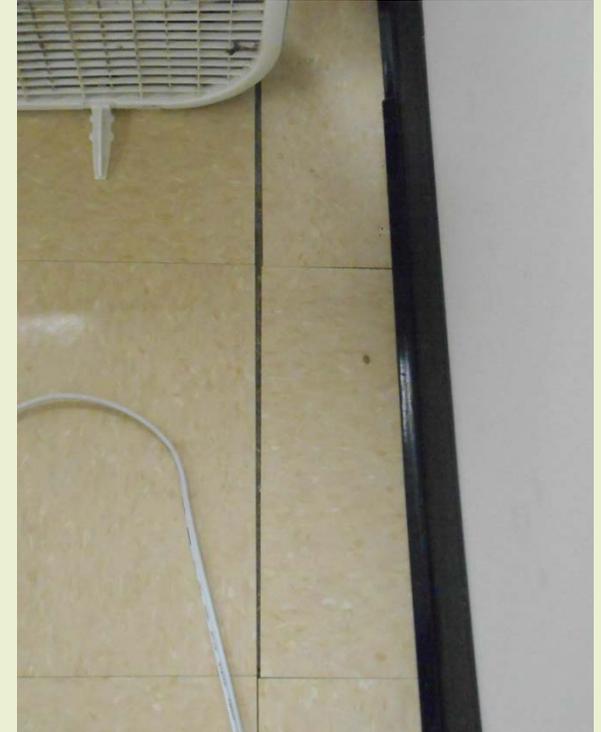
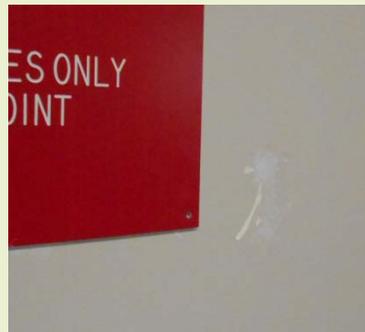
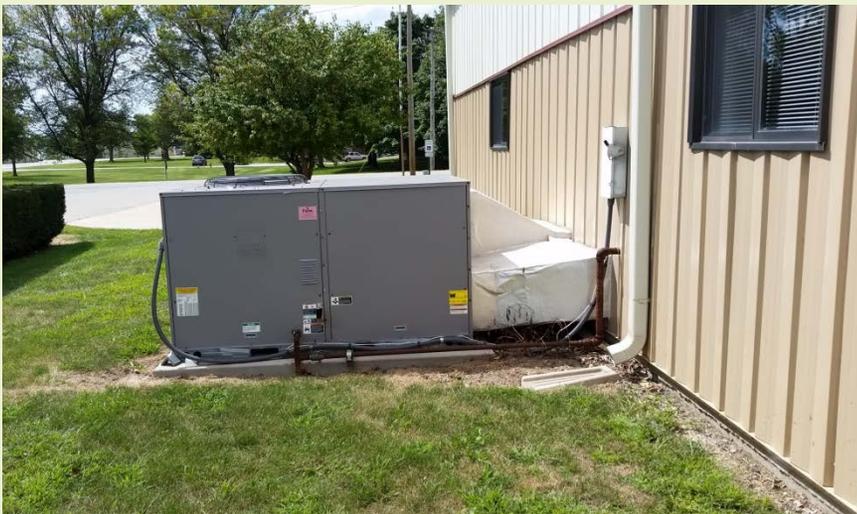
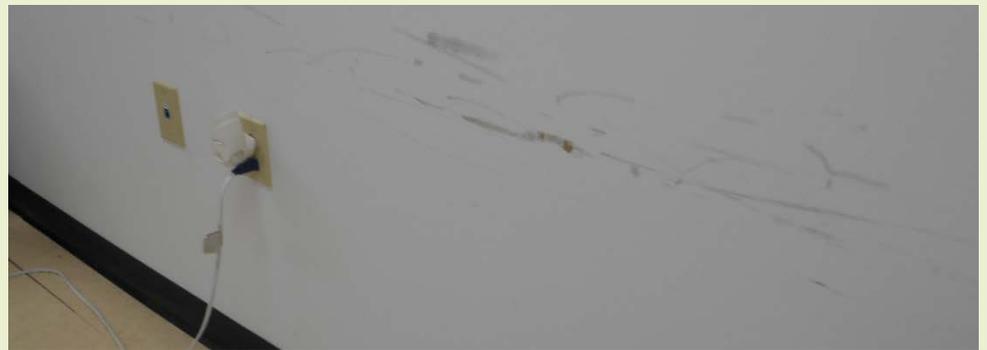
- Building is overall in good condition.
- Metal wall panels on exterior in good condition, minor damage.
- VCT flooring heavily scratched and worn, stained in some areas.
- Minor drywall damage, some impact damage and scratches.
- Insulation along foundation damaged and missing in places.
- Heavy water damage to landscaping at downspouts.
- Sealant failure along edge between metal panels and concrete.
- Ventilation provided by roof mounted exhaust fan in good condition.
- Heating provided by three gas fired unit heaters in good condition.

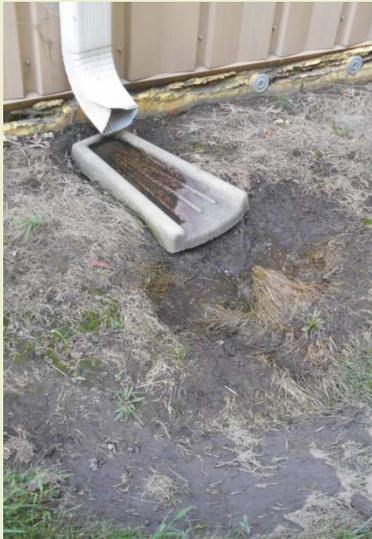
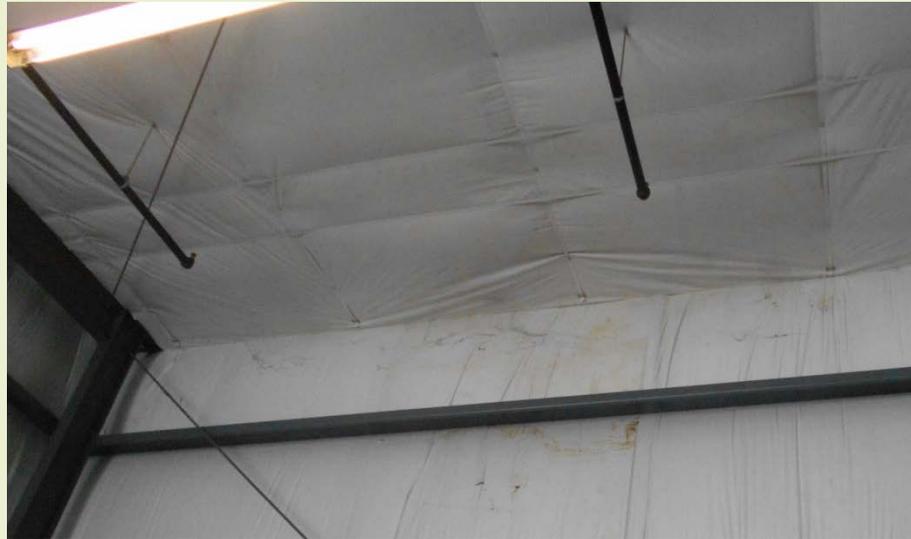
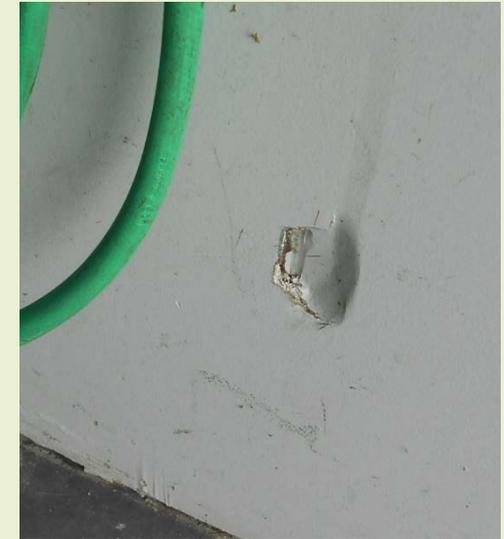
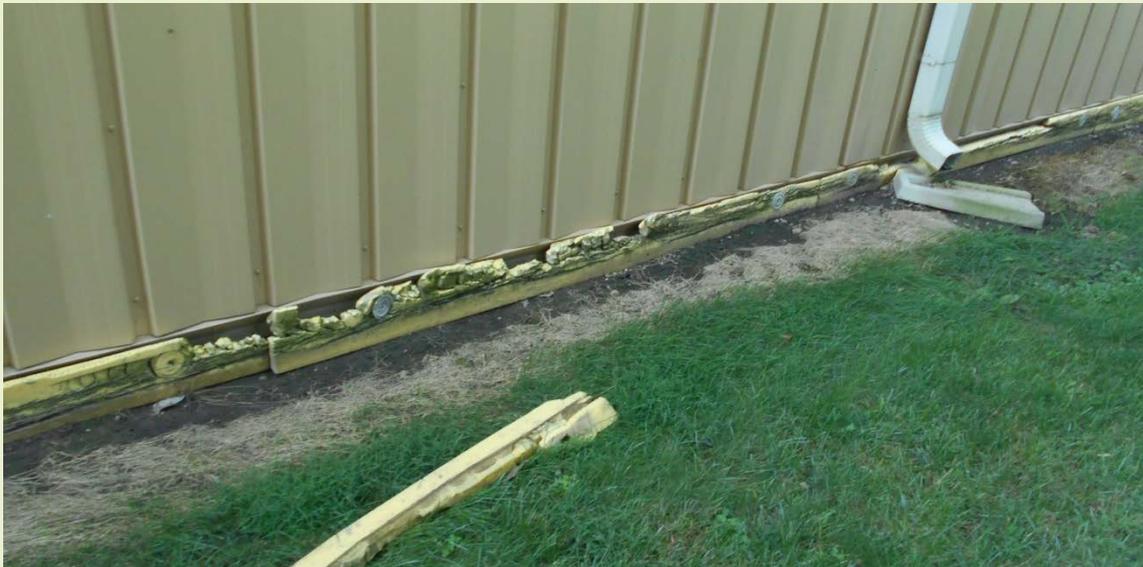
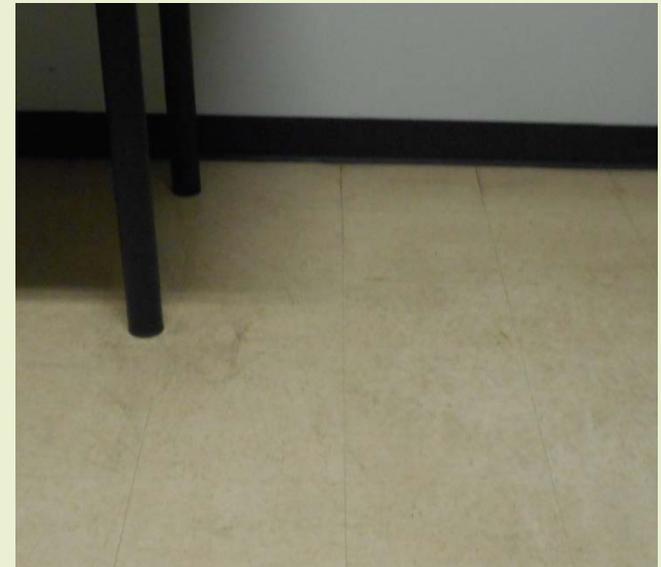
- This building is in good condition.
- Minor dents and cosmetic damage to exterior metal panels.
- Foundation insulation is damaged and missing in places.
- Interior sealed concrete flooring is stained and worn.
- Ceiling tiles are in good condition, few missing or stained.
- Rubber wall base missing in places.
- VCT in bathroom worn and stained.
- Interior drywall and finishes in good condition.
- HVAC provided by unit mounted on grade.

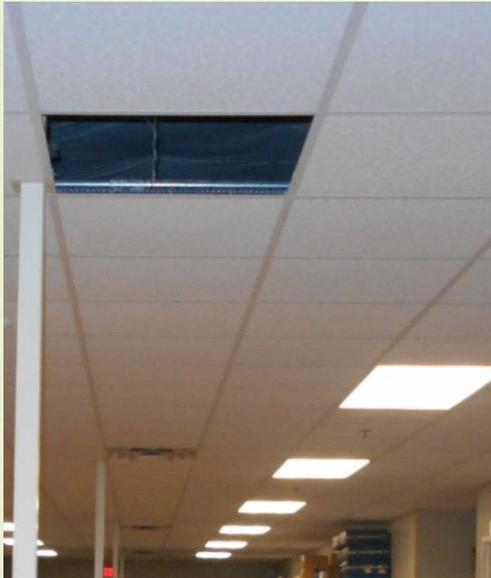
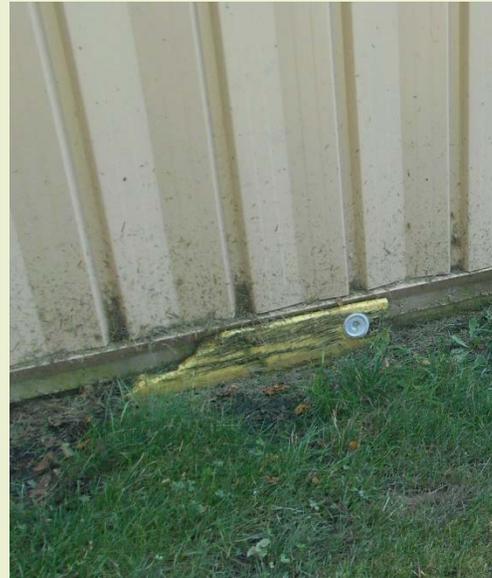
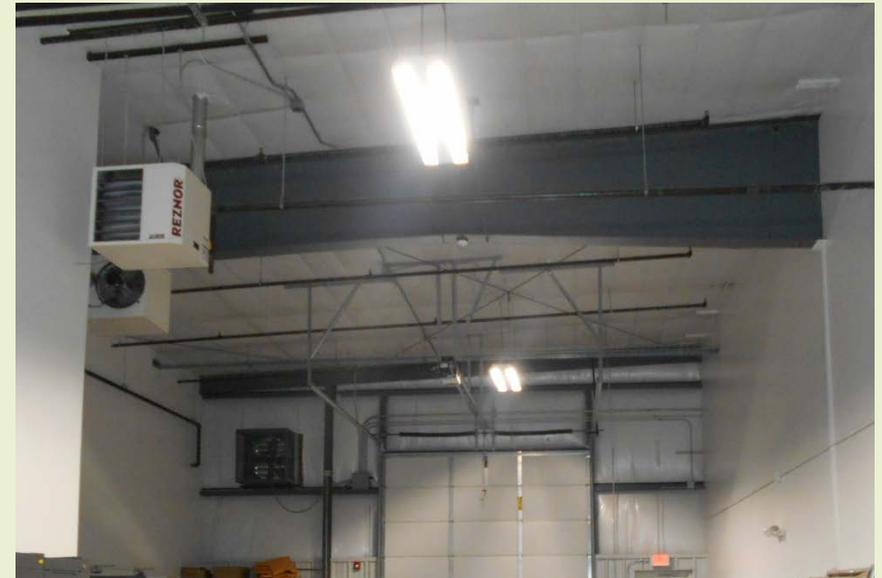
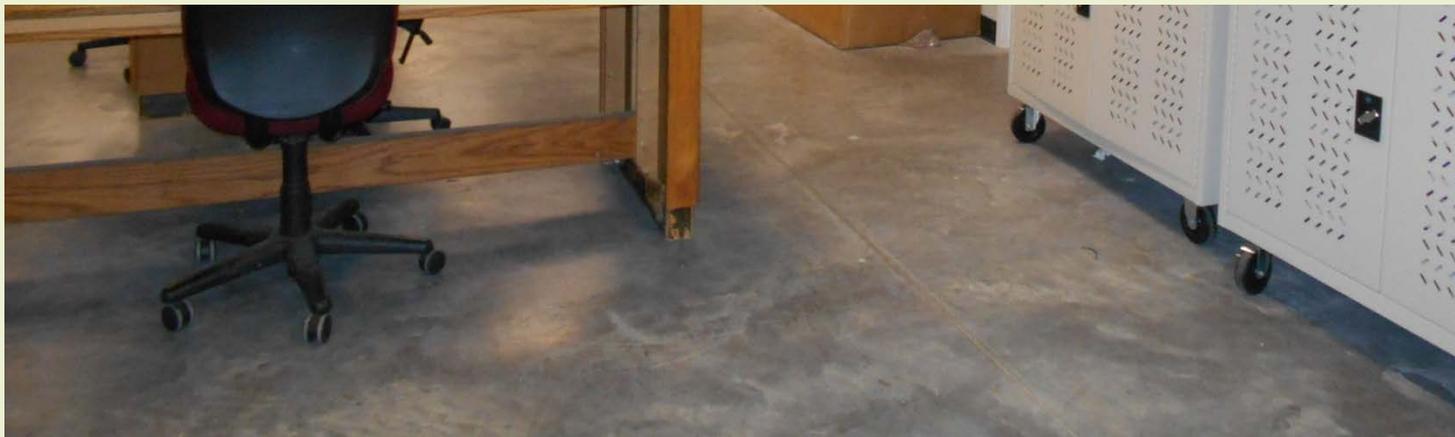
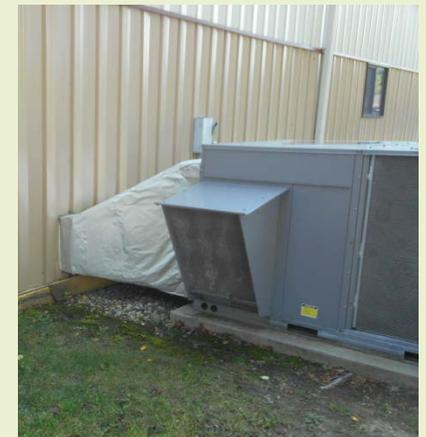
- Building is in overall good condition.
- Sealant failure at base of metal wall panels along concrete.
- Insulation along foundation broken, damaged and missing in places.
- Metal panels dented at corner.
- Interior drywall in fair condition, minor scratches; one puncture found.
- Sealed concrete flooring in good condition, minor wear.
- No rubber base at bottom of drywall.
- Exterior door in good condition.
- No ventilation. Heat provided by ceiling mounted gas fired unit heater.

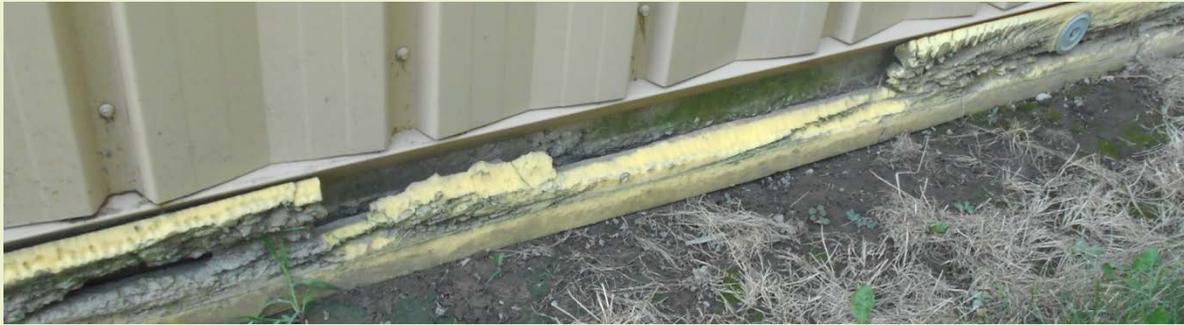
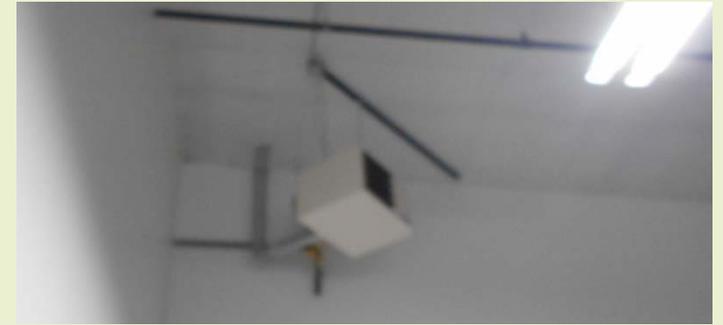
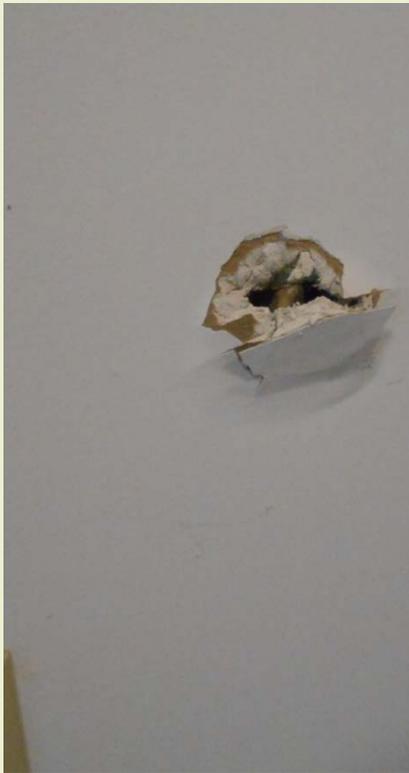
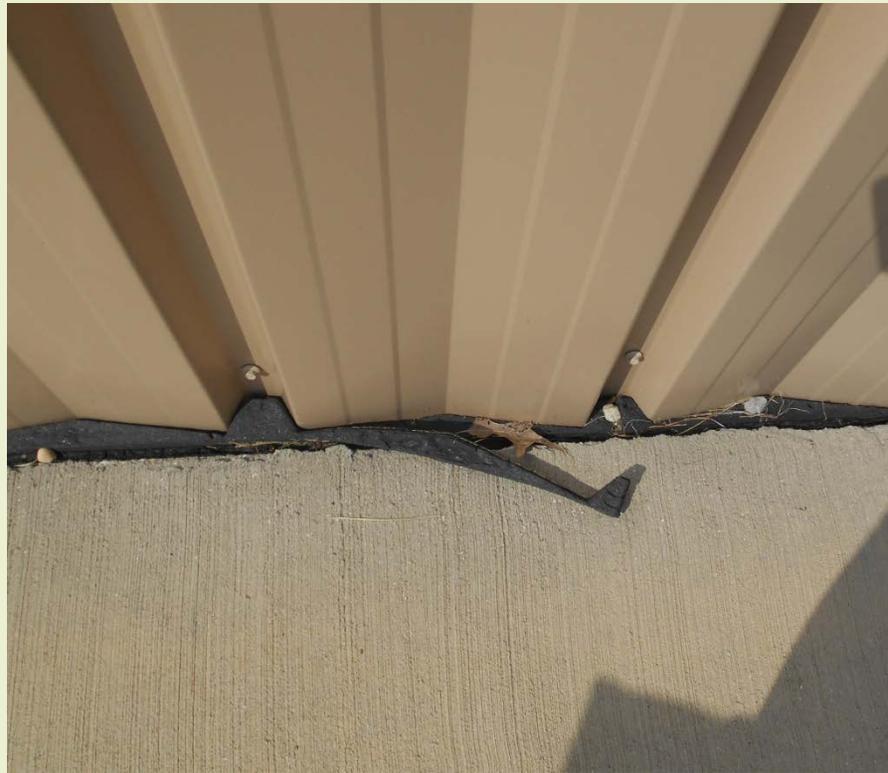
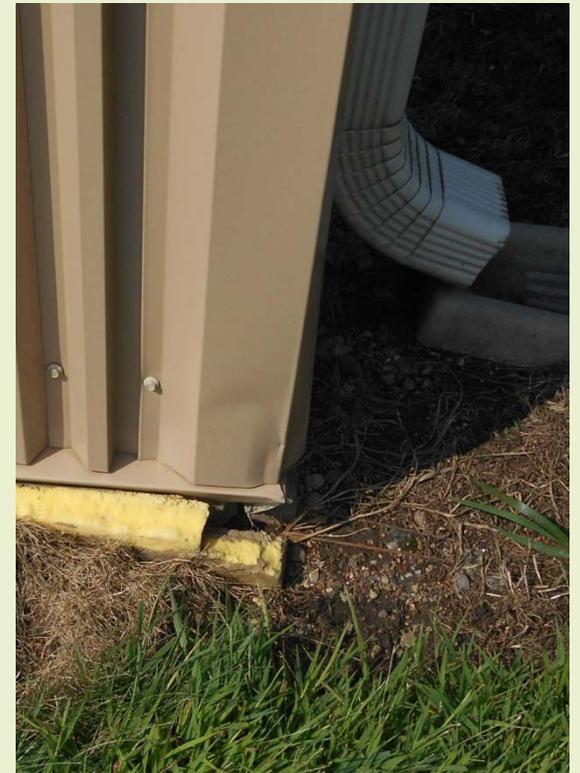
- This building has no back-up generator.
- Exterior metal wall panels have impact damage in multiple locations.
- Downspouts are in good condition, minor damage.
- Exterior wood door trim is deteriorated, paint peeling.
- Threshold sealants are failed.
- Ceiling tiles are in fair condition, some large stains in places.
- Overhead doors have impact damage on the exterior.
- Windows are in fair condition, some.
- HVAC provided by two packaged AHU's on grade in good condition.
