Facility Condition Assessment Summary of Results November 19, 2015

Champaign County

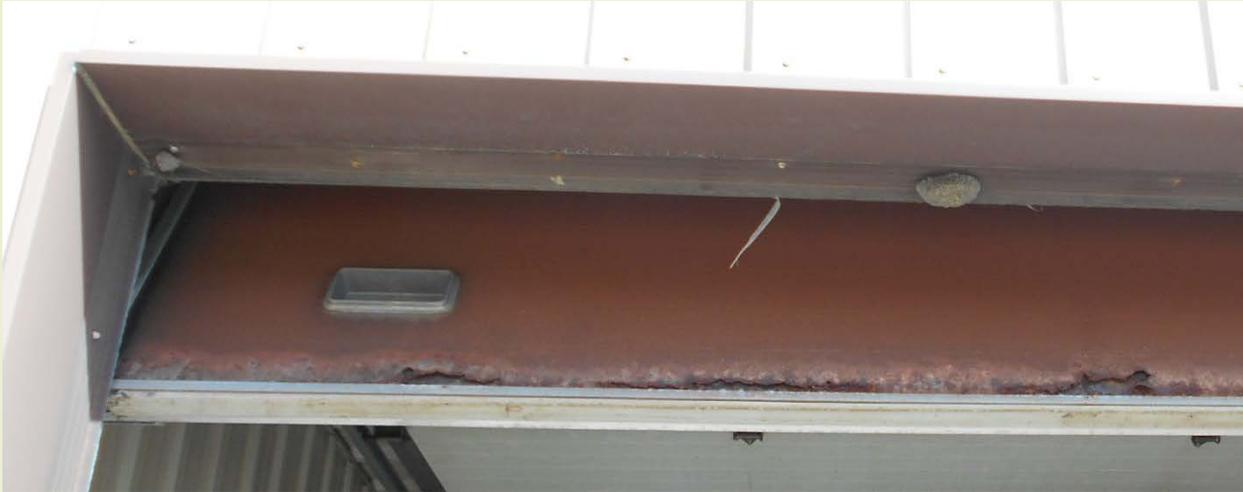
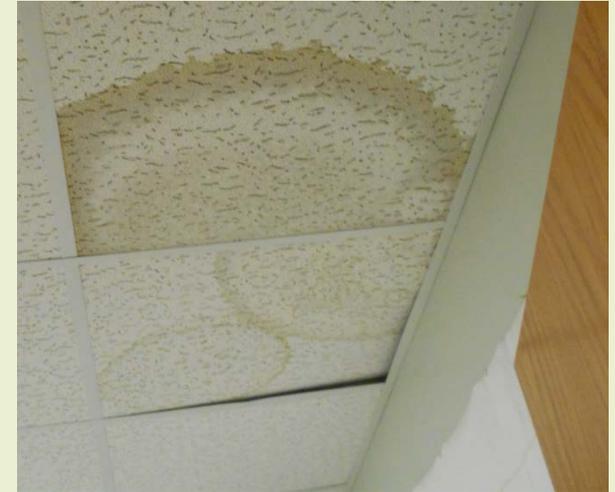
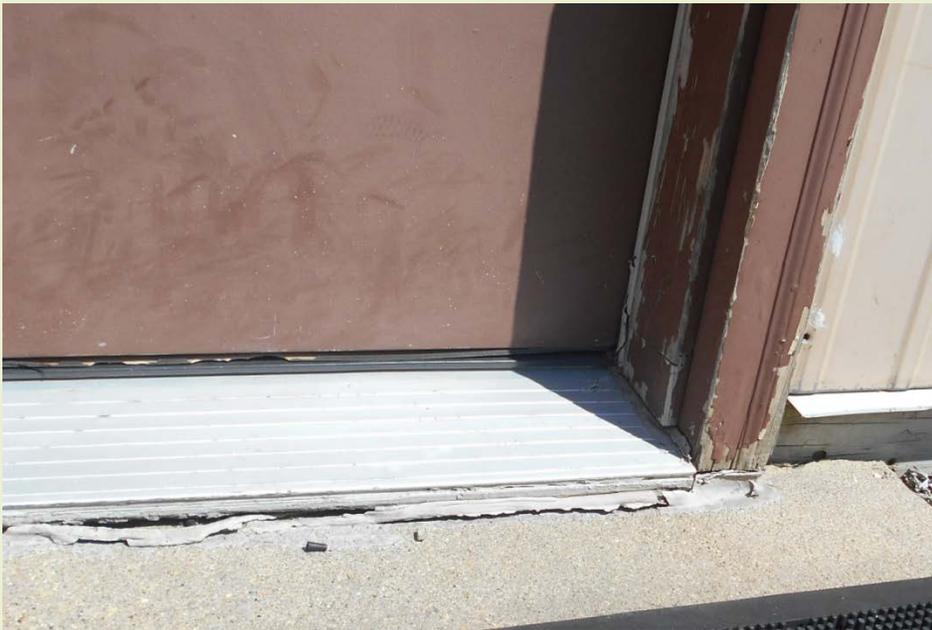
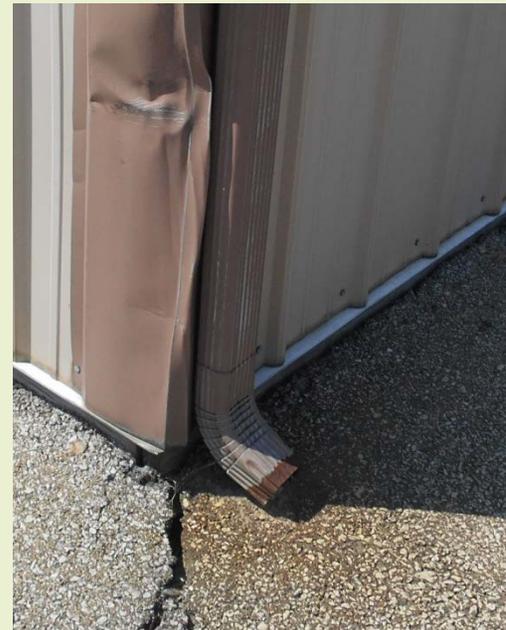
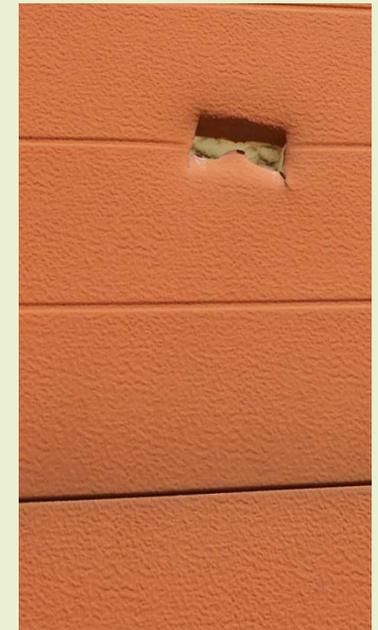
- Exterior door finishes deteriorated at base of doors.
- Exterior wall panels in fair condition, minor damage and deterioration.
- Downspouts damaged, finish worn and integrity compromised.
- Soffits and gutters rusted, paint deteriorated.
- Perimeter sealant/patch at concrete joints failed.
- Weatherstripping at overhead doors failed. Trim broken and missing.
- Gaps in metal panels at penetration locations, require sealant.
- Interior insulation panels worn, some impact damage.
- Concrete flooring heavily worn and pitted.

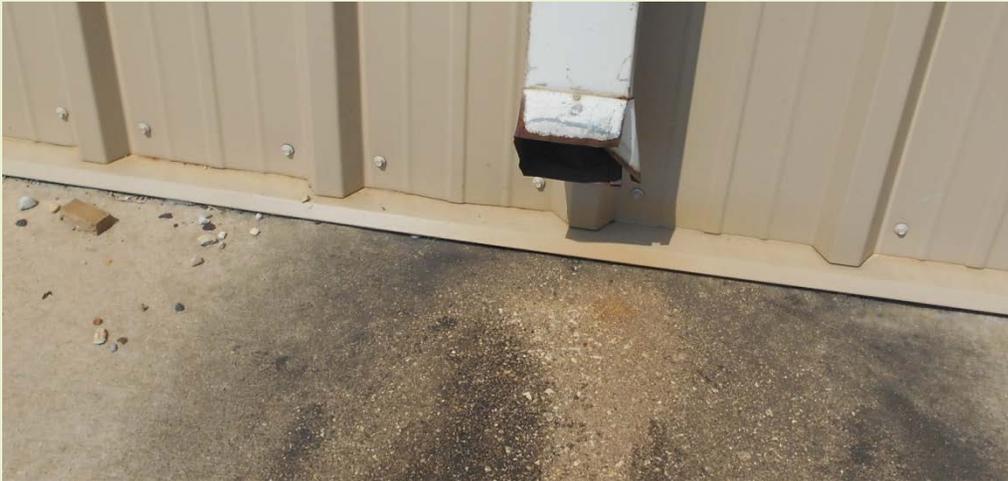
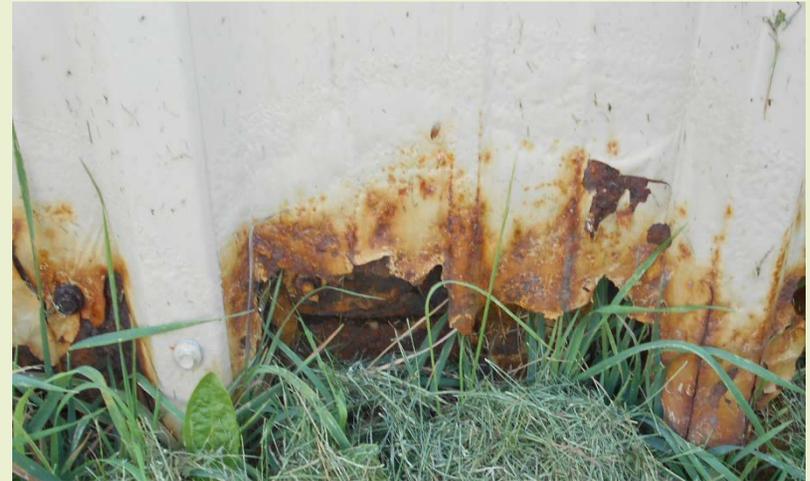
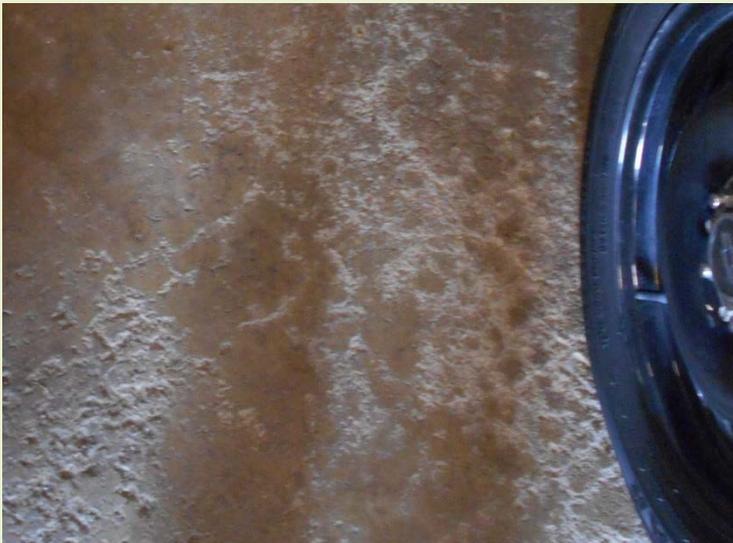
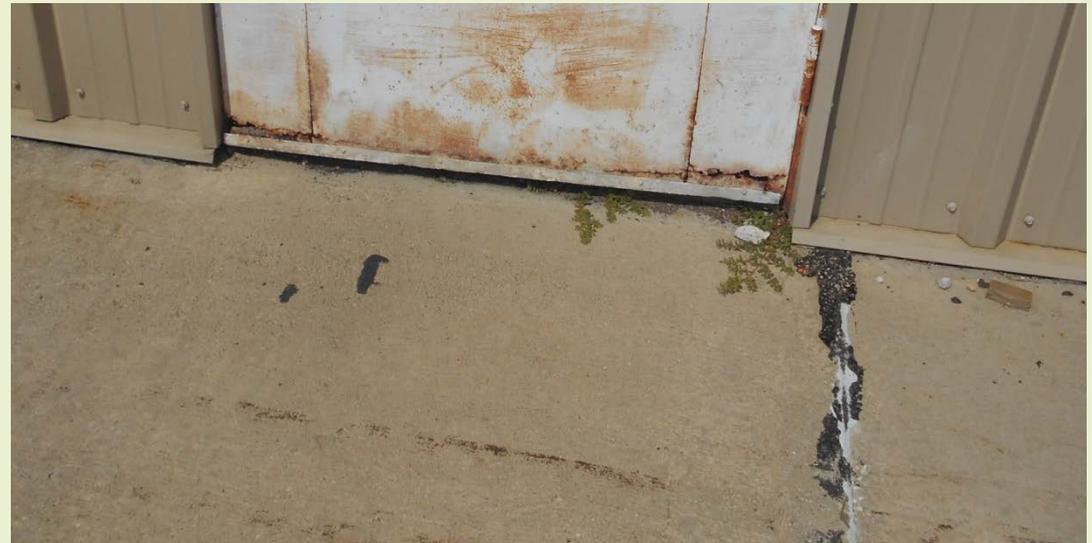
- The garage overall is in fair condition.
- Concrete flooring stained and worn, minor cracks.
- Exterior door finishes and frames are deteriorated and rusted at base.
- Fiberglass overhead doors and frames are damaged.
- Moisture damage and rust at base of metal wall panels.
- Metal wall panel seams dented, peeling apart, several large tears.
- Sealant at base of metal wall panels along concrete deteriorated.
- Bollards damaged from impact.
- No ventilation or heating present. No oil interceptor at trench drains.

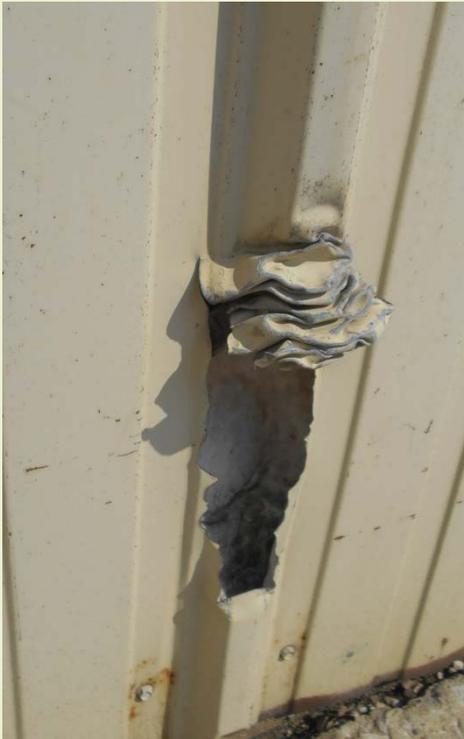
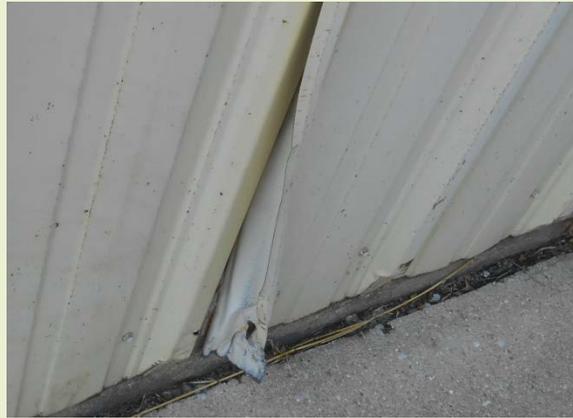
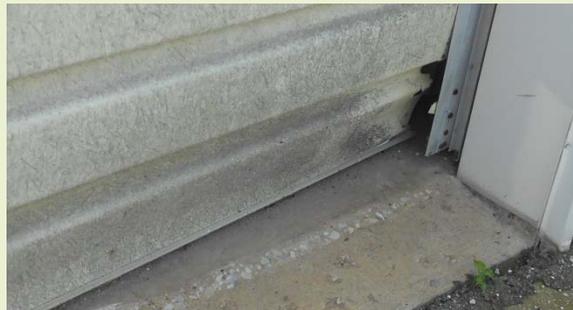
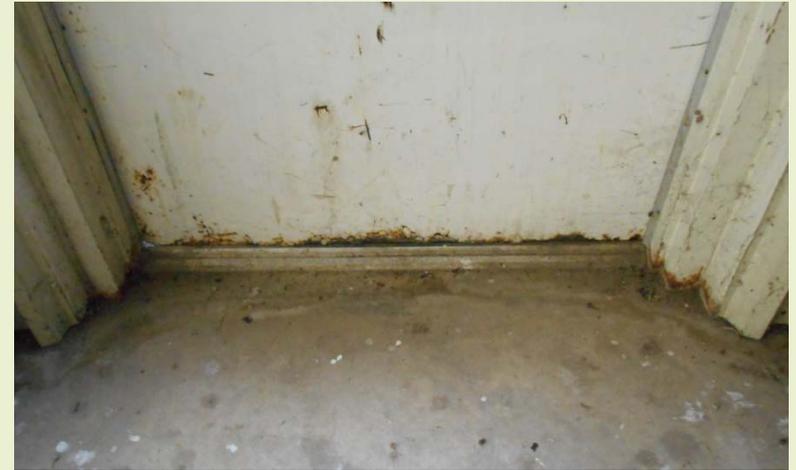
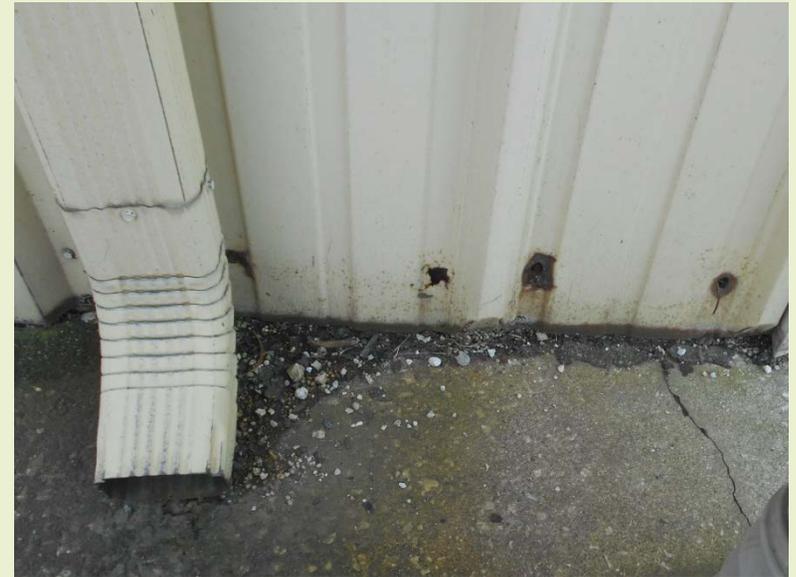
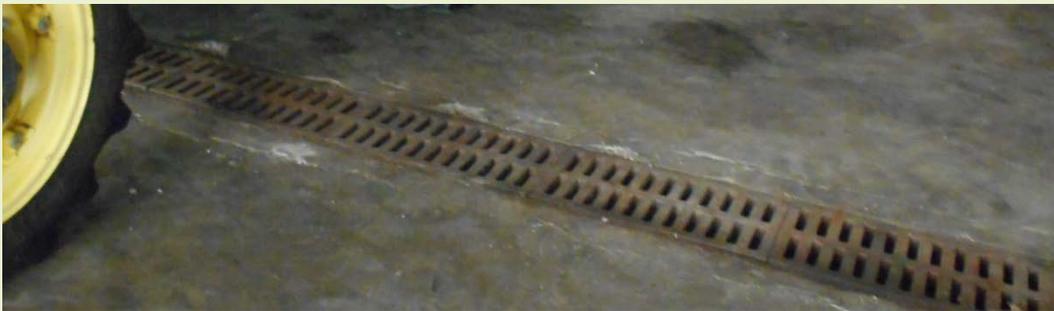
- A few large cracks in concrete flooring.
- Interior and exterior deterioration on metal panel.
- Metal downspouts deteriorated, leaks found at joints.
- Exterior trim bent and damaged at door openings.
- Interior steel structure worn and deteriorated.
- Punctures, bent and damaged metal panels along base of exterior.
- Oil interceptor at trench drains and exhaust fan installed.
- No ventilation. Ceiling mounted gas fired unit heater nearing end of useful life.

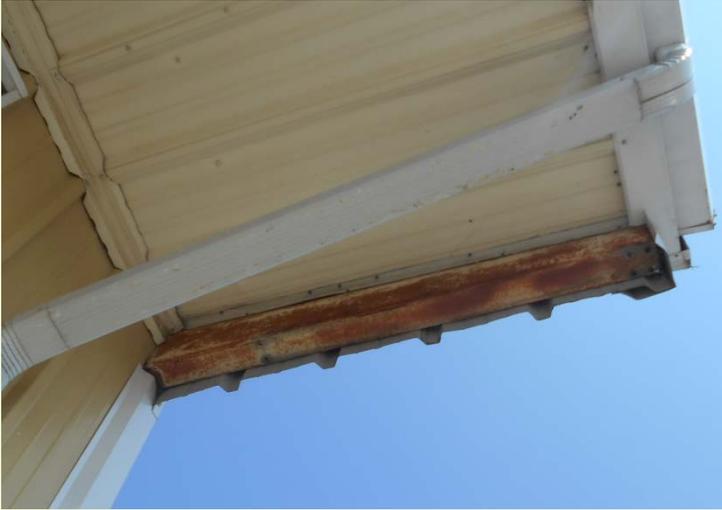
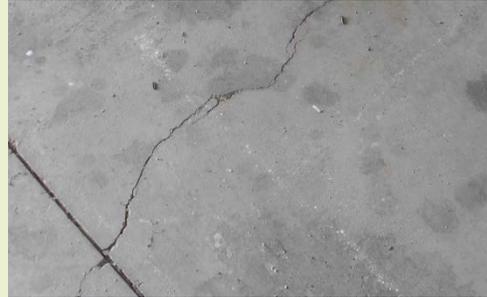
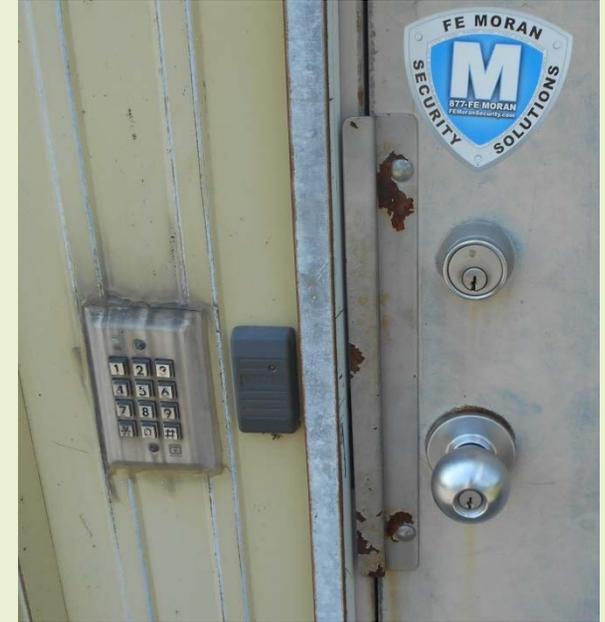
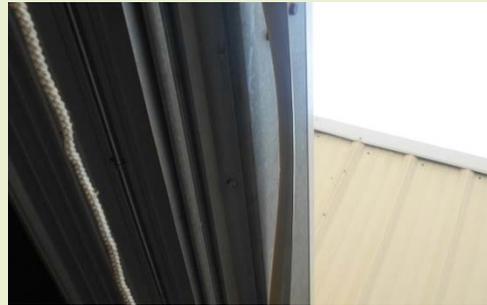
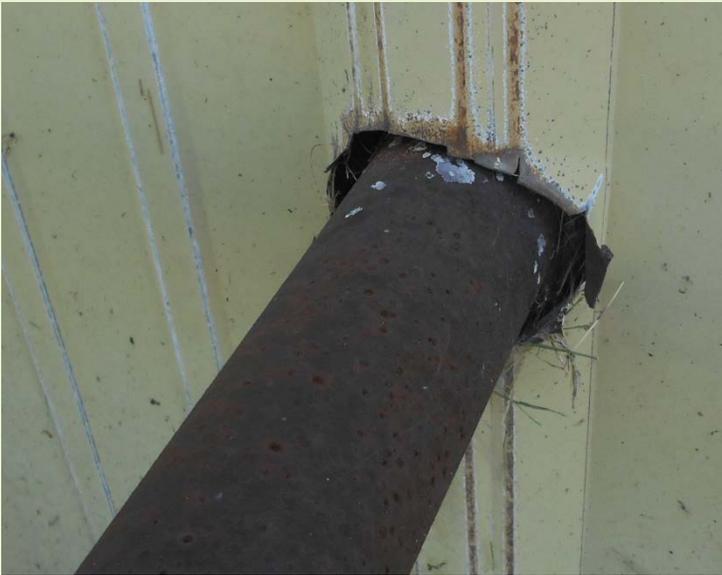
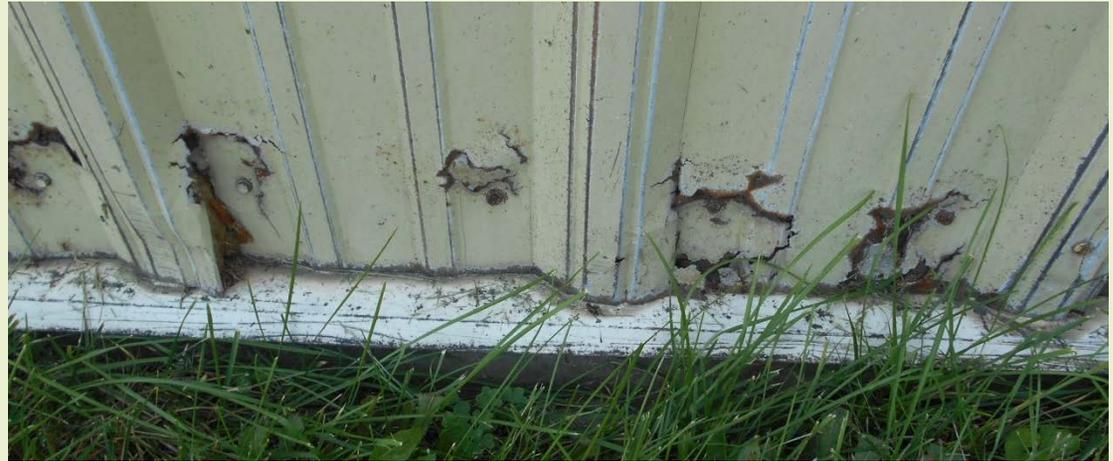
- ILEAS Garage 1 is connected to EMA Garage.
- The building is in overall good condition.
- Sealed concrete flooring is scratched and worn in places.
- Finish on interior exposed structure is worn and deteriorated.
- Overhead door and frame is in fair condition.
- Gutters and downspouts are in good condition.
- Some plant growth in cracks along exterior concrete and pavement.
- Sealant deterioration in places along concrete.
- No ventilation. Heat provided by ceiling mounted gas fired unit heater.

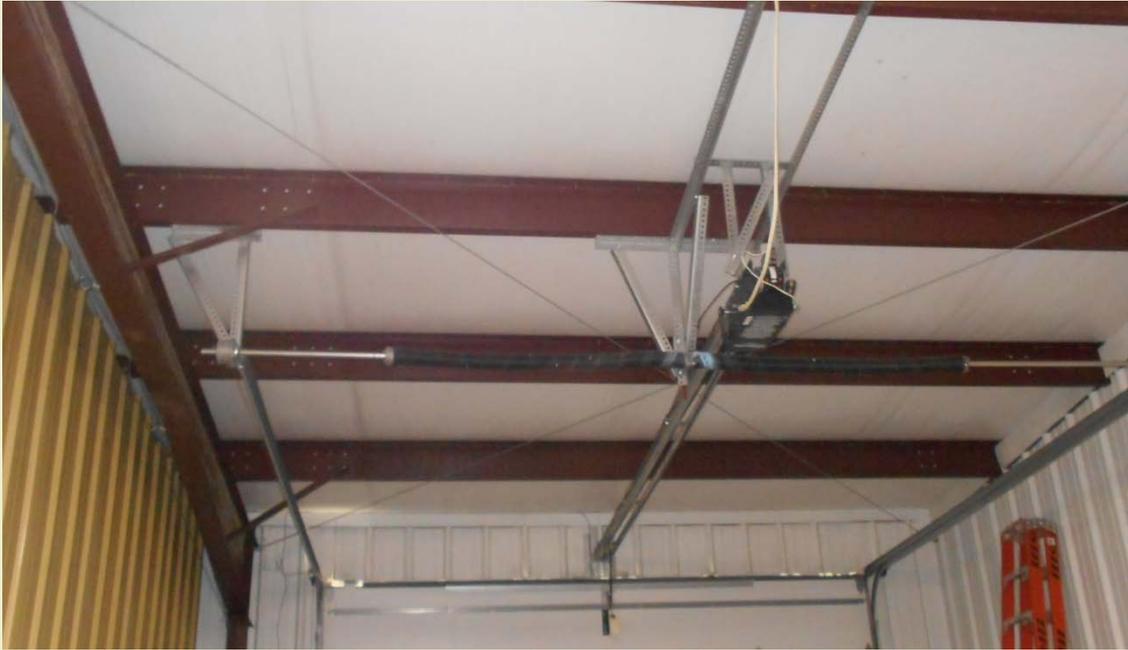
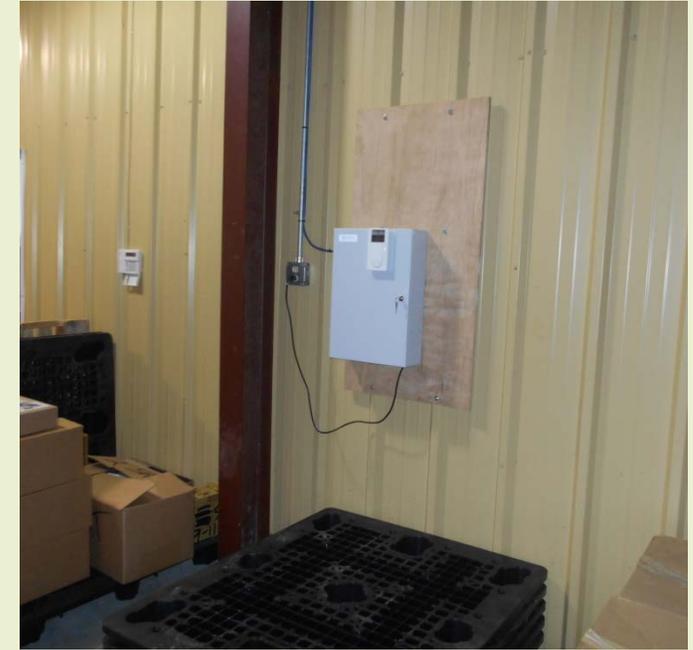
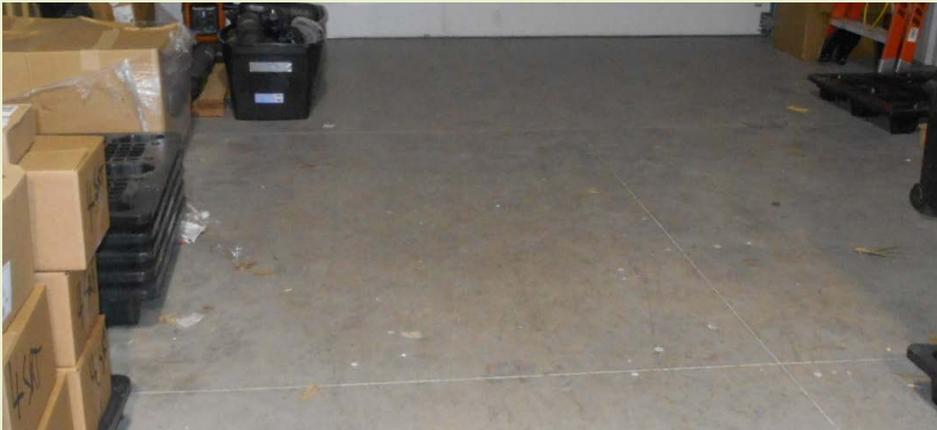
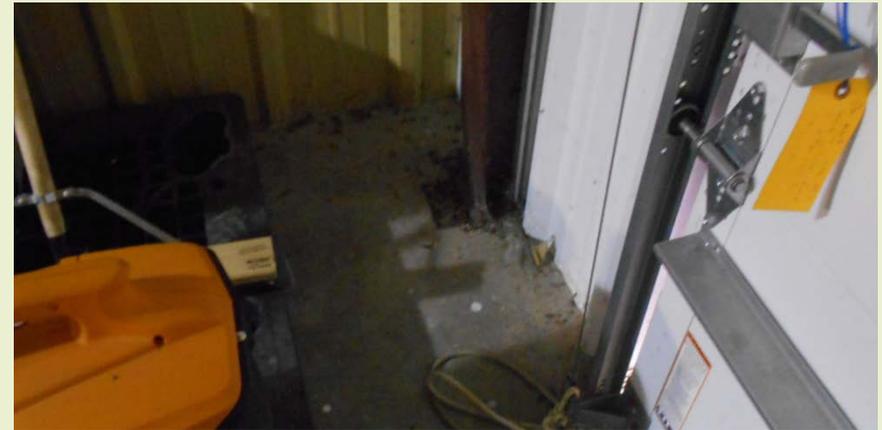
- ILEAS Garage 2 is connected to Sheriff's Garage.
- The building is in overall fair condition.
- Sealed concrete flooring is scratched and worn in places.
- Doors are worn with some deterioration.
- Finish on interior exposed structure is worn and deteriorated.
- Gutters and downspouts are deteriorated.
- Roof overhang is deteriorated and has impact damage.
- Organic plant growth in cracks along exterior concrete.
- No ventilation. Heat provided by ceiling mounted gas fired unit heater.

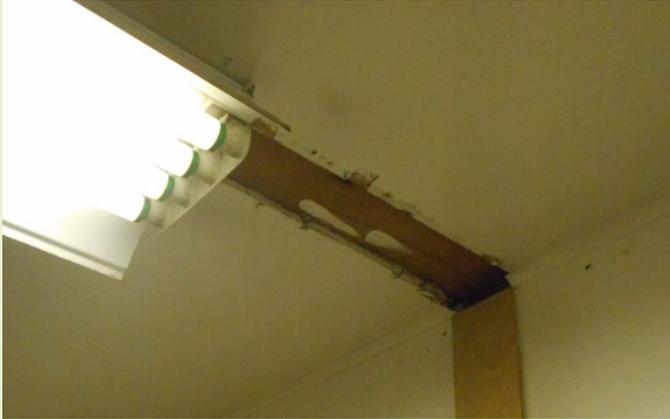
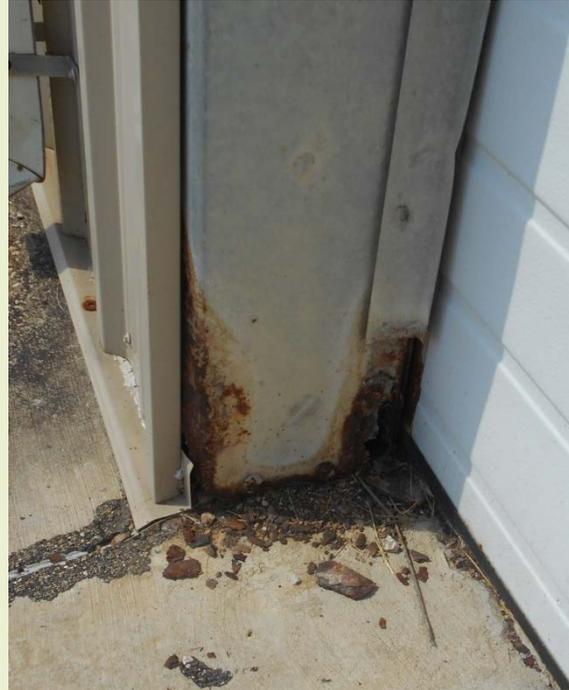
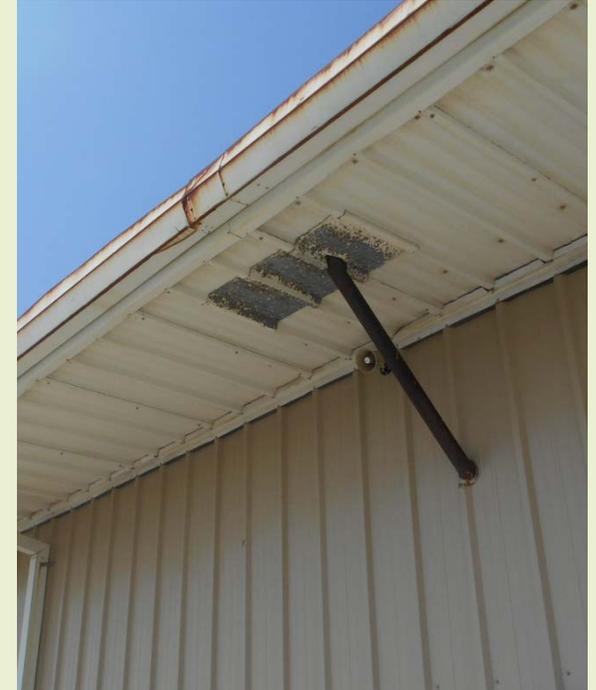
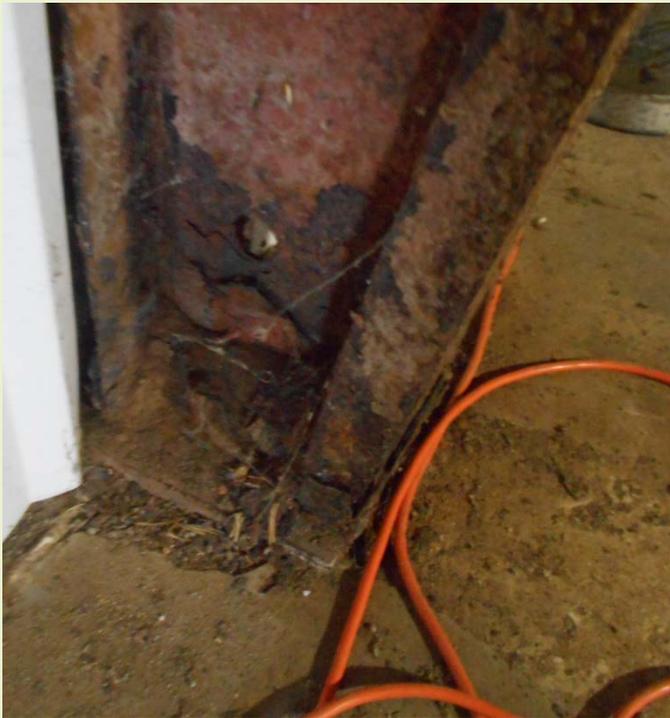
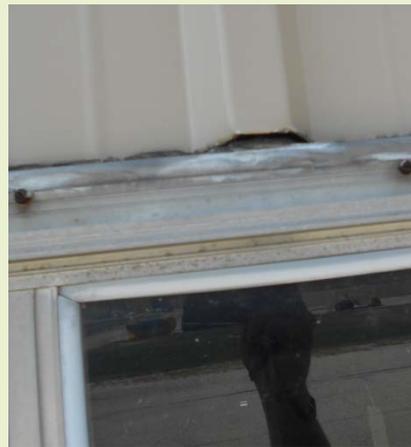
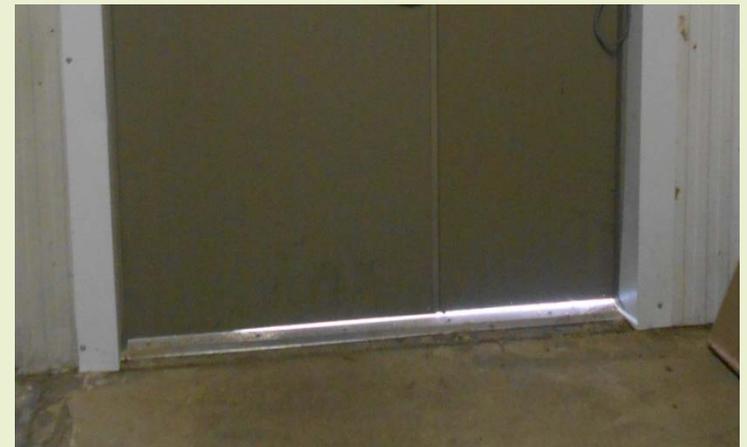
- ILEAS Garage 3 is connected to County Highway Garage.
- The building is in overall fair condition.
- Sealed concrete flooring is scratched and worn in places.
- Finish on interior exposed structure is worn and deteriorated.
- Doors have some deterioration and are in fair condition.
- Interior structure is in good condition, some deterioration.
- Overhead door is in fair condition, minor impact damage.
- Sealant deterioration in places along concrete.
- No ventilation. Heat provided by ceiling mounted gas fired unit heater.
